ADA SELF EVALUATION AND TRANSITION PLAN

City of South Gate

Volume 3
Right of Way Barriers Assessment Report

March 2018

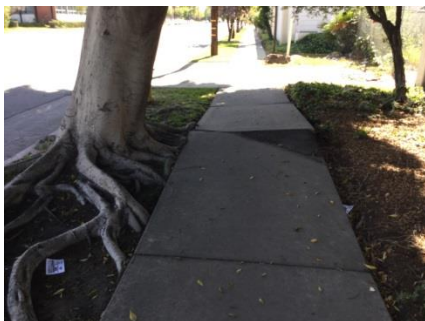
Tree roots tend to grow under sidewalk access routes and push the concrete slabs, creating vertical displacements that prevent access to wheelchairs and/or can cause tripping hazards to those who are visually impaired. Additionally, roots can lift one side of the sidewalk, creating a cross slope barrier that exceeds 2.0% and create a vertical displacement.

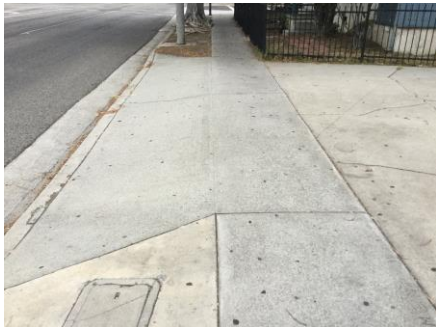
Compliant Example:

Driveways present another commonly found barrier to the path-of-travel. California Building Code states that the cross slope of an access route must not exceed 2.0% grade. If a driveway crosses the path of travel there must remain a minimum access width of 4 ft with a grade of less than 2.0% cross slope.

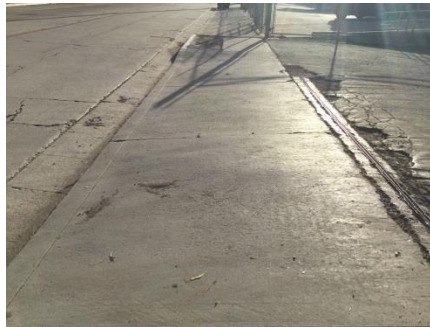
Noncompliant example:

Owen Group surveyors record each occurrence of a noncompliant driveway. If driveways have a slope greater than 2% grade and is the only path in the pedestrian right-of-way than it is noncompliant. Essentially, a level passing lane must be provided for the entire length of the driveway. Pictures are taken for each noncompliant occurrence.
