# City of South Gate

# Volume 2

## Appendix B Facilities Barrier Assessment Report

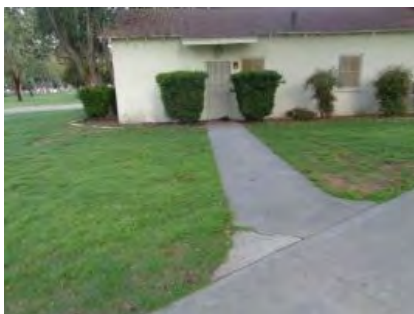
**Item Description:** Broken concrete;

**Findings:** Concrete walk is broken.

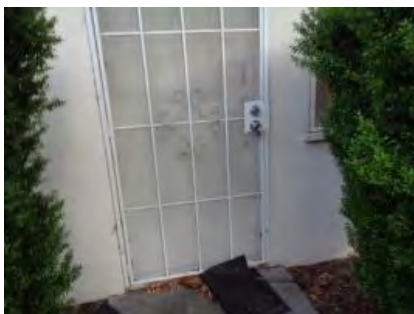
**Item Description:** Round door knob;

**Findings:** Door stop at the push side of door interferes with the requirement for a smooth door surface.

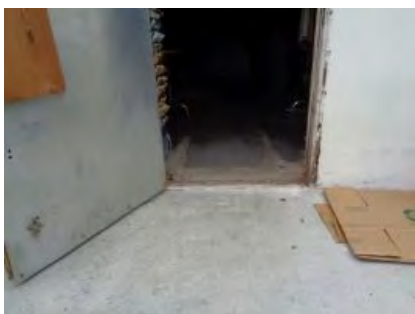
**Findings:** The 3 inch change in elevation at the entrance door is not accessible.

**Recommendations:**  
The elevation difference of the interior floor and the exterior ramp landing requires that the door frame be raised and the ramp and ramp landing be demolished and rebuilt, or, an interior ramp be cut into the existing concrete floor.

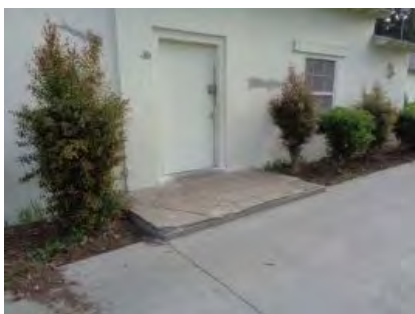
**Item Description:**    Door landing;

**Findings:** The change in elevation at the entrance door is not accessible. The required additional 24" clearance beyond the strike-side of the door is not provided.

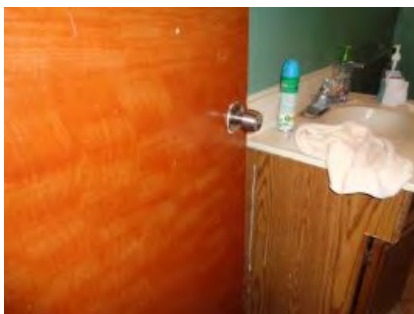
**Findings:** Round door knob at restroom door is not accessible.

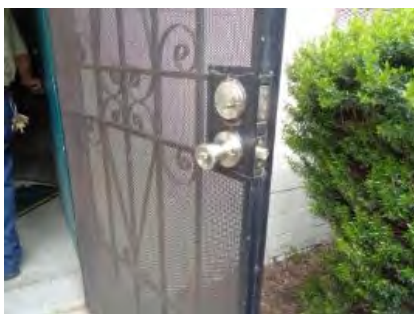
**Findings:** Round door knobs at both entrance doors are not accessible.

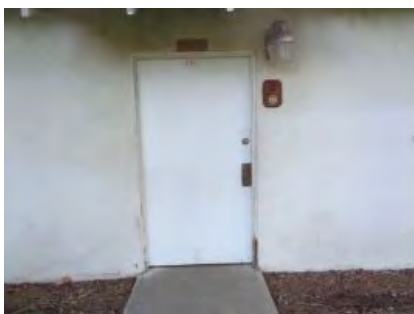
**Item Description:** Round door knob;

**Findings:** Round door knob at entrance door is not accessible.

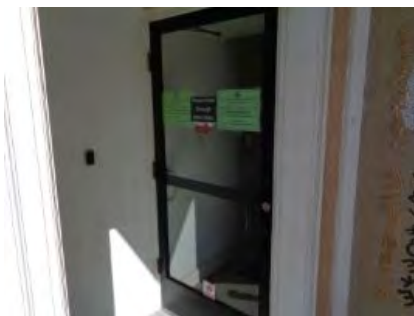
Item Description: Signage; Exterior Two-way communication system; Accessible door

Findings: The in-accessible entrance at the left does not have proper signage indicating the location of the accessible entrance. Visual indicator and a sign explaining the visual indicator have not been provided at the two-way communication system. The required side clearance at door is not provided at the interior side of door.

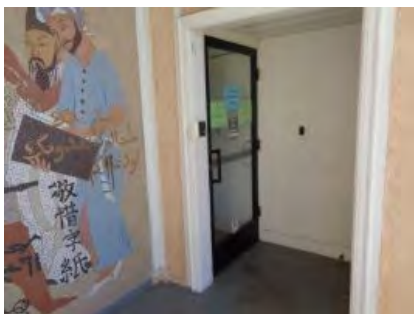
Item Description: Signage;

Findings: The required ISA sign is not provided at the accessible door.

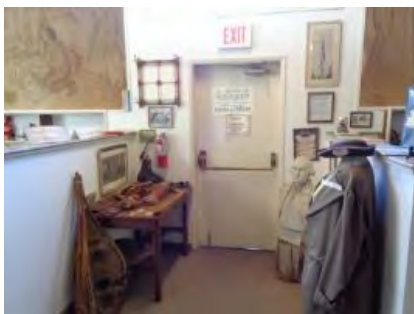
**Findings:**      Tactile exit signs are not provided at grade level exit doors.

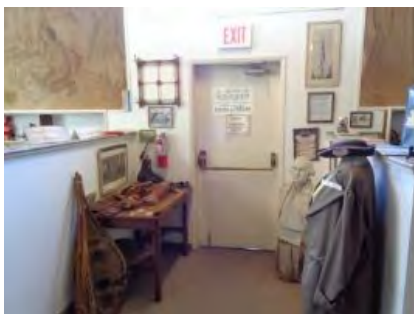
**Item Description:**      Exit door; Exit door

**Findings:** The required wheelchair maneuvering space is not provided. Table interferes projects into the required floor space. Door stop at the push side of door interferes with the requirement for a smooth door surface.

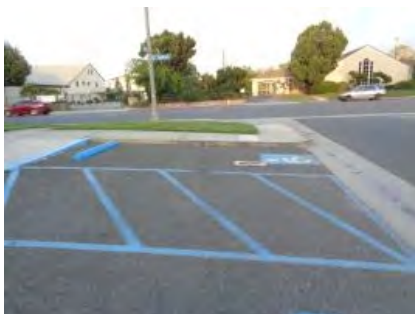
**Item Description:** Accessible Route;

**Findings:** Walkway next to parking has a noncompliant slopes at areas where a change in direction occurs. At any walkway where a change in direction occurs, that area shall be level, with slopes not greater than 2.1" in any direction

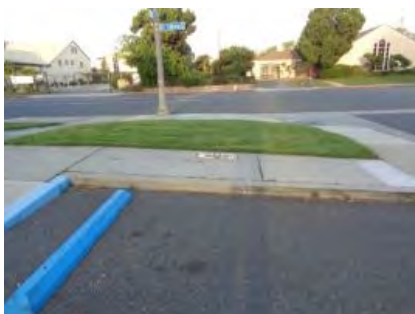
**Item Description:** Accessible Route;

**Findings:** Walkway next to parking has a noncompliant slope of 5.6%.

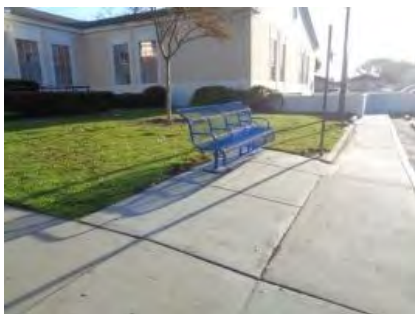
**Item Description:** Fixed Seating ;

**Findings:** The seating area at the South entrance does not provide for wheelchair seating.

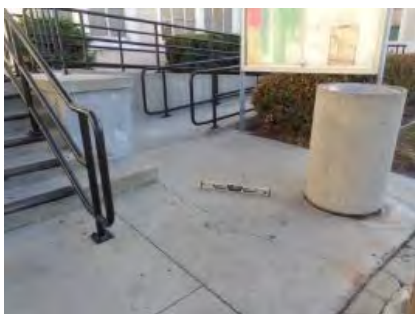
**Item Description:** Accessible Route;

**Findings:** The path that bypasses the stairs and leads to the ramp serving the entrance door is not compliant as the cross slope of 5.2%.

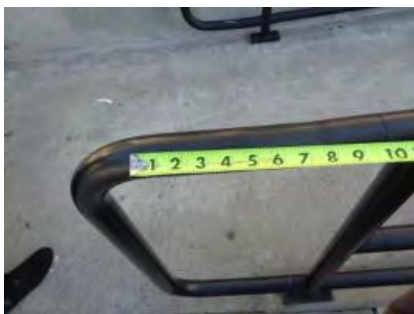
**Item Description:**    Pedestrian ramp handrails;

**Findings:** Handrail extensions do not turn level for a minimum of 12" before turning down.

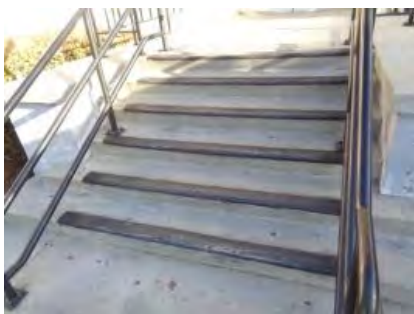
**Item Description:**    Warning stripes;

**Findings:** Warning stripes at stair are aged and need to be repainted.

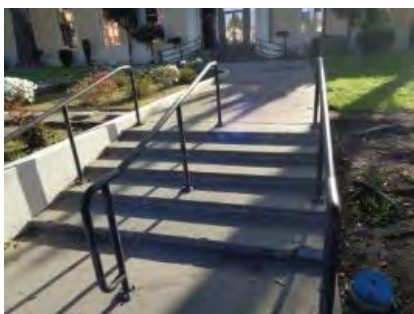
**Item Description:**      Broken Step;

**Findings:** Stair tread leading to City Hall is broken.

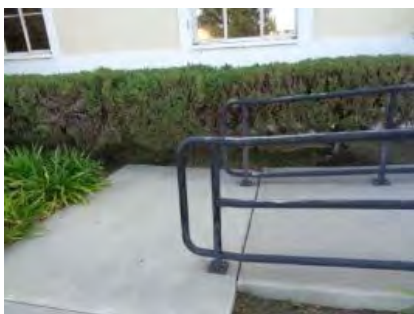
**Item Description:** Ramp Landing;

**Findings:** The lower ramp landing is not compliant for length.

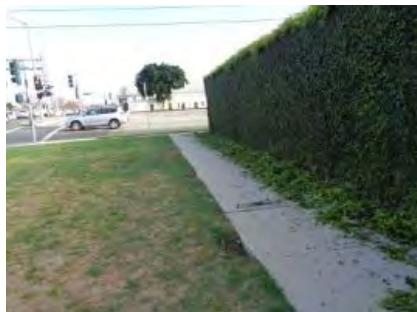
**Item Description:**      Walkway Raised slab;

**Findings:**      One walkway slab section between Ardmore Ave. and the entrance to the Police Station main entrance is heaving, creating raised edges at each end. Raised edges are greater than 1-4" high. The same slab has a non-compliant cross slope of 2.6% due to heaving.

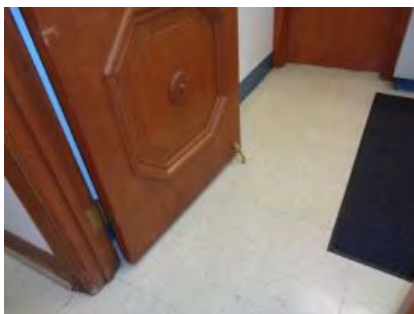
**Item Description:** Door stops;

**Findings:** Door stops at the push side of doors interfere with the requirement for a smooth door surface.

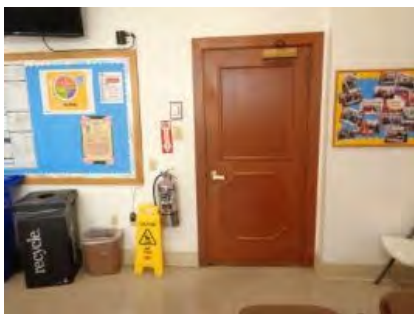
**Item Description:** Door closers;

**Findings:** All doors with automatic closers require adjustment for opening force and closing speed.

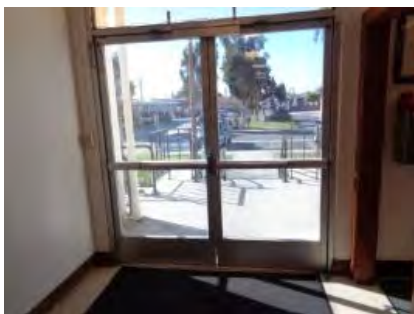
**Item Description:**      Tactile exit signs;

**Findings:**      Tactile exit signs are not provided at all exit doors.

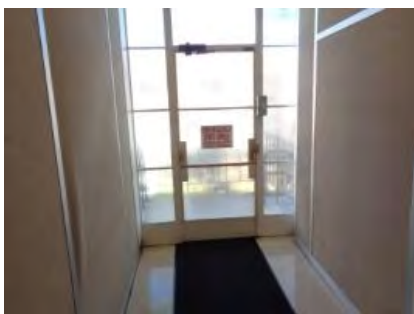
**Item Description:**      Directional signs;

**Findings:**      At exits doors with only stairs, signage is not provided to indicate the location of the accessible exit door.

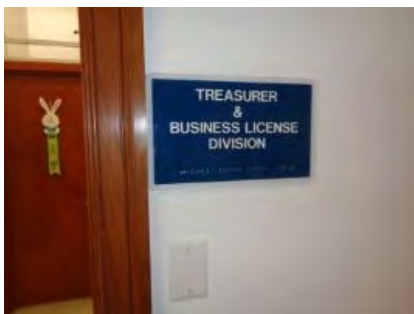
**Item Description:**      Room Identification signs;

**Findings:** The required tactile room I.D. signs are not provided at various rooms. The existing room ID signs have federal braille font which does not conform to California Braille requirements. All existing room ID signs shall be replaced.

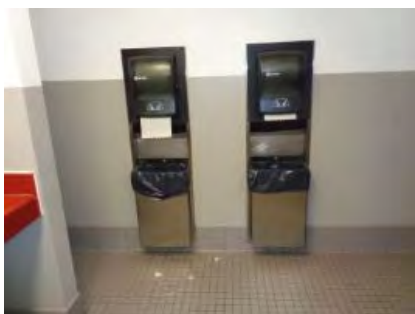
**Item Description:** Paper towel dispensers;

**Findings:** Dispensers are not accessible due to height. Both dispensers are not accessible as they require use of both hands.

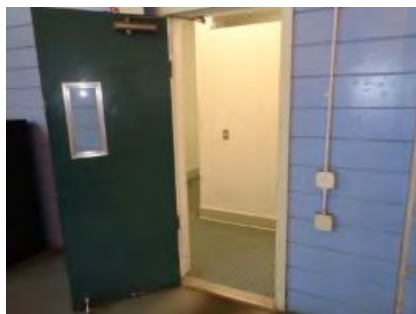
**Item Description:** Restroom door width; Smooth surface at door

**Findings:** Clear width at entrance to restroom is 1 inch less than the required width of 32". Door stop at the push side of door interferes with the requirement for a smooth surface.

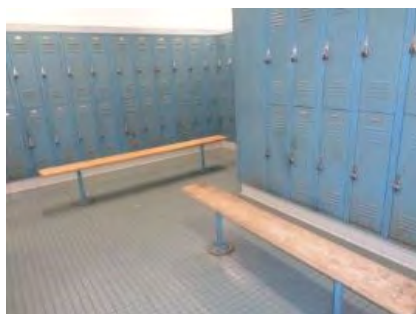
**Item Description:** Locker room benches;

**Findings:** 58 lockers are available. No accessible locker benches have been provided. Five percent of all lockers shall be accessible with accessible benches.

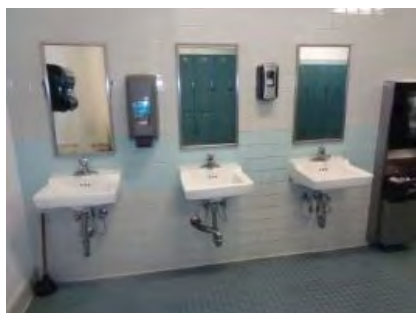
**Item Description:** Lavatory mirrors;

**Findings:** Mirrors over lavatory are not compliant for height at 41" AFF to the lowest reflective edge.

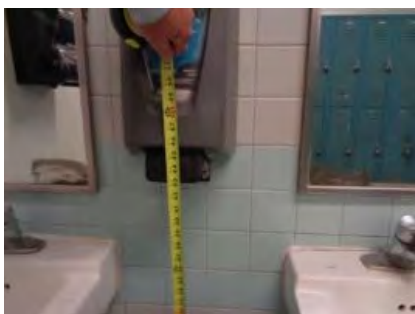
**Item Description:**      Soap Dispenser;

**Findings:**      The low soap dispenser is not compliant for height at 43-1/2" to the highest operable part.

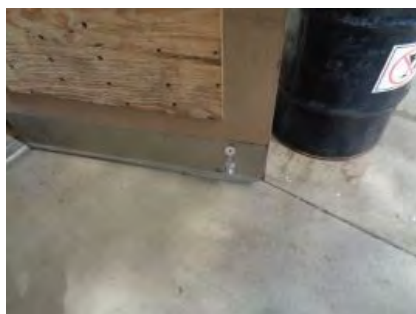
**Item Description:** Door stop;

**Findings:** Door stop at the push side of door interferes with the requirement for a smooth door surface.

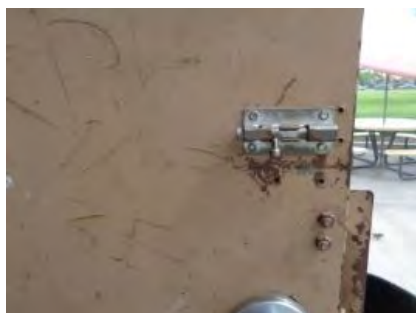
**Item Description:** Door lock;

**Findings:** The barrel latch on door is not accessible as it requires tight grasping.

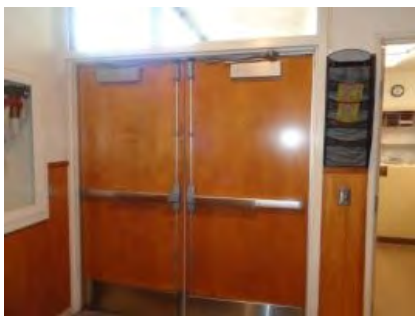
**Item Description:** Tactile Exit Signs;

**Findings:** Tactile exit signs are not provided at all grade level exit doors.

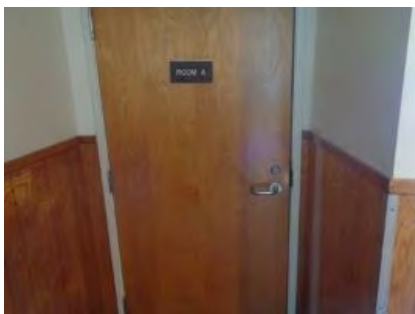
**Item Description:** Tactile room identification signs;

**Findings:** Compliant room Identification wall signs are not provided.

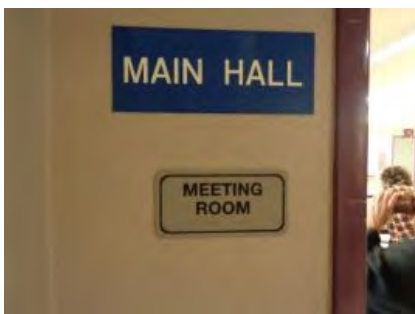
**Findings:**      Federal Braille spacing was used on all signs, which does not conform to California requirements.

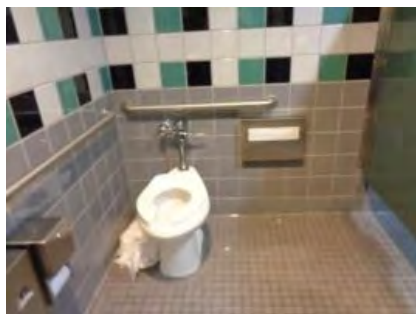
**Item Description:**      Rear grab bar; WC location; Toilet paper dispenser

**Findings:** Rear grab bar is not compliant for location. The accessible WC is not compliant for location, centered 16-5/8" from the side wall. Dispenser is not compliant for location, centered 12" in front of the WC.

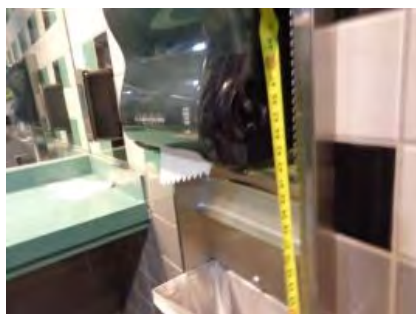
**Item Description:**      Paper towel dispenser in stall;

**Findings:** Dispenser is not accessible due to height. Dispenser is not compliant as it require use of two hands and requires tight grasping and pinching. The side wheel for advancing paper requires twisting of the wrist.

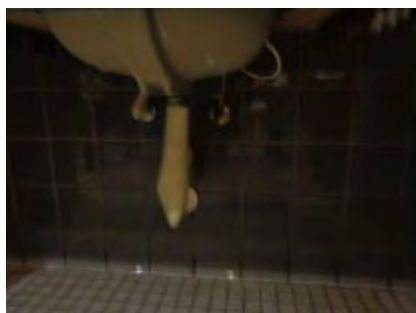
**Item Description:**      Lavatory Insulation;

**Findings:** Insulation beneath the lavatory is not complete.

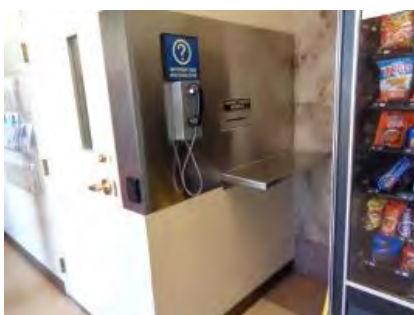
**Findings:** Phone is not accessible. Height of phone is excessive at 57" and the handset cord is 28" long. Counter is not accessible due to a height of 39-3/4". Deposit slot in wall is not accessible due to a height of 52" AFF.

**Recommendations:**  
Lower phone. The highest operable part shall not be higher than 48" AFF. Provide a new handset cord, 29" minimum in length. Lower counter. Counter height shall not be greater than 34" AFF. Lower deposit slot to a height not greater than 48" AFF.

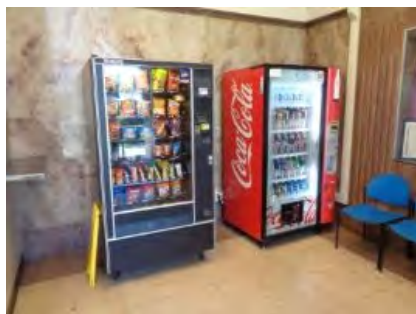
**Item Description:** Vending machines; Vending machines

**Findings:** The left snack vending machine interferes with the required clear floor space at the telephone and counter. Access to the right vending machine is partially blocked by chairs.

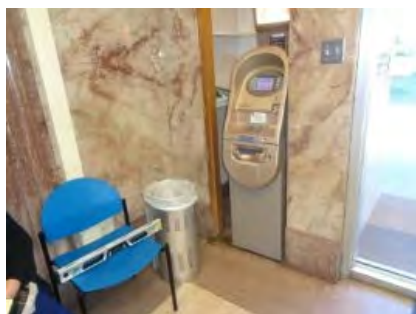
**Item Description:** ATM;

**Findings:** The required clear floor space in front of the ATM is obstructed by a waste can and chair.

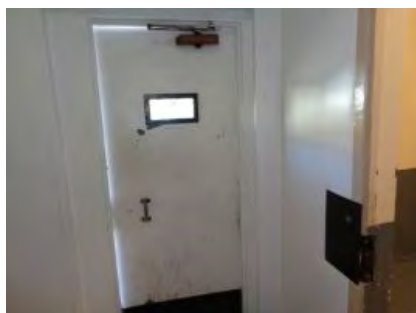
**Item Description:** Exterior doors;

**Findings:** Exterior door to holding cells is not accessible due to a clear width less than 32".

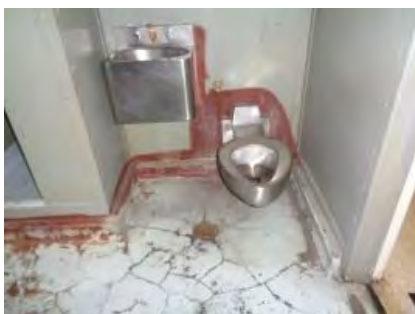
**Item Description:** WC seat height; Grab bars

**Findings:** Seat height at WC is not accessible at 16" AFF. Grab bars are not provided at WC.

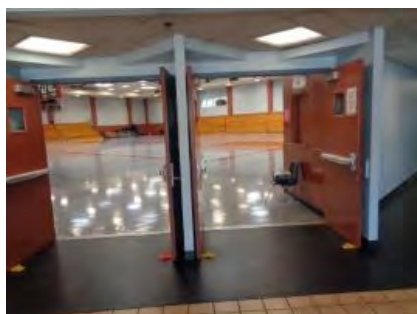
**Comment**      **SC-004**                      **Priority: 1**      **Estimated Direct Cost:**      \$1,665                      Maintenance  
**Item Description:**      Door closers; Signage

**Findings:** All doors with automatic closers require adjustment for opening force and closing speed. Signage is not provided at lobby area or basketball courts to inform patrons of the availability of the assistive listening system.

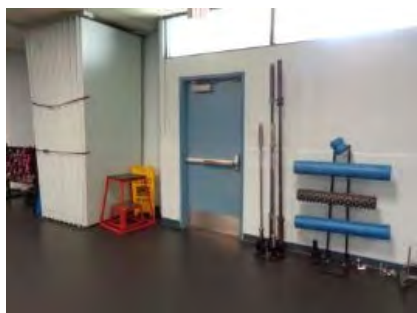
**Comment**      **SC-005**                      **Priority: 1**      **Estimated Direct Cost:**      \$600                      Maintenance  
**Item Description:**      Tactile exit signs;

**Findings:** Tactile exit signs are not provided at all grade level exit doors.

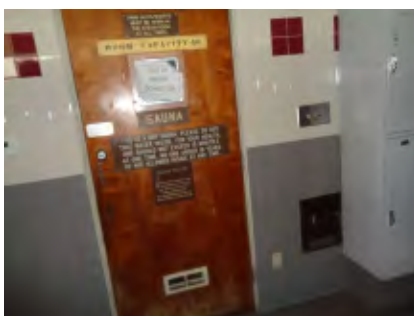
**Findings:** Sauna controls at wall are not accessible, requiring tight grasping and twisting of the wrist.

**Recommendations:**  
Sauna is not in operation. If operation is resumed, accessible controls will need to be added.

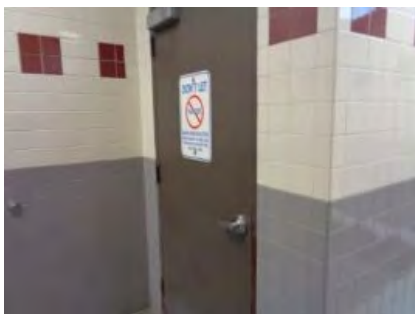
**Item Description:** Door closers;

**Findings:** All doors with automatic closers require adjustment for opening force and closing speed.

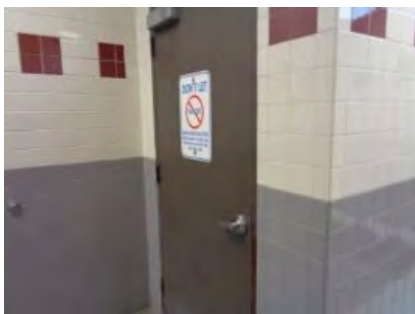
**Findings:** The required tactile room I.D. signs are not provided at various rooms. I.D. signs for interior rooms or spaces are required. Tactile Exit signs are also not provided at interior rooms leading to corridor or hallway, nor are they provided at all grade-level exit doors and gates.

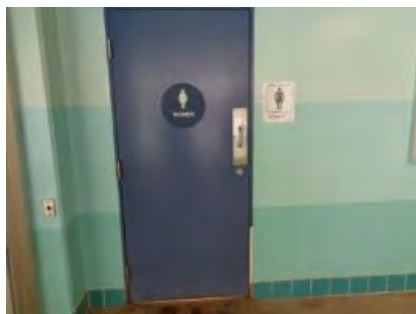
**Findings:** The geometric door sign color fails to provide contrast with the door color. The required tactile wall sign is not provided at the restroom doorway.

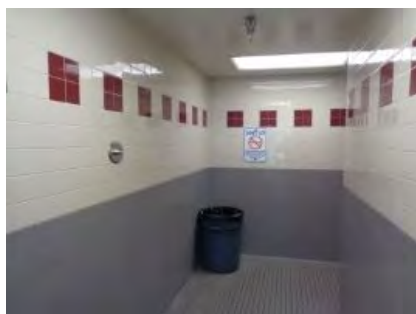
**Findings:** Wall control valve for overhead sprayer is not accessible for height at 58-1/2" AFF.

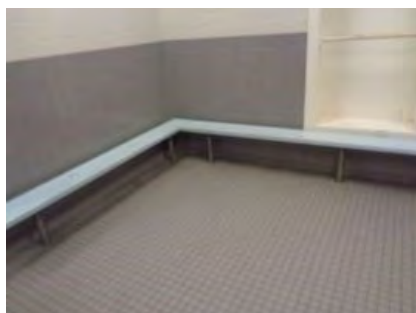
**Findings:** Accessible benches are not provided.

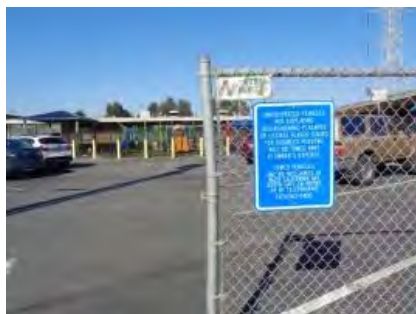
**Findings:** The posted tow-away warning sign at the entrance to the parking area is not compliant, having the wrong text.

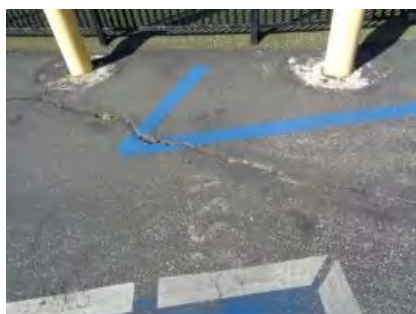
**Findings:** Parking surface has large cracks and is not level, with slopes up to 4.9% at the head of the access aisle. Stalls are required to be level.

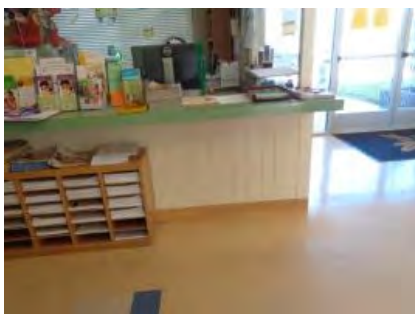
**Findings:** Counter is not accessible, having a surface height of 36-1/2".

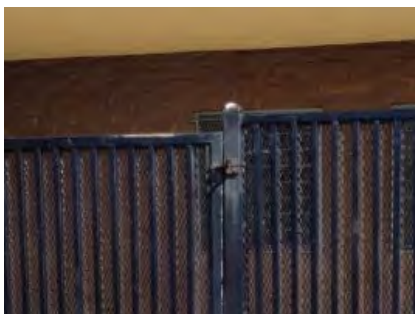
**Findings:** In addition to gate latching hardware, a non-compliant gate latch is mounted at the top of gates outside of the allowable reach range.

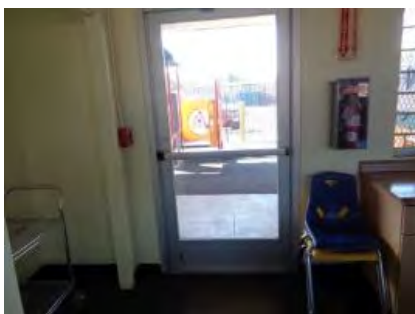
**Findings:** The required minimum side-strike clearance of 12" is not provided, measuring 9-1/2".

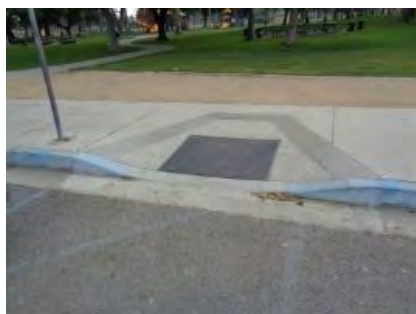
**Findings:** The side flare slopes are greater than 10% and were found to be 14%.

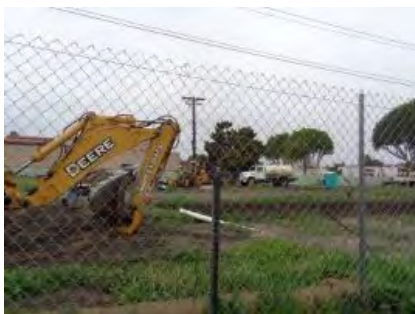
**Findings:** At the time of survey, park construction was active with an expected completion of Fall 2016

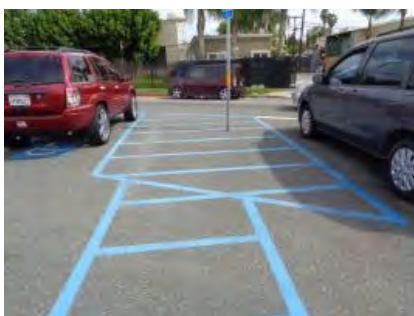
Findings: Diagonal stripes within access aisles do not provide the required visual contrast with the parking surface. The words "NO PARKING" are not painted on the ground within the access aisle.
