# City of South Gate

# Volume 2

## Appendix B Facilities Barrier Assessment Report

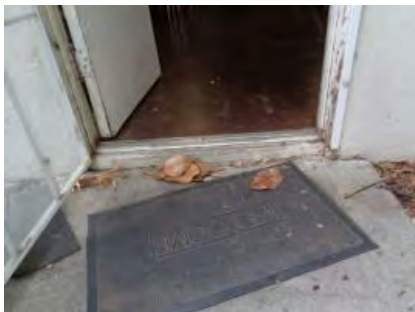
**Item Description:** Door landing;

**Findings:** The change in elevation at the entrance door is not accessible. The required additional 24" clearance beyond the strike-side of the door is not provided.

**Recommendations:**  
Provide a new level landing at the exterior side of the door, measuring 60"X60". Transition the new landing into the existing walkway with a directional slope not greater than 5.0%.

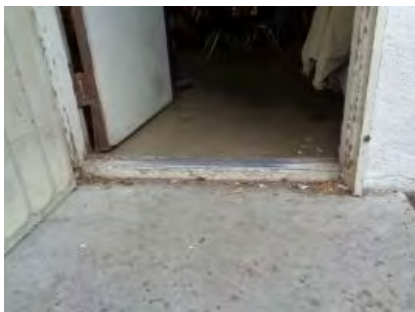
**Item Description:** Door landing;

**Findings:** The 2 inch change in elevation at the entrance door is not accessible. The required additional 24" clearance beyond the strike-side of the door is not provided.

**Recommendations:**  
Provide a new level landing at the exterior side of the door, measuring 60"X60". Transition the new landing into the existing walkway with a directional slope not greater than 5.0%.

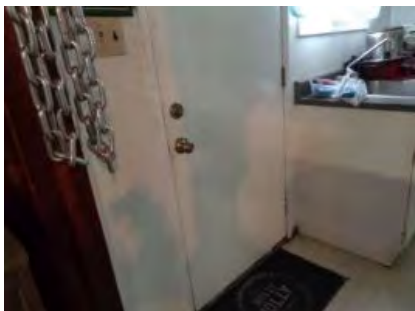
**Item Description:** Round door knob;

**Findings:** Round door knob at entrance door is not accessible.

**Recommendations:**  
Replace round door knob with a lever handle. The end of levers shall return to within 1/2" of the door surface.

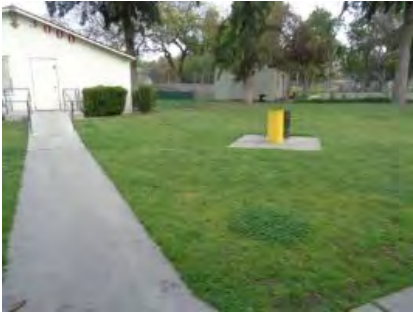
**Comment**     **BSC-006**     **Priority: 3**     **Estimated Direct Cost:**     \$750     Contractor

**Item Description:** Drinking fountain;

**Findings:** A compliant POT is not provided to DF.

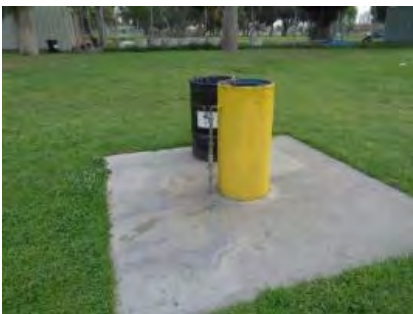
**Comment**     **BSC-007**     **Priority: 3**     **Estimated Direct Cost:**     \$5,000     Contractor

**Item Description:** Drinking fountain;

**Findings:** DF is not accessible

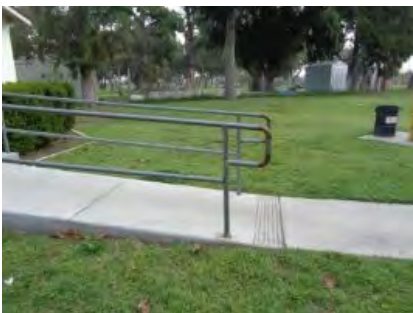
**Comment**     **BSC-008**     **Priority: 1**     **Estimated Direct Cost:**     \$2,500     Contractor

**Item Description:** Handrails;

**Findings:** Ramp handrail does not extend the full length of ramp. Level handrail extensions are not provided.

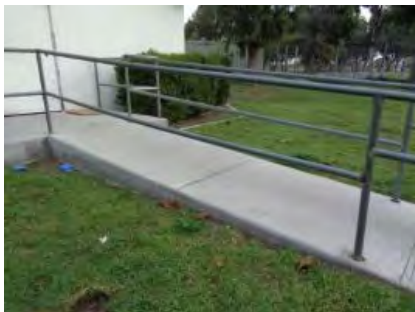
**Item Description:**    Edge protection;

**Findings:** Ramp is missing edge protection at landing and both sides of ramp.

**Recommendations:**  
Provide barrier of matching galvanized pipe that prevents the passage of a 4 inch diameter sphere, where any portion of the sphere is within 4 inches of the concrete surfaces. To prevent wheel entrapment, the barrier shall provide a continuous and uninterrupted barrier along the length of the ramp.

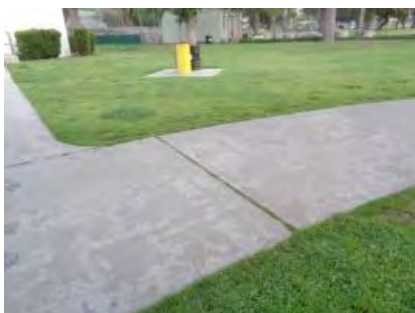
**Item Description:**    Slab joints;

**Findings:** Various slab joints are greater than 1/2" wide and 1/4" deep.

**Recommendations:**  
Clean joints of vegetation and fill with epoxy caulk.

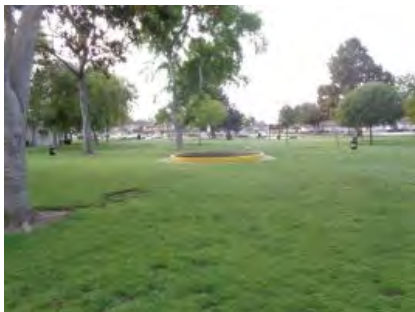
**Comment**    **BSC-012**                    **Priority: 3**            **Estimated Direct Cost:**    \$15,000                    Contractor

**Item Description:**    Fire Ring;

**Findings:** A compliant POT has not been provided to the fire ring.

**Recommendations:**  
Provide a minimum of two POT's to fire ring.

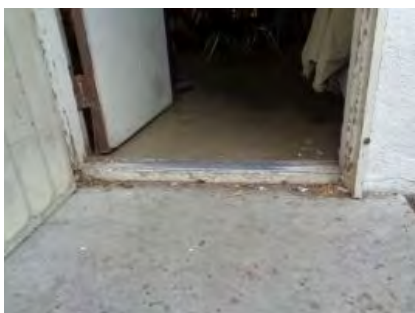
**Comment**    **BSC-014**                    **Priority: 1**            **Estimated Direct Cost:**    \$330                    Contractor

**Item Description:**    Step at doors;

**Findings:** Both restrooms have a step.

**Recommendations:**  
Provide a new 60"X60" minimum landing at the exterior side of doors with a ramp down to the existing concrete walkways.

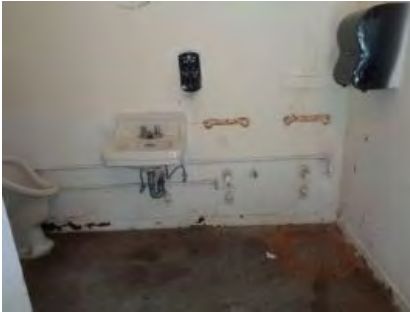
**Comment**    **BSC-015**                    **Priority: 2**            **Estimated Direct Cost:**    \$10,000                    Contractor

**Item Description:**    Accessible Restrooms;

**Findings:** Both restrooms are not accessible.

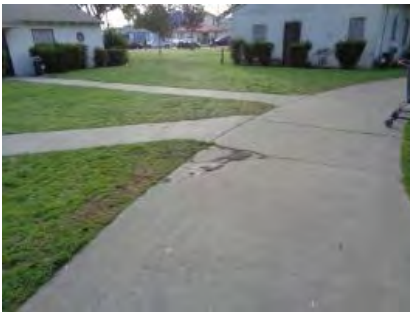
**Comment**    **BSC-016**                    **Priority: 1**            **Estimated Direct Cost:**    \$600                    Contractor

**Item Description:**    Broken concrete;

**Findings:** Concrete walk is broken.

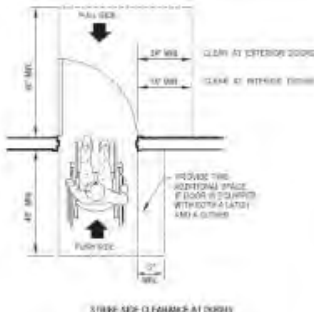
**Comment**    **BSC-017**                    **Priority: 1**            **Estimated Direct Cost:**    \$525                    Contractor

**Item Description:**    Door landing;

**Findings:** The 3-1/2" change in elevation at the entrance door is not accessible. The required additional 24" clearance beyond the strike-side of the door is not provided.

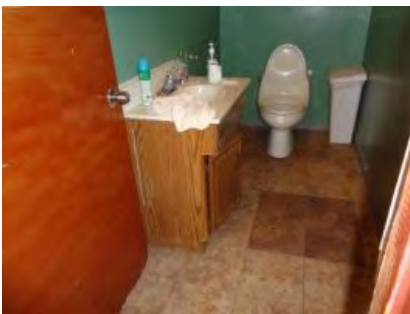
**Item Description:**    Accessibility;

**Findings:** Restroom is not accessible.

Replace sink base with wall-hung lavatory, relocate WC waste line to position WC 17"-18" from a side wall and Install grab bars.

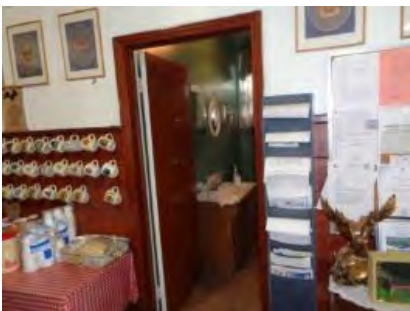
**Item Description:**    Door width;

**Findings:** Door is not accessible for clear width at 29-3/4".

Replace door with a 36" door. Work includes removal of existing doorway, new framing, drywall, door and paint.

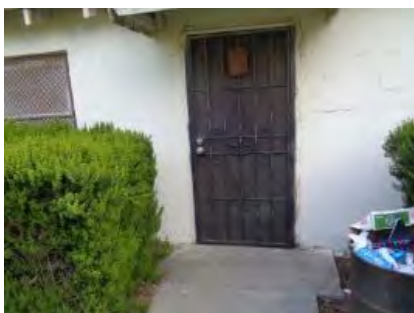
**Item Description:**    Door landing;

**Findings:** The 3/4 inch change in elevation at the entrance door is not accessible. The required additional 24" exterior clearance beyond the strike-side of the door is not provided.

Provide a new concrete landing at exterior. Increase door landing to 60"X60" minimum. New landing elevation shall meet the interior floor elevation.

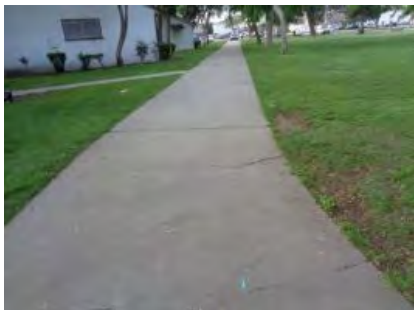
**Findings:**    Concrete walk is broken between Units F and G.

**Recommendations:**  
Remove and replace a section of concrete walk.

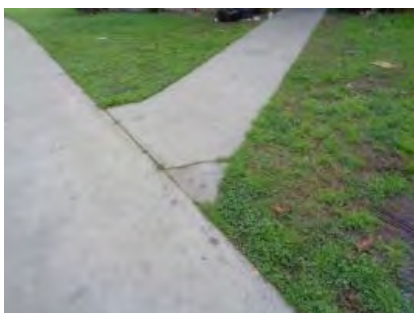
**Findings:**    Concrete walk to Unit G is broken.

**Recommendations:**  
Remove and replace triangular section of concrete.

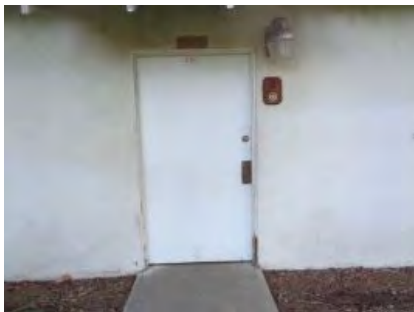
**Item Description:** Door landing;

**Findings:** The required additional 24" exterior clearance beyond the strike-side of the door is not provided.

**Recommendations:**  
Increase door landing to 60"X60" minimum.

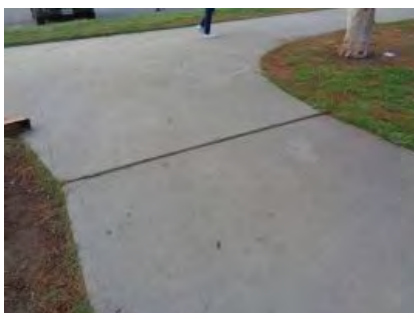
**Item Description:** Raised edge;

**Findings:** A raised edge between slabs is greater than 1/4".

**Recommendations:**  
Grind the high edge across the full width.

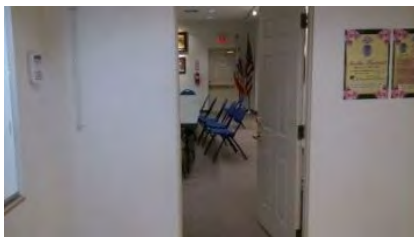
**Item Description:**      Tactile room identification signs;

**Findings:**      Room Identification wall signs with Braille are not provided.

Provide a room I.D. sign package for the building. Mount signs on the wall at the latch side of doors, centered at 56" AFF.

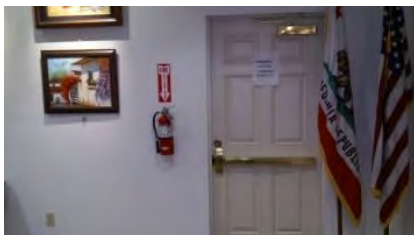
**Item Description:**      Door closers;

**Findings:**      All doors with automatic closers require adjustment for opening force and closing speed.

Adjust all door closers to provide an operational effort of 5 lbf maximum and so that from an open position of 90 degrees, the time required to move the door to a position of 12 degrees from the latch is 5 seconds minimum.

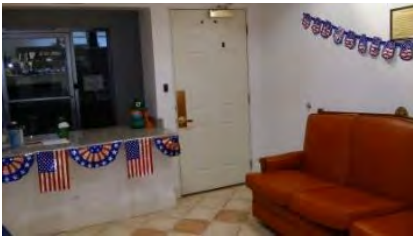
**Comment**    **CC-008**                    **Priority: 2**            **Estimated Direct Cost:**    \$190                    Maintenance  
**Item Description:**    Entrance;

**Findings:** The required wheelchair maneuvering space is not provided. The counter and settee protrude into the required floor space.

**Recommendations:**  
Relocate settee away from door and cut counter back. The required clear floor space is 54" minimum along the face of the door and 60" minimum deep.

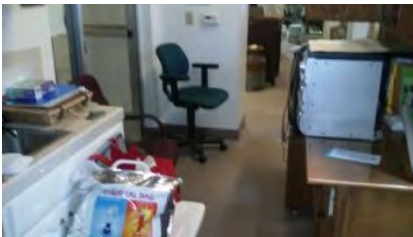
**Comment**    **CC-009**                    **Priority: 1**            **Estimated Direct Cost:**    \$95                    Maintenance  
**Item Description:**    Aisles;

**Findings:** Interior aisles are not accessible.

**Recommendations:**  
Clear aisles to provide a minimum width of 36". Where aisles serve elements at both sides they shall be 44" minimum.

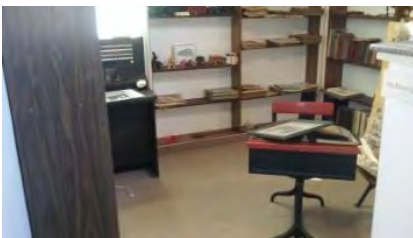
**Comment**    **CC-010**                    **Priority: 2**            **Estimated Direct Cost:**    \$95                    Maintenance  
**Item Description:**    Turning space;

**Findings:** At most rooms, sufficient space is not provided for a wheelchair to enter and turn around.

**Recommendations:**  
Clear space within each room as needed to provide a 60" diameter turning space.

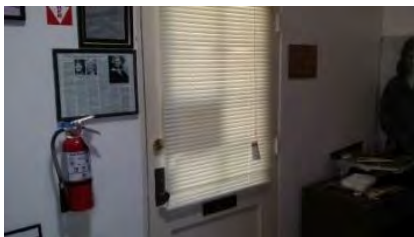
**Comment**      **CC-013**                      **Priority: 1**              **Estimated Direct Cost:**      \$95                      Maintenance

**Item Description:**      Exit door;

**Findings:** The round door knob is not accessible.

**Recommendations:**  
Replace round door knob with a lever handle. The end of lever shall return to within 1/2" of the door surface.

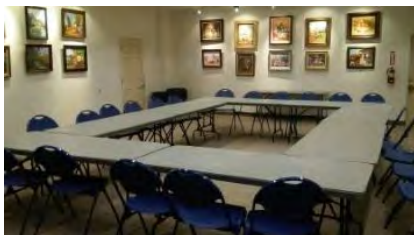
**Comment**      **CC-014**                      **Priority: 3**              **Estimated Direct Cost:**      \$6,750                      Maintenance

**Item Description:**      Assistive listening devices;

**Findings:** An assistive listening system is required for meeting rooms, but was not found to be available.

**Recommendations:**  
Provide a temporary or permanent assistive listening system. Consult with a sound engineer as each system varies in advantages and disadvantages.

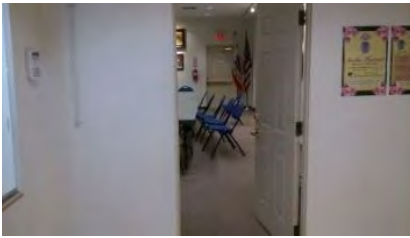
**Comment**    **CC-015**                    **Priority: 3**    **Estimated Direct Cost:**    \$75                    Maintenance  
**Item Description:**    Signage;

**Findings:** Signage is not provided to inform patrons of the availability of the assistive listening system.

**Recommendations:**  
Provide a sign informing of the availability of the assistive listening system. Sign shall state "Assistive-Listening System Available" and be posted in a prominent place at or near the assembly area entrance. Assistive listening sign shall include the International Symbol of Access for Hearing Loss.

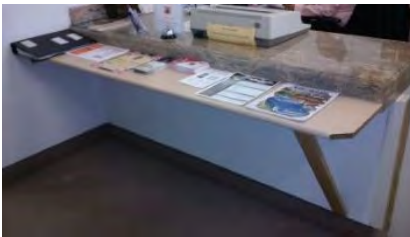
**Comment**    **CC-016**                    **Priority: 3**    **Estimated Direct Cost:**    \$60                    Maintenance  
**Item Description:**    Counter;

**Findings:** Counter is used to display printed materials. A clear space is not provided.

**Recommendations:**  
Clear an area 36" wide and maintain this clear area at all times.

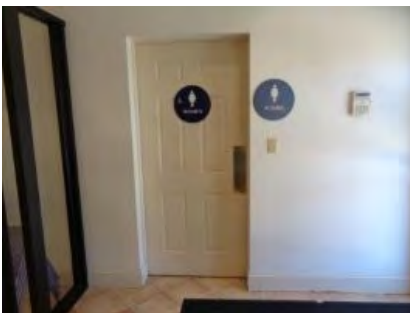
**Comment**    **CC-017**                    **Priority: 2**    **Estimated Direct Cost:**    \$75                    Maintenance  
**Item Description:**    Door Signage;

**Findings:** The geometric door signs have been mounted at the wall.

**Recommendations:**  
Remove door sign from wall and mount geometric sign on door, centered 58"-60" AFF.

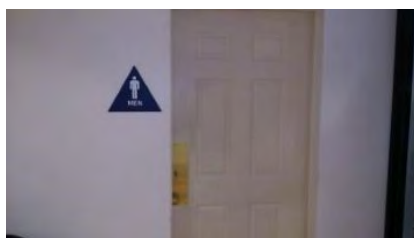
**Comment**    **CC-018**                    **Priority: 2**            **Estimated Direct Cost:**    \$75                    Maintenance  
**Item Description:**    Tactile wall sign;

**Findings:** The required tactile wall signs are not provided at the restroom doorway.

**Recommendations:**  
Provide a tactile wall sign at each doorway, having Grade 2 Braille beneath raised text and a raised pictogram.

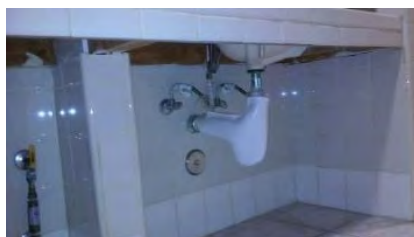
**Comment**    **CC-019**                    **Priority: 2**            **Estimated Direct Cost:**    \$75                    Maintenance  
**Item Description:**    Lavatory Insulation;

**Findings:** Insulation beneath lavatories is not complete.

**Recommendations:**  
Cover, wrap, or otherwise insulate all water lines, drains, valves and fittings. There shall also be no exposed sharp or abrasive elements under any lavatory.

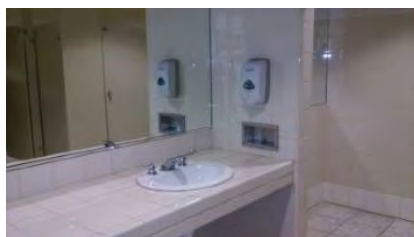
**Comment**    **CC-020**                    **Priority: 2**            **Estimated Direct Cost:**    \$300                    Contractor  
**Item Description:**    Soap Dispenser;

**Findings:** Soap dispensers at lavatories are not accessible due to height.

**Recommendations:**  
Lower one soap dispenser to a height not greater than 40" AFF to the highest operable part.

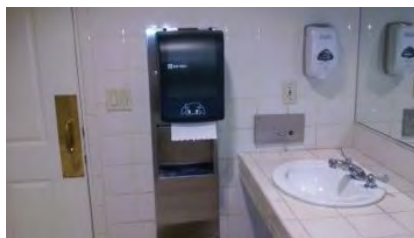
**Comment**    **CC-021**                      **Priority: 2**            **Estimated Direct Cost:**    \$600                      Contractor  
**Item Description:**    Paper towel dispensers;

**Findings:** Dispensers are not accessible due to height. Dispensers are not compliant, requiring use of two hands, tight grasping and pinching. The side wheel for advancing paper requires twisting of the wrist.

**Recommendations:**  
 Remove and replace one paper towel dispenser. New dispenser shall not require tight grasping, pinching or twisting of the wrist. Mount new dispenser not higher than 40" AFF to the highest operable part.

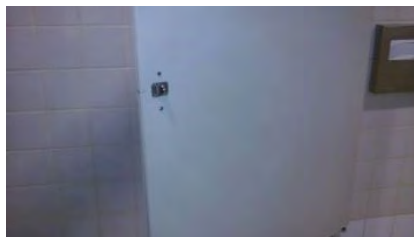
**Comment**    **CC-022**                      **Priority: 2**            **Estimated Direct Cost:**    \$190                      Maintenance  
**Item Description:**    Stall Door; Stall Door

**Findings:** The accessible stall door is not self-closing. Each accessible stall door are missing the required U-pull handle at the pull side.

**Recommendations:**  
 Replace the self-closing hinges. Install a U-shaped pull handle below the latch.

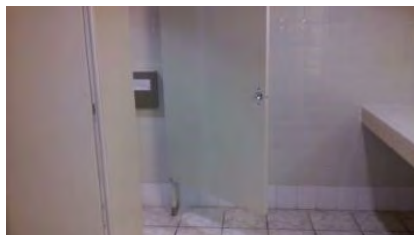
**Comment**    **CC-024**                      **Priority: 2**            **Estimated Direct Cost:**    \$2,500                      Contractor  
**Item Description:**    Stall Door;

**Findings:** Stall door is located directly in front of WC.

**Recommendations:**  
 The door opening shall be 4 inches maximum from the side partition farthest from the water closet.

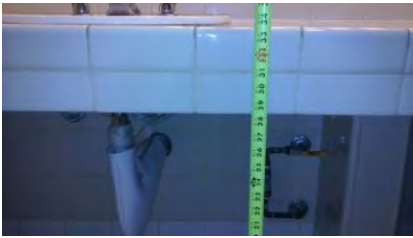
**Comment**      **CC-025**                      **Priority: 2**      **Estimated Direct Cost:**      \$1,500                      Contractor  
**Item Description:**      Lavatory apron height;

**Findings:** Apron at front of lavatory is not a minimum 29" high, measured at 28-1/2" AFF.

**Recommendations:**  
Modify tile face of apron to provide a minimum height of 29" AFF.

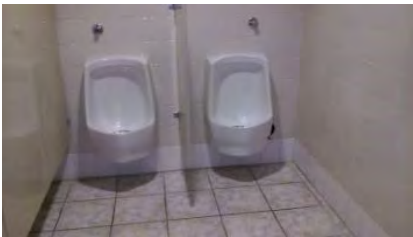
**Comment**      **CC-026**                      **Priority: 2**      **Estimated Direct Cost:**      \$3,200                      Contractor  
**Item Description:**      Accessible Urinal;

**Findings:** Urinal rim height is not compliant at 17-3/4" AFF.

**Recommendations:**  
Lower fixture to a rim height of 17" AFF maximum at one fixture.

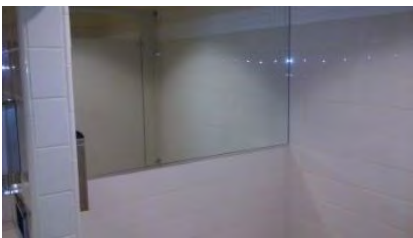
**Comment**      **CC-027**                      **Priority: 2**      **Estimated Direct Cost:**      \$1,200                      Maintenance  
**Item Description:**      Wall mirror;

**Findings:** Wall mirror is not compliant for height at 39-1/2" to the bottom edge..

**Recommendations:**  
Lower mirror. The lowest reflective edge shall be 35" maximum AFF.

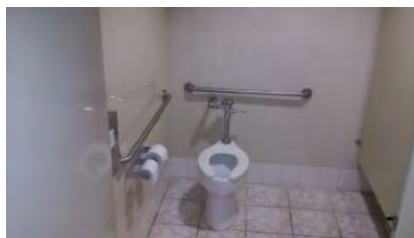
**Comment**      **CC-028**                      **Priority: 2**                      **Estimated Direct Cost:**      \$6,300                      Contractor  
**Item Description:**      Accessible stall width; Toilet paper dispenser; WC location

**Findings:** Stall is not a minimum 60" wide, measuring at 59-1/2". Dispenser, by design, does not allow continuous flow of paper. The accessible WC is not compliant for location, centered 18-5/8" from the side wall.

**Recommendations:**  
Move partition panel as needed to provide a minimum width of 60". Replace dispenser rollers. The flow of paper shall be continuous. Reset waste line to center WC 17"-18" from the side wall.

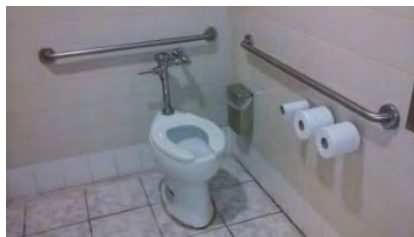
**Comment**      **CC-031**                      **Priority: 2**                      **Estimated Direct Cost:**      \$2,000                      Contractor  
**Item Description:**      Grab bars;

**Findings:** Grab bars are not compliant for location.

**Recommendations:**  
Reset grab bars per detail D033.

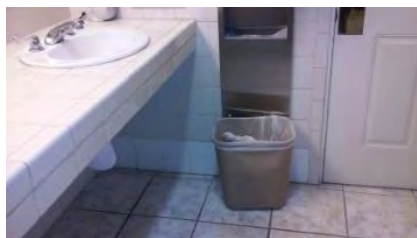
**Comment**    **CC-033**                    **Priority: 2**            **Estimated Direct Cost:**    \$60                    Maintenance  
**Item Description:**    Loose waste basket;

**Findings:** The loose waste can could move and block access to fixtures and dispensers.

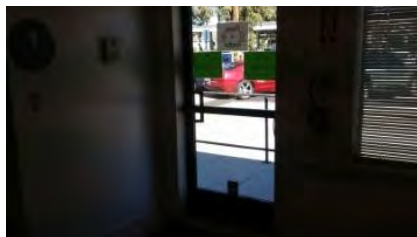
**Comment**    **CC-034**                    **Priority: 1**            **Estimated Direct Cost:**    \$455                    Contractor  
**Item Description:**    Exit door; Exit door

**Findings:** Exit door is missing the required additional 12" clearance at the latch side. Door stop at the push side of door interferes with the requirement for a smooth door surface.

**Recommendations:**  
Reverse the swing of the door. Place hinges at the opposite side of frame. Remove door stop.

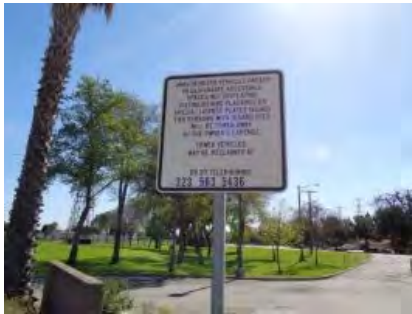
**Comment** CH-E-001 **Priority:** 1 **Estimated Direct Cost:** \$500 **Contractor**

**Item Description:** Tow-away Signs;

**Findings:** The required tow-away warning signs are not provided at the parking entrances. The existing sign at the City Hall South parking area is not properly posted and not visible upon entering the parking area.

**Recommendations:** Provide one post-mounted CALTRANS R-100B tow sign at each park entrance, within direct upon entering the parking areas. The blank spaces for vehicle reclaiming information shall be filled-in and made a permanent part of the sign, in lettering a minimum 1 inch high.

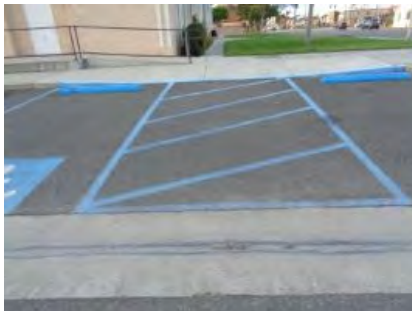
**Comment** CH-E-002 **Priority:** 1 **Estimated Direct Cost:** \$750 **Contractor**

**Item Description:** Access aisle stripes;

**Findings:** Diagonal stripes in access aisles fail to provide the required visual contrast with the parking surface.

**Recommendations:** Re-stripe access aisles with white diagonal stripes, 36" O.C. maximum. Interrupt white stripes at area of white lettering stating "NO PARKING". Access aisle border shall remain blue.

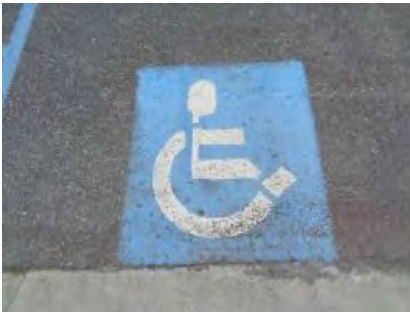
**Comment**      **CH-E-003**      **Priority: 1**      **Estimated Direct Cost:**      \$400      Contractor

**Item Description:**      Stall ISA markings;

**Findings:** Stall ISA markings are not compliant for size and do not have the required white border.

**Recommendations:**  
Provide larger ISA's at each stall. Symbol shall be a minimum 36" high with a white border.

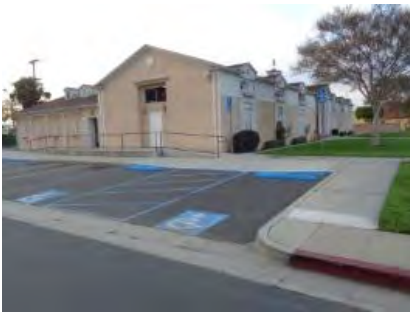
**Comment**      **CH-E-004**      **Priority: 1**      **Estimated Direct Cost:**      \$75      Contractor

**Item Description:**      Accessible Parking;

**Findings:** Accessible parking at the North side of the Civic Center is not compliant due to excessive slopes within the parking area and associated ramps and accessible route which will require extensive re-grading to raise the roadway and parking area to meet the building walkway elevations. Building walkways have excessive cross slopes.

**Recommendations:**  
Consider relocating accessible parking to the East side of building and creating an accessible entrance at the East door.      Otherwise, provide civil plans to adjust elevations to raise the existing parking area and construct a new accessible route to the building entrance.      SEE the Following Entries.

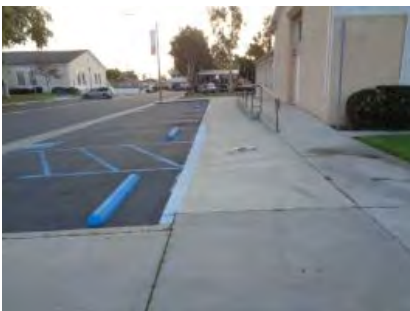
**Comment**      **CH-E-005**      **Priority: 1**      **Estimated Direct Cost:**      \$4,020      Contractor

**Item Description:**      Accessible Parking;

**Findings:** Curb ramp is not compliant due to excessive slope and adjoining walkway slopes.

**Recommendations:**  
This curb ramp and the adjoining walkway is part of the issues identified in ITEM #4

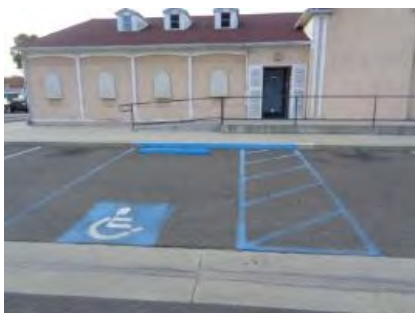
**Item Description:** Accessible Parking;

**Findings:** The single accessible stall does not have a curb ramp available for vertical access to the walkway.

**Recommendations:**  
Install a parallel curb ramp, or relocate the accessible parking stall to the East side of the building.

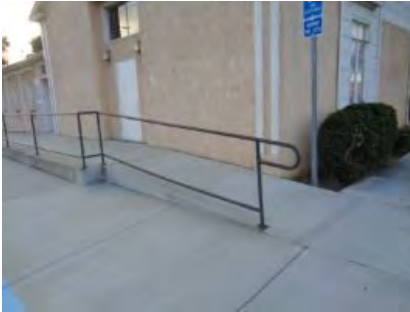
**Comment**      **CH-E-009**      **Priority: 1**      **Estimated Direct Cost:**      \$5,000      Contractor

**Item Description:**      All Pedestrian Ramps;

**Findings:** Handrails are missing at both sides of ramps, at the North, South and East sides of the building.

**Recommendations:**  
Add handrails as needed.

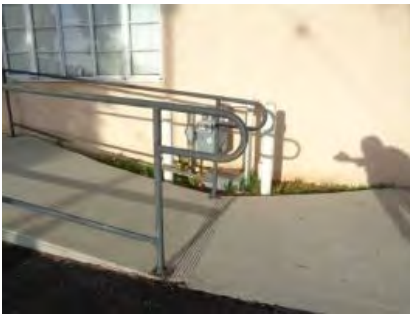
**Comment**      **CH-E-010**      **Priority: 1**      **Estimated Direct Cost:**      \$500      Contractor

**Item Description:**      All Pedestrian Ramps;

**Findings:** Handrail extensions fail to turn level over the level landings at the top and bottom of ramps.

**Recommendations:**  
Modify handrail extensions to turn level over the level landings of ramps.

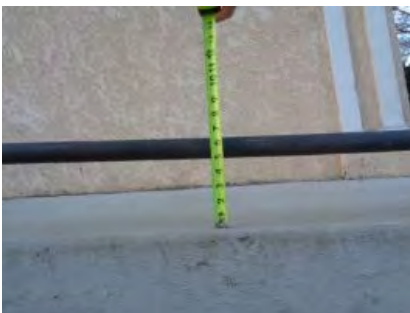
**Comment**      **CH-E-011**      **Priority: 1**      **Estimated Direct Cost:**      \$2,400      Contractor

**Item Description:**      All Pedestrian Ramps;

**Findings:** Edge protection is not compliant for height The guide rails at all ramps found at the North, East and South sides of the building are centered at 5-1/2" above the ramp surface.

**Recommendations:**  
Lower guide rails at all ramps to a position which prevents the passage of a 4 inch diameter sphere, where any portion of the sphere is within 4 inches of the ramp surface.

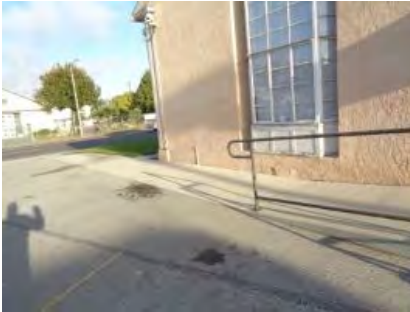
**Comment**      **CH-E-012**      **Priority: 1**      **Estimated Direct Cost:**    \$1,152      Contractor

**Item Description:**    East and South Pedestrian Ramps;

**Findings:** Ramps lead down to vehicular drive areas without curbs or railings to provide pedestrian separation.

**Recommendations:**  
Install a truncated dome pad at the bottom of each ramp at the level concrete walk, within 6" of the ramp slope..

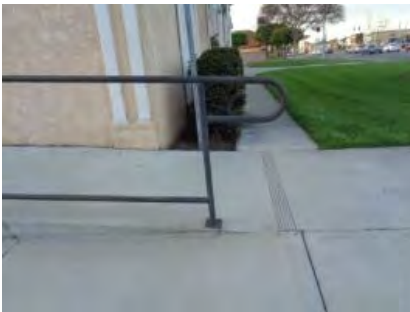
**Comment**      **CH-E-013**      **Priority: 1**      **Estimated Direct Cost:**    \$1,000      Contractor

**Item Description:**    Pedestrian Ramp;

**Findings:** Ramp handrail at North side does not extend the full length of ramp.

**Recommendations:**  
Lengthen handrail and modify extension to turn level over the level landing.

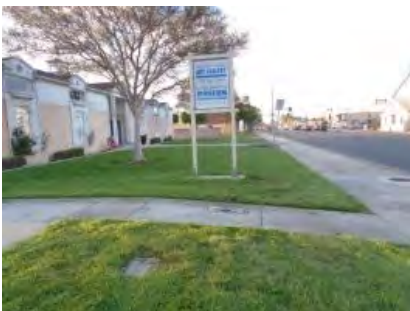
**Comment**      **CH-E-014**      **Priority: 1**      **Estimated Direct Cost:**    \$1,200      Contractor

**Item Description:**    Walkway;

**Findings:** The sloped walkway from the city sidewalk shown has excessive slope measuring 8.6%. Slopes at walkways shall not exceed 8.33%.

**Recommendations:**  
Demolish sloped walkway. Provide a new walkway using the least slope possible, not to exceed 8.33%. When walkway slope is greater than 5.0%, handrails are required at both sides.

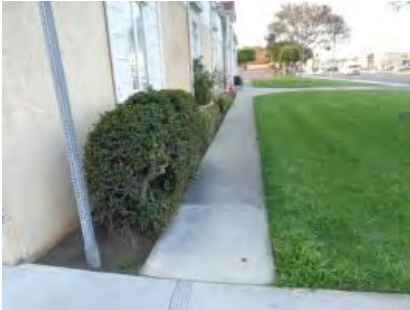
**Comment**      **CH-E-015**      **Priority: 1**      **Estimated Direct Cost:**      \$400      Contractor

**Item Description:**      Walkway;

**Findings:** The walkway across the West side of the building pad is not accessible due to width.

**Recommendations:**  
At each end of walkway provide a directional sign directing to the city sidewalk.

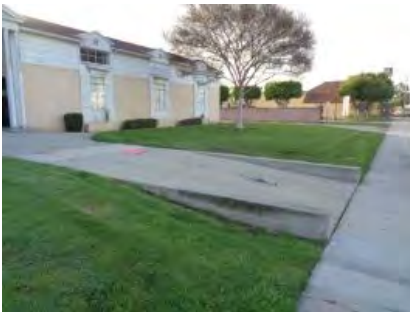
**Comment**      **CH-E-016**      **Priority: 1**      **Estimated Direct Cost:**      \$1,200      Contractor

**Item Description:**      Entrance Walkway;

**Findings:** The sloped walkway from the city sidewalk shown has excessive slope measuring 8.9%. Slopes at walkways shall not exceed 8.33%.

**Recommendations:**  
Demolish sloped walkway. Provide a new walkway using the least slope possible, not to exceed 8.33%. When walkway slope is greater than 5.0%, handrails are required at both sides.

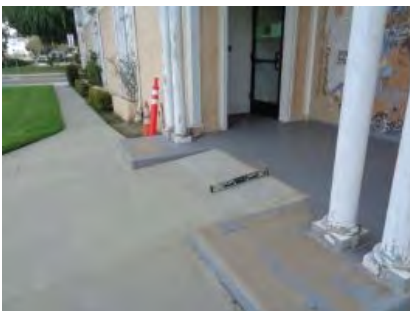
**Comment**      **CH-E-017**      **Priority: 1**      **Estimated Direct Cost:**      \$1,610      Contractor

**Item Description:**      Entrance Ramp;

**Findings:** Ramp slope is excessive at entry of building.

**Recommendations:**  
Construction of a new ramp is needed. Provide civil plans for new ramp due to the impact of various elevations leading to this entry.

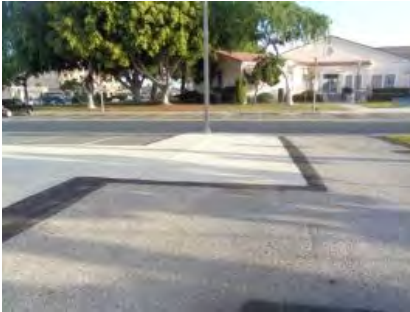
**Comment**      **CH-E-018**      **Priority: 1**      **Estimated Direct Cost:**    \$14,400      Contractor

**Item Description:**    Detectable Warning Surface;

**Findings:** At all flush transitions between the pedestrian route and the vehicular way at the East parking area, North side, a curb or railing is not provided for pedestrian separation.

**Recommendations:**  
Install truncated domes across all areas of flush transition. Domes shall be 36" deep in the direction of travel.

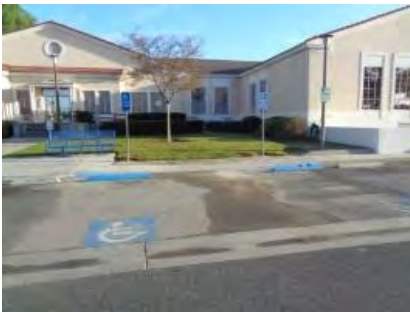
**Comment**      **CH-E-019**      **Priority: 1**      **Estimated Direct Cost:**    \$1,400      Contractor

**Item Description:**    Accessible Stall Surface;

**Findings:** The right stall surface is not level due to the raised edges around the vault cover.

**Recommendations:**  
Provide an asphalt overlay at stalls to match the elevation of the vault cover. Re-stripe stalls.

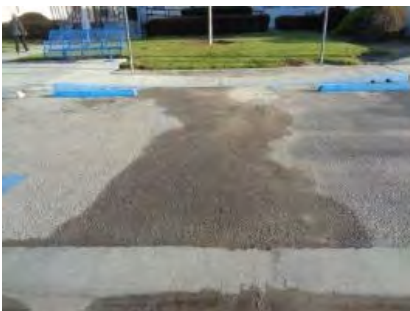
**Comment**      **CH-E-020**      **Priority: 1**      **Estimated Direct Cost:**    \$576      Contractor

**Item Description:**    Curb ramp;

**Findings:** Curb ramp is missing the required truncated domes.

**Recommendations:**  
Provide a truncated dome mat across the lower ramp landing, with the edge of mat within 6"- 8" from the face of the curb line. Domes shall be 36" in the direction of travel.

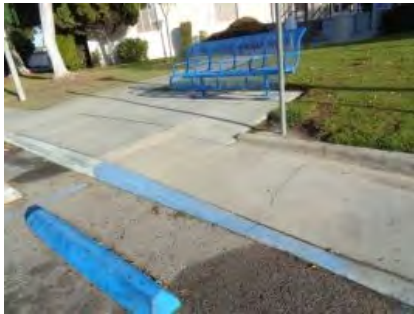
**Comment**      **CH-E-021**      **Priority: 1**      **Estimated Direct Cost:**      \$2,460      Contractor

**Item Description:**      Curb ramp;

**Findings:**      Curb ramp is not compliant due to excessive cross slope, measured at 4.8% at the West ramp section.

**Recommendations:**  
Demolish and rebuild ramp. Slope and cross slopes shall not exceed 8.33% and 2.1% respectively.

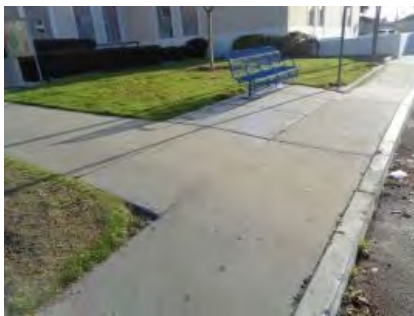
**Comment**      **CH-E-022**      **Priority: 1**      **Estimated Direct Cost:**      \$3,500      Contractor

**Item Description:**      Accessible Route;

**Findings:**      The concrete walkway leading from accessible parking is not compliant due to excessive cross slopes measuring up to 5.7%.

**Recommendations:**  
Demolish and rebuild walkway leading away from accessible parking. Slope and cross slopes shall not exceed 5.0% and 2.1% respectively at walkways. Slopes where a change in direction occur shall not exceed 2.1% in any direction.

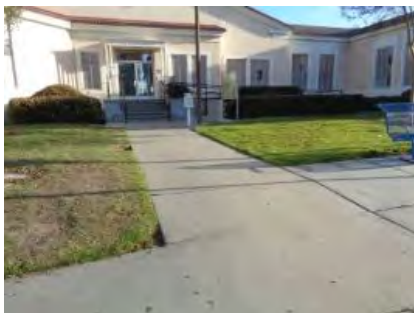
**Comment**      **CH-E-023**      **Priority: 1**      **Estimated Direct Cost:**      \$2,250      Contractor

**Item Description:**      Accessible Route;

**Findings:**      Walkway leading to building entrance is not accessible due to excessive slopes measured up to 9.8%.

**Recommendations:**  
Demolish and rebuild walkway leading to building entrance. Slope and cross slopes shall not exceed 5.0% and 2.1% respectively at walkways. Slopes where a change in direction occur shall not exceed 2.1% in any direction.

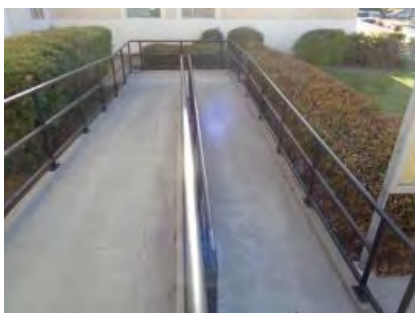
**Item Description:** Pedestrian ramp;

**Findings:** Ramp is not compliant, having varying slopes at ramp runs, as high as 10.3%. The bottom ramp landing is not level, requiring a new landing which will change the starting elevation, rendering the existing lower ramp segment unusable.

**Recommendations:**  
Remove and replace ramp. Have grades surveyed and civil plans drawn for new ramp.

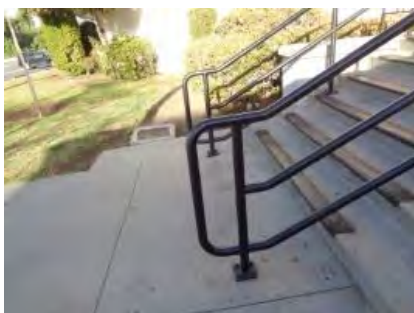
**Comment**      **CH-E-029**      **Priority: 1**      **Estimated Direct Cost:**    \$1,500      Contractor

**Item Description:**    Stair handrail extensions;

**Findings:** Handrail extensions do not turn level for a minimum of 12" before turning down.

**Recommendations:**  
Modify handrail extensions as needed at top and bottom of stairs.

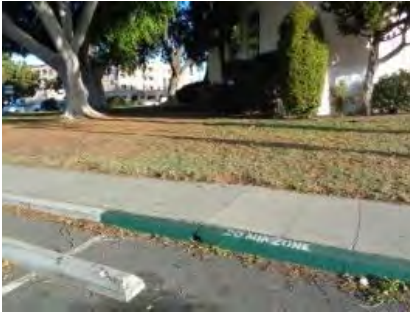
**Comment**      **CH-E-030**      **Priority: 1**      **Estimated Direct Cost:**      \$150      Contractor

**Item Description:**      Accessible Route;

**Findings:** Concrete walkway shows signs of heaving, with large cracks and abrupt edges greater than 1/4".

**Recommendations:**  
The source of movement beneath the slab is not known. Grinding the high edges would cure the exposed edges, but slab may continue to move.

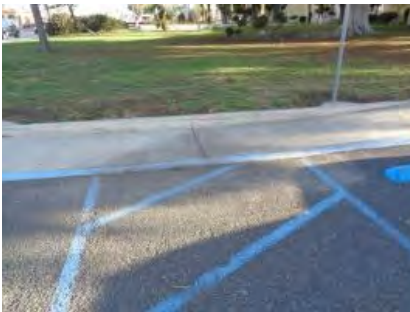
**Comment**      **CH-E-031**      **Priority: 1**      **Estimated Direct Cost:**      \$576      Contractor

**Item Description:**      West parking stalls;

**Findings:** Curb ramp is missing the required truncated domes.

**Recommendations:**  
Provide a truncated dome mat across the lower ramp landing with the mat edge located within 6"- 8" from the face of the curb line. Domes shall be 36" in the direction of travel.

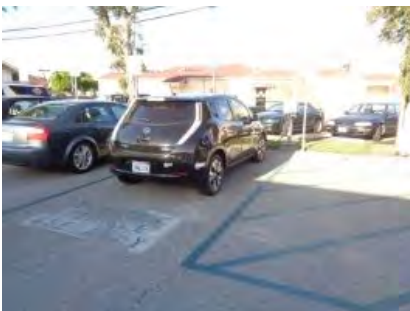
**Comment**      **CH-E-032**      **Priority: 1**      **Estimated Direct Cost:**      \$16,500      Contractor

**Item Description:**      Electric vehicle charging station

**Findings:** A compliant accessible route is not provided from the city sidewalk to the parking area of the EV charging station. Stall and access aisle are marked with blue paint. Blue stall markings are associated with accessible parking stalls. Lettering is not provided within the access aisle stating "NO PARKING".

**Recommendations:**  
A compliant path of travel needs to be provided from the accessible electric vehicle parking stalls to the city sidewalk. Location should be at the head of the accessible stalls, use wheel stops to prevent accessible path of travel encroachment. Additionally the stall striping and access aisle borders must be painted in green. The hatched lines inside of the access aisle must be painted white. with white letters stating "No Parking".

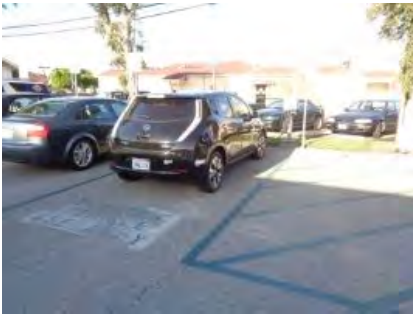
**Item Description:**    Electric vehicle charging station;

**Findings:**    Stall markings are faded.

**Recommendations:**  
Repaint stall markings to state "EV CHARGING ONLY" in white lettering centered on each EV stall.

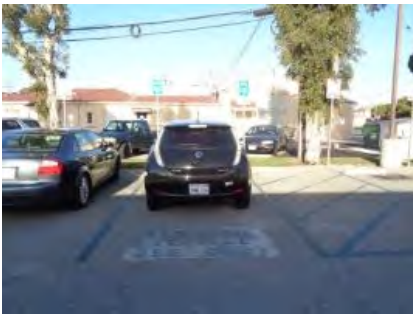
**Item Description:**    Electric vehicle charging station;

**Findings:**    Signage indication that the EV stall is Van accessible is not provided.

**Recommendations:**  
Provide additional signs stating "VAN ACCESSIBLE" under the existing stall signs.

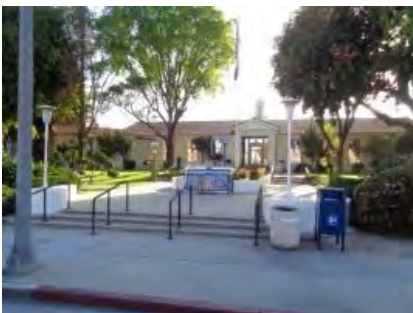
**Item Description:**    Stair handrail extensions;

**Findings:**    Handrail extensions at California Avenue stairs to City Hall do not turn level for a minimum of 12" before turning down.

**Recommendations:**  
Modify handrail extensions as needed at top and bottom of stairs.

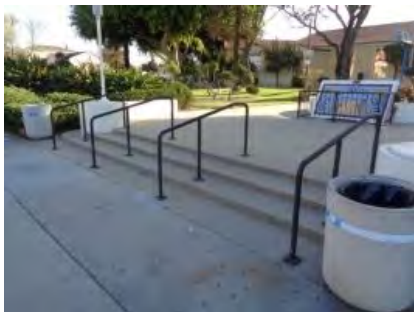
**Comment**      **CH-E-038**      **Priority: 1**      **Estimated Direct Cost:**      \$190      Maintenance

**Item Description:**      Warning stripes;

**Findings:** Warning stripes have not been provided for all stairs from the city sidewalk at California Avenue to the Main Entrance of City Hall.

**Recommendations:**  
The upper approach and all treads of each exterior stair shall be marked by a stripe of clearly contrasting color, 2" to 4" wide, placed parallel to and not more than 1" from the nose of the step or landing to alert the visually impaired. The stripe shall be of material that is at least as slip resistant as the treads of the stair. A painted stripe is acceptable.

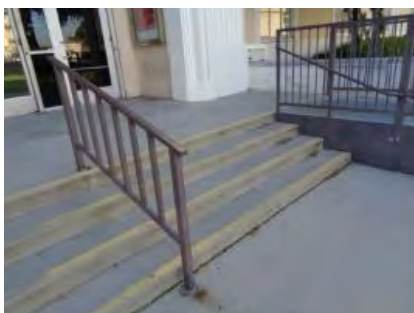
**Comment**      **CH-E-040**      **Priority: 1**      **Estimated Direct Cost:**      \$3,750      Contractor

**Item Description:**      Stair handrail extensions;

**Findings:** Handrail shape is non-conforming and not accessible at Court House stairs. Handrail extensions are not provided.

**Recommendations:**  
Replace handrails. Provide compliant handrails with conforming gripping surface. Add extensions as needed at top and bottom of stairs.

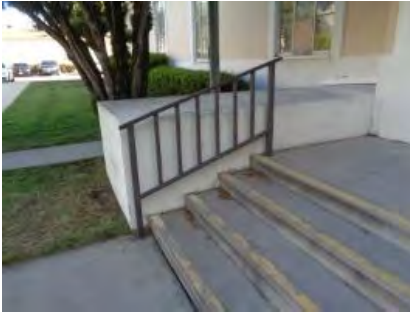
**Item Description:** Warning stipes;

**Findings:** Warning stripes at Court House steps are faded.

Restripe stair treads. The upper approach and all treads of the stair shall be marked by a stripe of clearly contrasting color, 2" to 4" wide, placed parallel to and not more than 1" from the nose of the step or landing to alert the visually impaired. The stripe shall be of material that is at least as slip resistant as the treads of the stair. A painted stripe is acceptable.

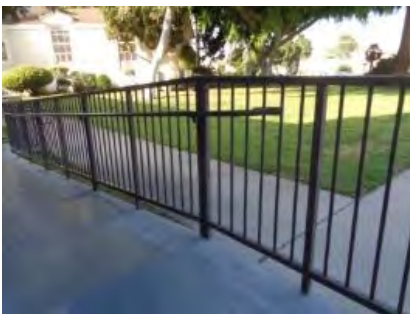
**Item Description:** Ramp handrail;

**Findings:** Handrail extension at the top of the ramp fails to turn level over the level landing.

Modify handrail extension as needed.

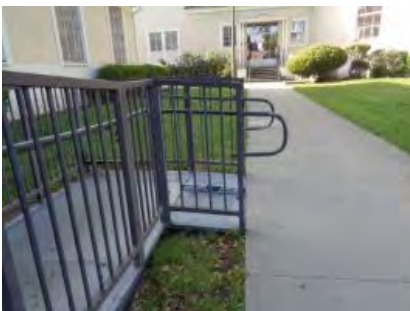
**Item Description:** Ramp handrail;

**Findings:** Handrail extensions at the bottom of the ramp fail to turn level over the level landing.

Modify handrail extension as needed.

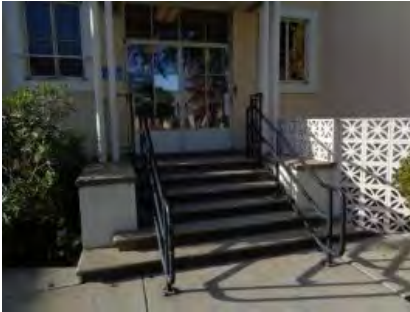
**Item Description:** Warning stipes; Guard rails

**Findings:** Warning stripes at City Hall steps are faded. Guards are not provided at the open sides of stair where the vertical drop is greater than 30" within 36" of the stairway.

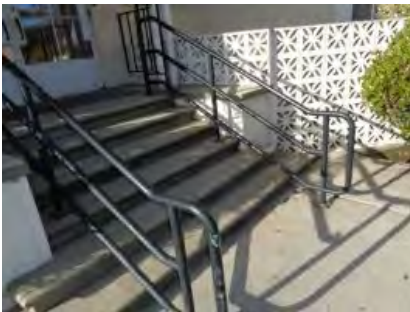
**Item Description:** Stair handrail extensions;

**Findings:** Handrail extensions fail to project a minimum of 12" before turning down.

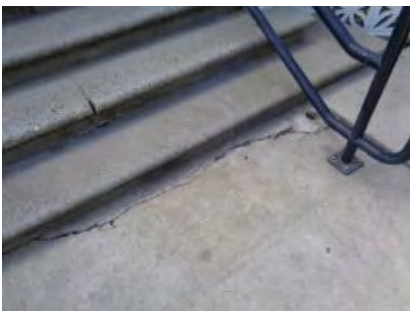
**Item Description:** Abrupt edge;

**Findings:** Concrete at the bottom stair landing is cracked and broken with exposed openings greater than 1/2".

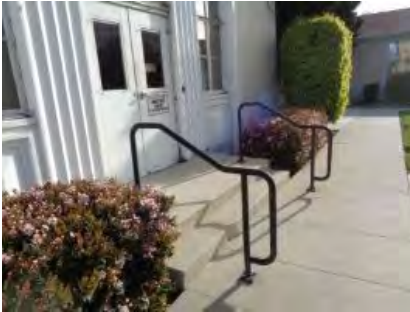
**Comment**      **CH-E-048**      **Priority: 1**      **Estimated Direct Cost:**      \$190      Maintenance

**Item Description:**      Warning stipes;

**Findings:**      Warning stripes at City Hall steps are faded.

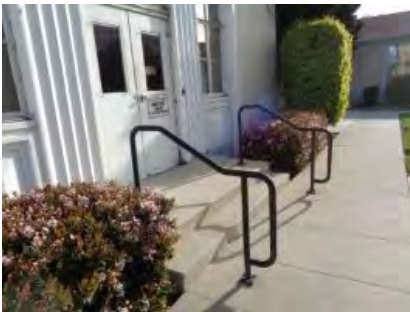
**Comment**      **CH-E-049**      **Priority: 1**      **Estimated Direct Cost:**      \$5,000      Contractor

**Item Description:**      Stair handrail extensions;

**Findings:**      Handrail extensions fail to project a minimum of 12" before turning down.

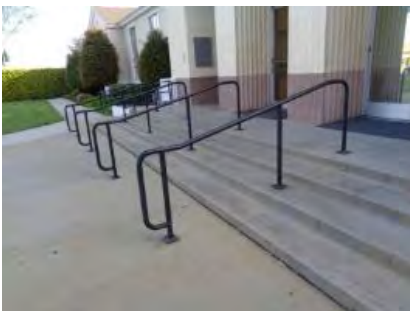
**Comment**      **CH-E-050**      **Priority: 1**      **Estimated Direct Cost:**      \$2,690      Contractor

**Item Description:**      Warning stipes; Stair handrail extensions

**Findings:**      Warning stripes at City Hall steps are faded. Handrail extensions fail to project a minimum of 12" before turning down.

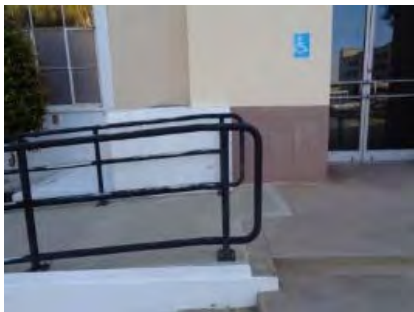
**Comment**      **CH-E-052**      **Priority: 1**      **Estimated Direct Cost:**      \$500      Contractor

**Item Description:** Ramp handrails;

**Findings:** Handrail extensions do not extend level for a minimum of 12" before turning down.

**Recommendations:**  
Modify handrail extension as needed.

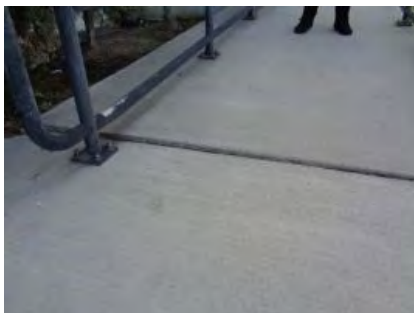
**Comment**      **CH-E-054**      **Priority: 1**      **Estimated Direct Cost:**      \$240      Contractor

**Item Description:** Ramp Landing;

**Findings:** At the connection between the lower ramp landing and the ramp slope, concrete is lifting, creating an abrupt edge greater than 1/4".

**Recommendations:**  
Grind the high edge of the ramp.

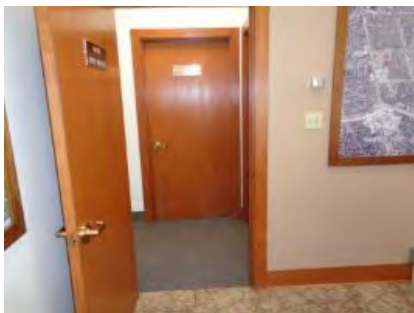
**Comment**      **CHL-005**      **Priority: 1**      **Estimated Direct Cost:**      \$75      Maintenance

**Item Description:**      Tactile exit signs;

**Findings:**      Tactile exit signs are not provided at interior rooms having access to a corridor or hallway leading to an exit door.

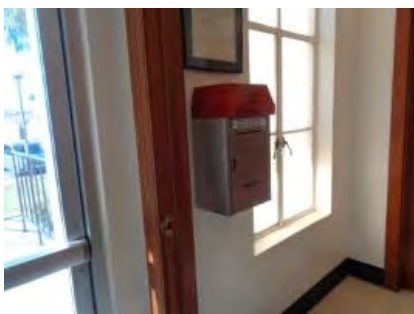
**Comment**      **CHL-007**                      **Priority: 1**              **Estimated Direct Cost:**      \$1,500                      Contractor

**Item Description:**      Payment Drop Box;

**Findings:** Payment drop box at wall projects 8" into the circulation path.

**Recommendations:**  
Relocate box away from circulation paths or recess box into wall. Maximum projection allowed in circulation paths is 4".

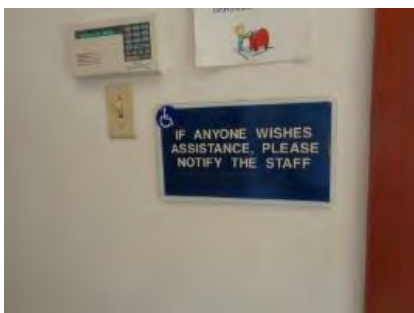
**Comment**      **CHL-008**                      **Priority: 1**              **Estimated Direct Cost:**      \$400                      Contractor

**Item Description:**      Wall sign;

**Findings:** Wall sign has a federal Braille font which does not conform to California Braille requirements.

**Recommendations:**  
Replace sign. New sign shall have Grade 2 Braille conforming to California spacing of 0.10" between dots within the same cell.

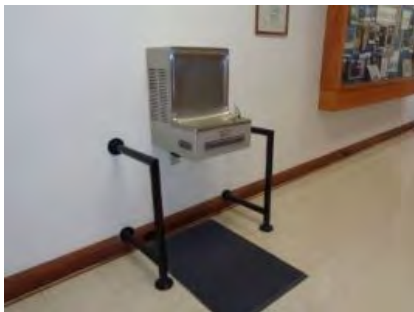
**Findings:**      Water flow is not a minimum 4" high.

**Recommendations:**  
Adjust bubbler to provide a water flow of 4" minimum.

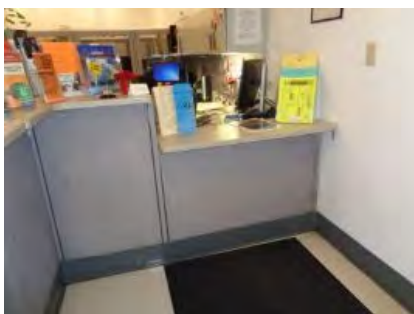
**Findings:**      Counter surface is mostly covered with printed materials which blocks access.

**Recommendations:**  
A majority of the counter shall be maintained clear for access.

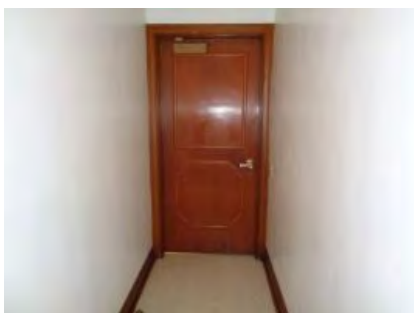
**Findings:**      Door at hall is not accessible as it has no strike-side clearance at the push side.

**Recommendations:**  
The requirement for side clearance is only when a door has both a closer and a latch. Remove the latch from door. Provide a U-shaped door pull or dummy lever at the pull side.

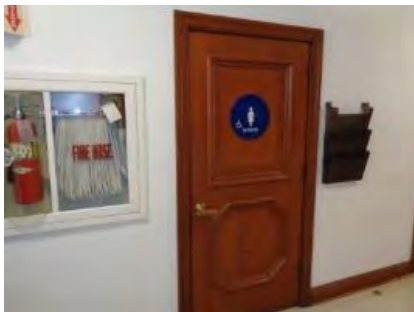
**Comment**      **CHL-015**      **Priority: 2**      **Estimated Direct Cost:**      \$75      Maintenance

**Item Description:**      Tactile wall sign;

**Findings:**      The required tactile wall sign is not provided at the restroom doorway.

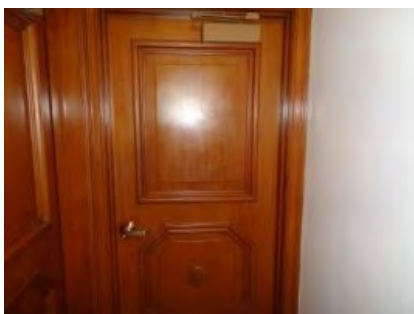
**Comment**      **CHL-016**      **Priority: 2**      **Estimated Direct Cost:**      \$185      Maintenance

**Item Description:**      Interior door;

**Findings:**      Interior corridor door to restroom is not accessible as it has no strike-side clearance at the push side.

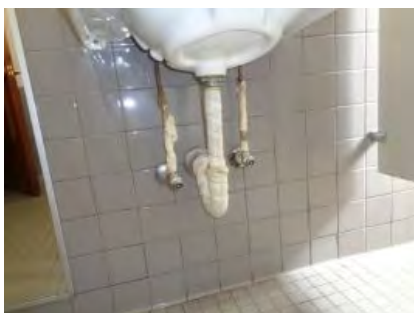
**Comment**      **CHL-017**      **Priority: 2**      **Estimated Direct Cost:**      \$75      Maintenance

**Item Description:**      Lavatory Insulation;

**Findings:**      Insulation beneath the lavatory is not provided.

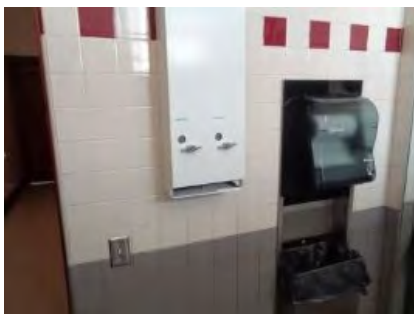
**Item Description:** Sanitary napkin dispenser;

**Findings:** Dispenser is currently non-operational. Dispenser controls are not accessible.

**Recommendations:**  
Remove dispenser. If replacement is desired, install a dispenser with controls which do not require tight grasping, pinching or twisting of the wrist.

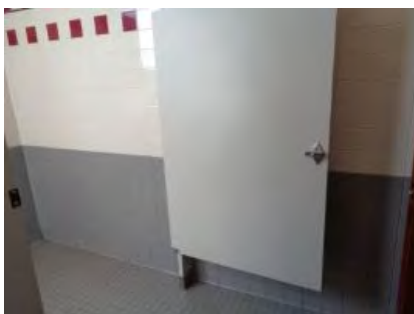
**Item Description:** Stall Door; Stall Door

**Findings:** The accessible stall door is not self-closing. Accessible stall door is missing the required U-pull handle at the pull side.

**Recommendations:**  
Replace the self-closing hinges. Install a U-shaped pull handle below the latch.

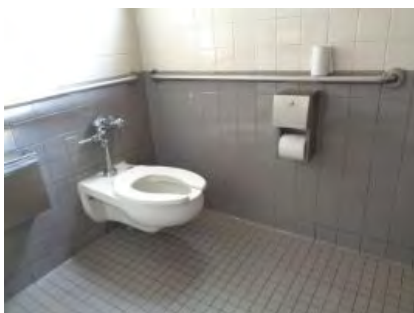
**Item Description:** Side grab bar;

**Findings:** Side grab bar is not compliant for location.

**Recommendations:**  
Relocate side grab bar to project a minimum 54" from the back wall.

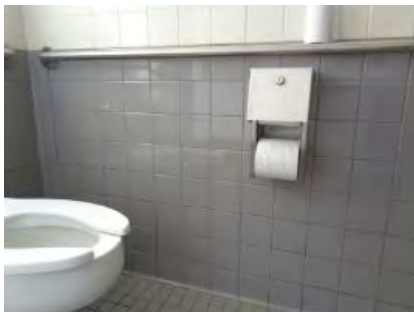
**Item Description:** Toilet paper dispenser;

**Findings:** Dispenser is not compliant for location, centered 11-1/2" in front of the WC.

**Recommendations:**  
Relocate dispenser. Center toilet paper dispenser at 7"-9" in front of the WC.

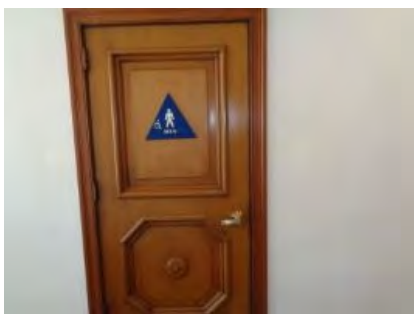
**Item Description:** Tactile wall sign;

**Findings:** The required tactile wall sign is not provided at the restroom doorway.

**Recommendations:**  
Provide a tactile wall sign at each doorway, having Grade 2 Braille beneath raised text and a raised pictogram.

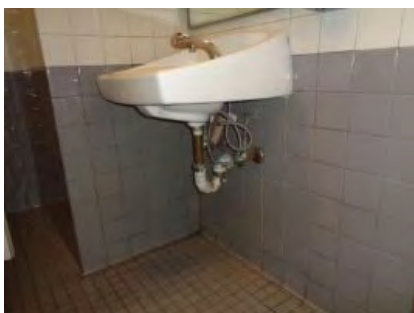
**Item Description:** Lavatory Insulation;

**Findings:** Insulation beneath the lavatory is not provided.

**Recommendations:**  
Complete insulation of all water lines, valves and fittings. There shall also be no exposed sharp or abrasive elements under lavatories.
