# City of South Gate

# Volume 2

## Appendix B Facilities Barrier Assessment Report

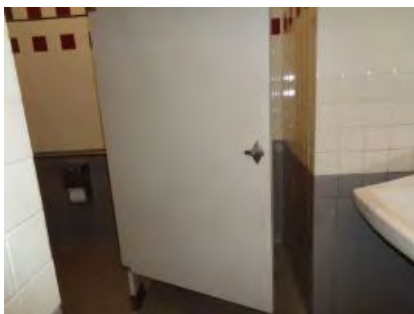
**Item Description:**      Stall Door;

**Findings:**      The accessible stall door is not self-closing.

**Recommendations:**  
Replace the self-closing hinges.

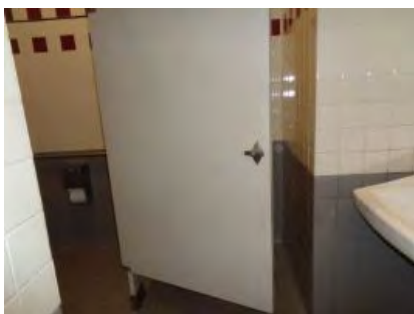
**Item Description:**      Stall Door;

**Findings:**      Accessible stall door is missing the required U-pull handle at the pull side.

**Recommendations:**  
Install a U-shaped pull handle below the latch.

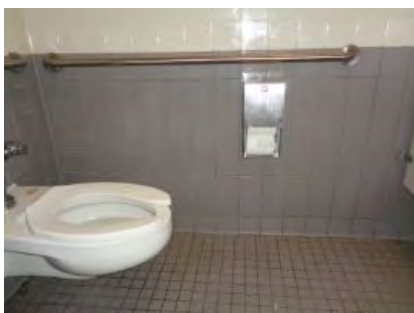
**Item Description:**      Toilet paper dispenser;

**Findings:**      Dispenser is not compliant for location, centered 12-1/2" in front of the WC.

**Recommendations:**  
Relocate dispenser. Center toilet paper dispenser at 7"-9" in front of WC.

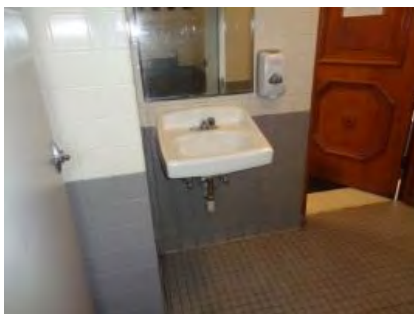
**Item Description:** Lavatory; Mirror over lavatory

**Findings:** Lavatory is centered 13-3/8" from the side wall. Mirror height is not compliant at 40-1/4" AFF to the lowest reflective edge.

**Recommendations:**  
Relocate lavatory, centered 18" minimum from the side wall. Lower mirror. The lowest reflective edge shall not be higher than 40" AFF.

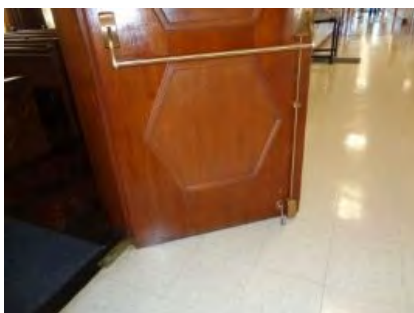
**Item Description:** All doors;

**Findings:** The required smooth surface at the push side of doors is obstructed by vertical latch rods.

**Recommendations:**  
Remove or cover vertical latch rods at the bottom of doors. The bottom 10" of all doors shall be smooth.

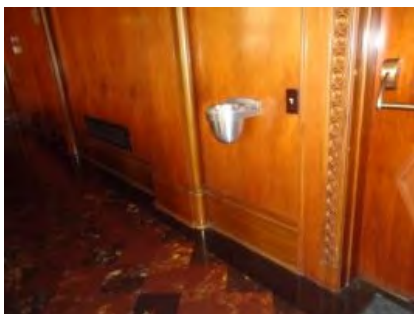
**Findings:**      The wall-mounted ash tray protrudes greater than 4" into the accessible route.

**Recommendations:**  
Remove ash tray.

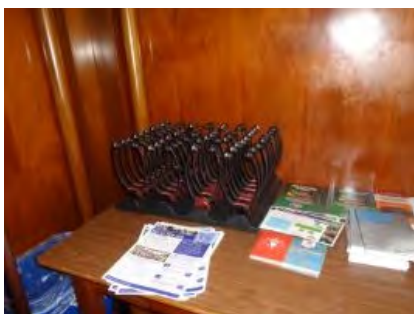
**Findings:**      An assistive listening system is provided but is only available for Spanish translation only.

**Recommendations:**  
Provide a second assistive listening system in English for the hearing impaired.

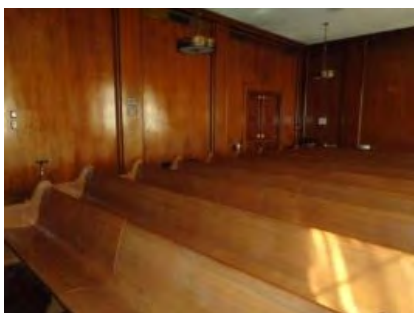
**Findings:**      Signage is not provided at the assembly area to inform patrons of the availability of the assistive listening system.

**Recommendations:**  
Provide signs informing of the availability of the assistive listening systems. Signs shall state "Assistive-Listening System Available" and be posted in a prominent place at or near the assembly area entrance. Assistive listening signs shall include the International Symbol of Access for Hearing Loss.

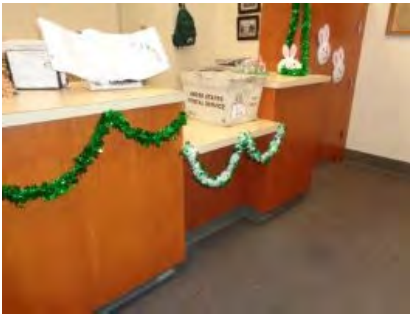
**Item Description:** Accessible counter;

**Findings:** Counter is not maintained clear at all times.

**Recommendations:**  
Maintain counter at the ready at all times for use by the disabled.

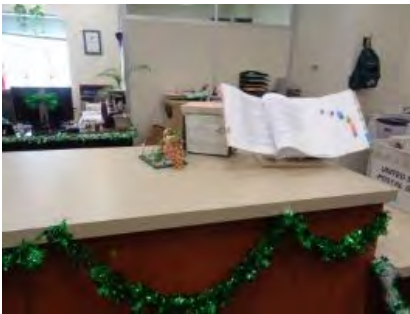
**Item Description:** Minutes of meetings;

**Findings:** Printed minutes of meetings are not accessible due to height of counter.

**Recommendations:**  
Provide a copy at the lower counter, or create a policy where staff will make the material available at the lower counter upon request.

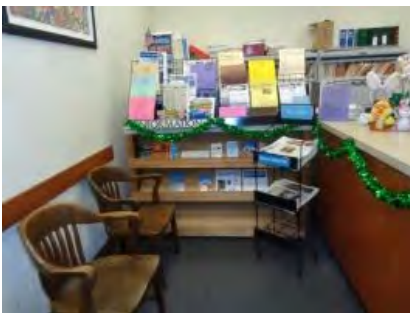
**Item Description:** Information rack;

**Findings:** Printed material is not accessible due to height and obstruction by chairs and paper rack.

**Recommendations:**  
Make material available online and eliminate information rack. Until such time this is possible, consolidate all materials to within 48" of the floor and not lower than 15" above the floor and move rack to hallway.

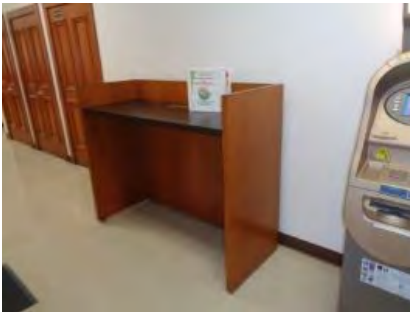
**Item Description:**      Job Announcement counter;

**Findings:** Counter is not accessible at 41-3/4" high.

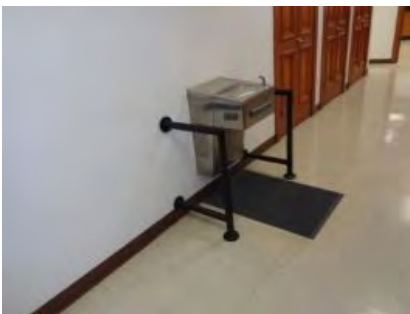
**Item Description:**      Drinking fountain;

**Findings:** Water flow is not a minimum 4" high.

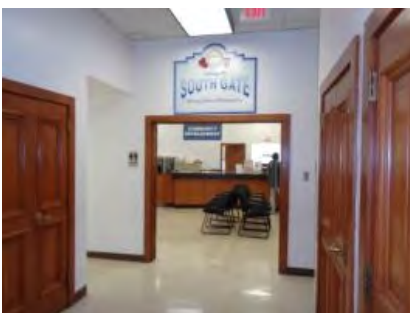
**Item Description:**      Restroom direction sign;

**Findings:** Compliant signage is not provided in the hall indicating the location of the accessible restrooms.

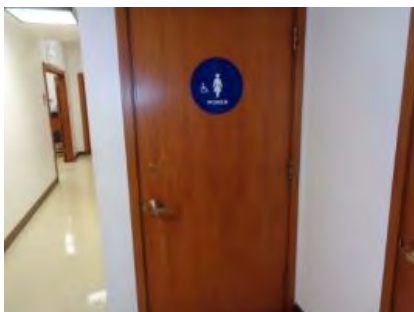
**Item Description:**      Tactile wall sign;

**Findings:**      The required tactile wall sign is not provided at the restroom doorway.

**Recommendations:**  
Provide a tactile wall sign at each doorway, having Grade 2 Braille beneath raised text and a raised pictogram.

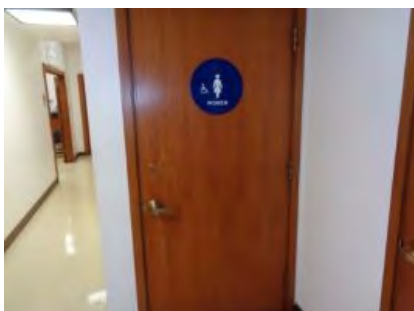
**Item Description:**      Door sign;

**Findings:**      Door sign is not compliant for height, centered at 62" AFF.

**Recommendations:**  
Reset door sign. Center sign at 58"-60" AFF.

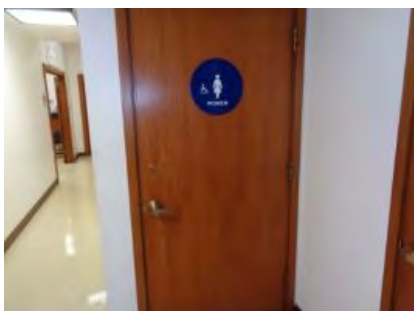
**Item Description:**      Entrance door;

**Findings:**      Door is not accessible as it has no strike-side clearance at the push side.

**Recommendations:**  
The requirement for side clearance is only when a door has both a closer and a latch. Remove the latch from door. Provide a U-shaped door pull or dummy lever at the pull side - and remove deadbolt.

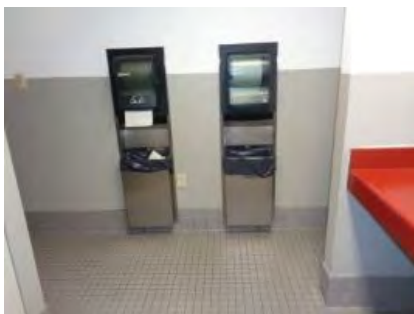
**Item Description:** Paper towel dispensers;

**Findings:** Dispensers are not accessible due to height.

Lower the right dispenser (WaveNdry). The highest operable part shall not be higher than 40" AFF. The cost analysis is for an in-wall dispenser to be lowered within the existing alcove and be mounted so that the operable parts are no higher than 40 inches.

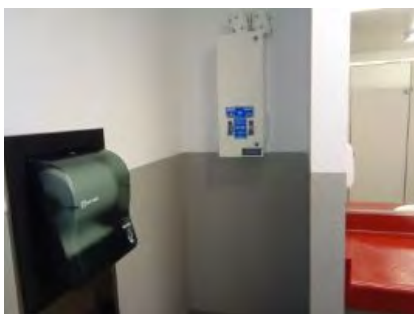
**Item Description:** Sanitary napkin dispenser;

**Findings:** Dispenser is not accessible due to height.

Lower dispenser to a maximum 40" AFF to the highest operable part.

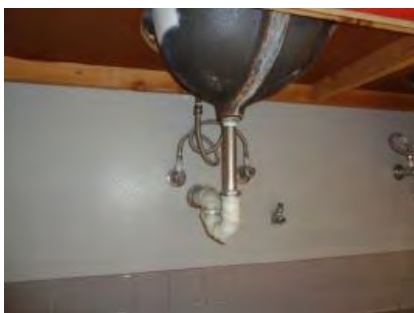
**Item Description:** Lavatory Insulation;

**Findings:** Insulation beneath the lavatories is not provided.

Cover, wrap, or otherwise insulate all water lines, drains, valves and fittings. There shall also be no exposed sharp or abrasive elements under lavatories.

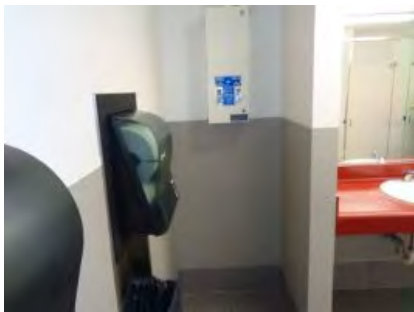
**Item Description:**      Lavatory faucets;

**Findings:**      Automatic self-closing faucets do not remain open for a minimum of 10 seconds.

**Recommendations:**  
Adjust the metering of each faucet to remain open for a minimum of 10 seconds.

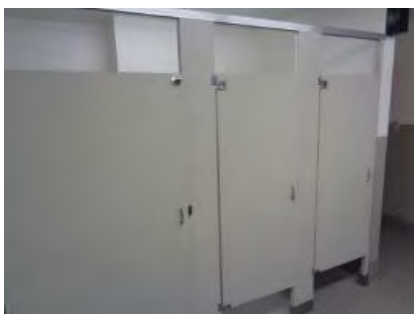
**Item Description:**      Accessible Stall;

**Findings:**      Three stalls are provided. None provide the required 60" turning radius.

**Recommendations:**  
Rearrange stalls to provide an accessible stall a minimum 60" wide.

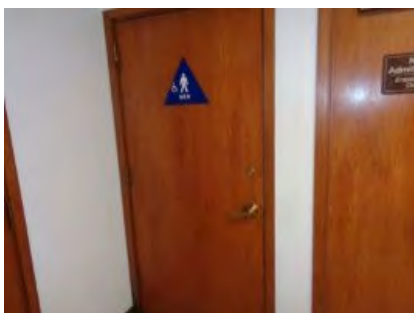
**Item Description:**      Entrance door;

**Findings:**      Door is not accessible as it has no strike-side clearance at the push side.

**Recommendations:**  
The requirement for side clearance is only when a door has both a closer and a latch. Remove the latch from door. Provide a U-shaped door pull or dummy lever at the pull side - and remove lock on door.

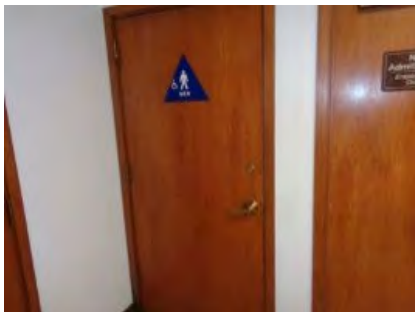
**Item Description:** Tactile wall sign; Door sign

**Findings:** The required tactile wall sign is not provided at the restroom doorway. Door sign is not compliant for height, centered at 64" AFF.

**Recommendations:**  
Provide a tactile wall sign at each doorway, having Grade 2 Braille beneath raised text and a raised pictogram. Reset door sign. Center sign at 58"-60" AFF.

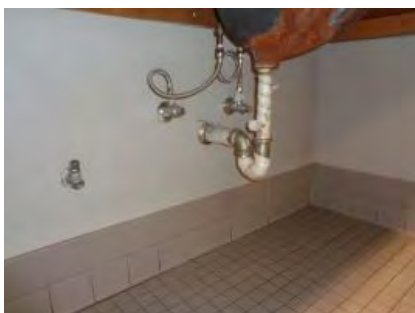
**Item Description:** Lavatory Insulation;

**Findings:** Insulation beneath the lavatories is not provided.

**Recommendations:**  
Cover, wrap, or otherwise insulate all water lines, drains, valves and fittings. There shall also be no exposed sharp or abrasive elements under lavatories.

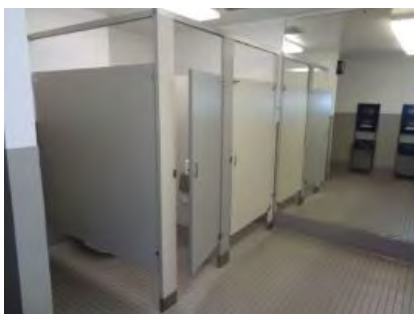
**Item Description:**      Accessible Stall;

**Findings:** Two stalls are provided. None provide the required 60" turning radius.

**Recommendations:**  
Rearrange stalls to provide an accessible stall a minimum 60" wide.

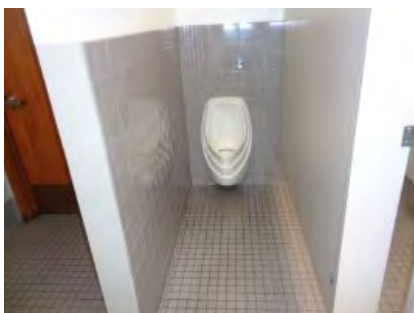
**Item Description:**      Urinal alcove;

**Findings:** Urinal alcove is not compliant for width at 29-1/2".

**Recommendations:**  
Move side partition wall. Alcove shall be a minimum 36" wide. Recenter urinal on the 36" clear floor space.

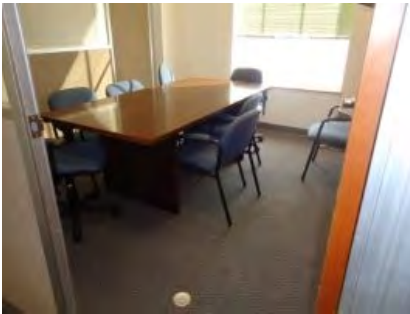
**Findings:** Sufficient space is not provided for furniture and a wheelchair to enter the room, turn and exit.

**Recommendations:**  
Relocate to a larger meeting room.

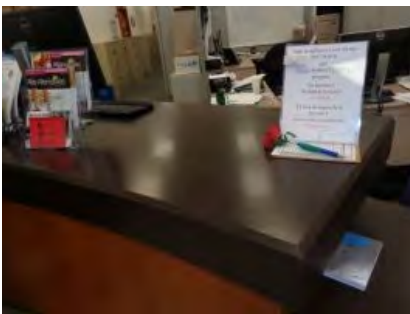
**Findings:** Push button and sign-in sheet for Section 8 and Home improvement program are not accessible

**Recommendations:**  
Lower sign-in sheet and call button to the lower counter.

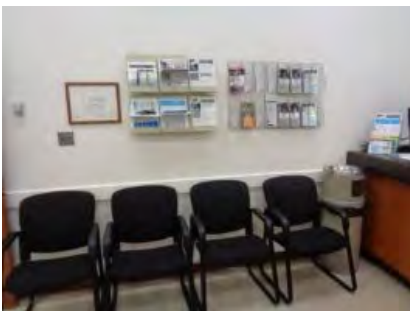
**Findings:** Pamphlets at wall rack are not accessible due to obstructed reach.

**Recommendations:**  
Relocate rack to hallway, or provide an additional new rack with the same printed materials, no higher than 48" AFF.

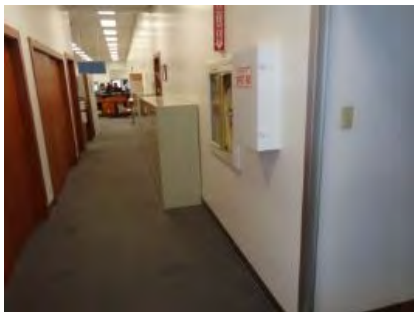
**Item Description:** First aid box;

**Findings:** First aid cabinet projects 5-1/2" into circulation route.

Recess cabinet into wall so projection is less than 4". The cost analysis is for removal of the first aid cabinet, cutting a wall alcove and moving the cabinet to the new location.

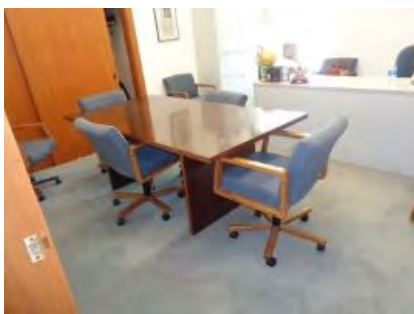
**Item Description:** Conference area;

**Findings:** Insufficient clear floor space is provided for a wheelchair to enter, turn around and exit.

Replace table with a smaller table. The minimum turning radius provided shall be 60".

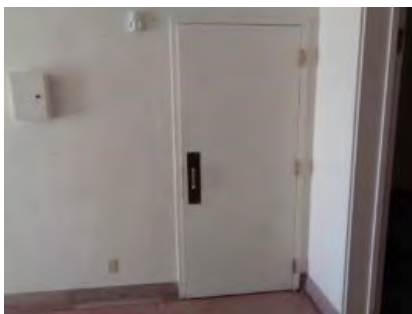
**Comment CHS-002** **Priority: 1** **Estimated Direct Cost:** \$2,340 **Maintenance**

**Item Description:** Tactile room identification signs; Door closers

**Findings:** Compliant room Identification wall signs are not provided. All doors with automatic closers require adjustment for opening force and closing speed.

Provide a room I.D. sign package for the building. Mount signs on the wall at the latch side of doors, centered at 56" AFF. Adjust or replace all door closers to provide an operational effort of 5 lbf maximum and so that from an open position of 90 degrees, the time required to move the door to a position of 12 degrees from the latch is 5 seconds minimum.

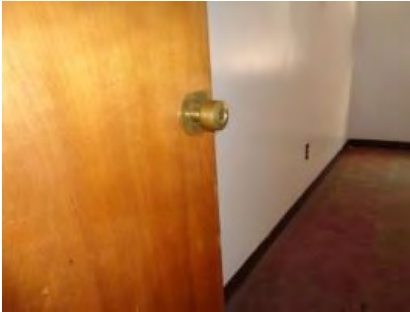
**Comment**      **CHS-004**      **Priority: 1**      **Estimated Direct Cost:**      \$1,850      Maintenance

**Item Description:** Round door knobs;

**Findings:** The office doors of the Park Superintendent and Park Director both have round door knobs, which are not accessible.

**Recommendations:**  
Replace all round door knobs with lever handles. The end of levers shall return to within 1/2" of the door surface.

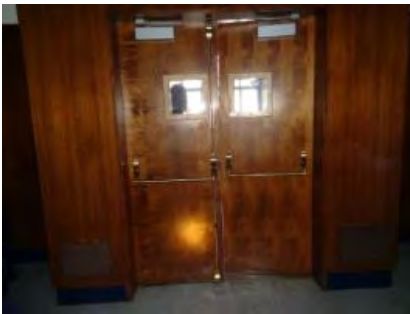
**Comment**      **CHS-005**      **Priority: 2**      **Estimated Direct Cost:**      \$2,250      Contractor

**Item Description:** Double doors;

**Findings:** Double doors each have door leaves providing only 27" clear width. Accessible doors require .

**Recommendations:**  
Alter one pair of doors to provide a single door leaf a minimum 36" width, or replace doors and door frame at 36".

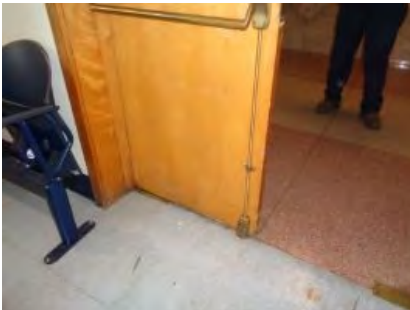
**Comment**      **CHS-006**      **Priority: 2**      **Estimated Direct Cost:**      \$190      Maintenance

**Item Description:** Vertical latch rods;

**Findings:** Doors with vertical latch rods are not accessible. Latch rods at the push side of doors interfere with the requirement for a smooth door surface.

**Recommendations:**  
Remove or cover vertical latch rods. Covers must provide a smooth surface for lower 10" of the door, across the full width.

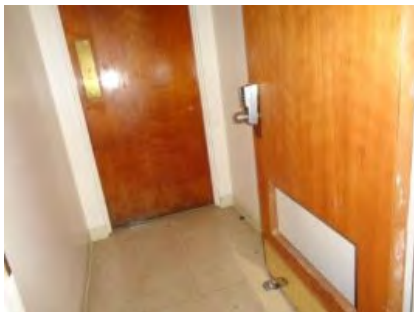
**Comment**      **CHS-007**      **Priority: 2**      **Estimated Direct Cost:**      \$5,000      Contractor

**Item Description:**      Strike-side clearance;

**Findings:**      Various doors lack sufficient clearances for wheelchair accessibility.

**Recommendations:**  
Alterations shall include updates to doorways as needed for accessible passage.

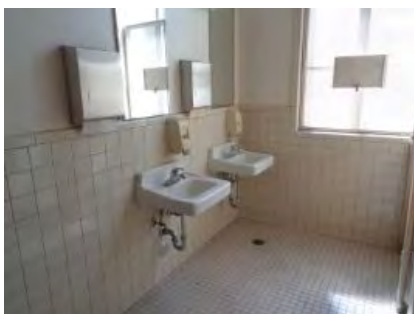
**Comment**      **CHS-008**      **Priority: 2**      **Estimated Direct Cost:**      \$10,000      Maintenance

**Item Description:**      Alterations;

**Findings:**      Restrooms were not compliant with access codes when the building was closed in 2004.

**Recommendations:**  
When alterations are made, they shall conform to the applicable codes at that future time.

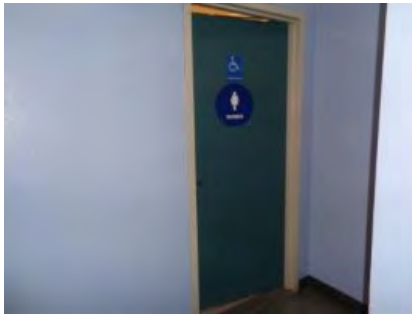
**Comment** CY-001 **Priority: 2** **Estimated Direct Cost:** \$150 **Maintenance**

**Item Description:** Door Sign; Tactile wall sign

**Findings:** The existing geometric door sign color fails to provide color contrast with the door color. Both are dark. The required tactile wall sign is not provided at each restroom doorway.

Replace geometric door sign with a light color geometric door sign. Provide a tactile wall sign, having Grade 2 Braille beneath raised text and a raised pictogram. Mount sign on the wall at the latch side.

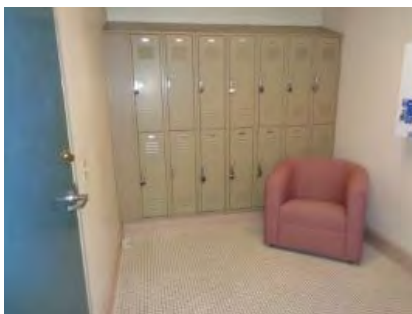
**Comment** CY-003 **Priority: 3** **Estimated Direct Cost:** \$575 **Contractor**

**Item Description:** Locker room bench;

**Findings:** Compliant accessible benches have not been provided.

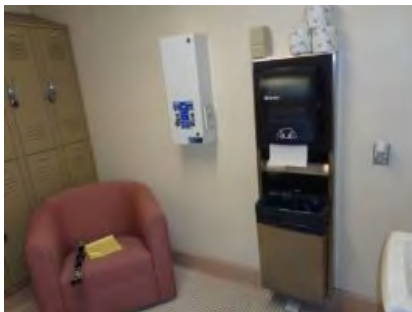
**Item Description:** Paper towel dispenser;

**Findings:** Dispensers are not accessible as they both requires use of two hands, requiring tight grasping and pinching. The side wheel for advancing paper requires twisting of the wrist.

**Recommendations:**  
Remove and replace one paper towel dispenser. New dispenser shall not require tight grasping, pinching or twisting of the wrist. Mount new dispenser not higher than 30" AFF to the highest operable part.

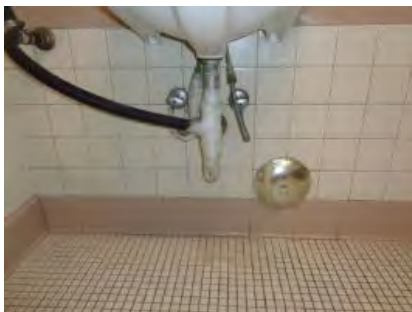
**Item Description:** Lavatory Insulation;

**Findings:** Insulation beneath the lavatory is not complete.

**Recommendations:**  
Cover, wrap, or otherwise insulate all water lines, valves and fittings. There shall also be no exposed sharp or abrasive elements under lavatory.

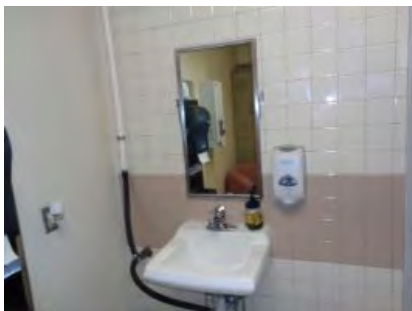
**Item Description:** Lavatory mirror;

**Findings:** Mirror over lavatory is not compliant for height at 40-3/4" AFF to the lowest reflective edge.

**Recommendations:**  
Lower mirror. The lowest reflective edge shall not be higher than 40" AFF.

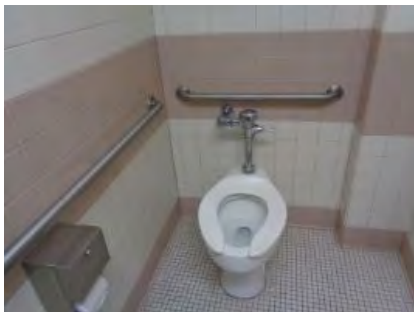
**Item Description:** WC location; Toilet paper dispenser

**Findings:** The accessible WC is not compliant for location, centered 18-3/4" from the side wall. Dispenser is not compliant for location, centered 11-1/2" in front of the WC.

**Recommendations:**  
Reset waste line to center WC at 17"-18" from the side wall. Relocate dispenser. Center toilet paper dispenser at 7"-9" in front of the WC.

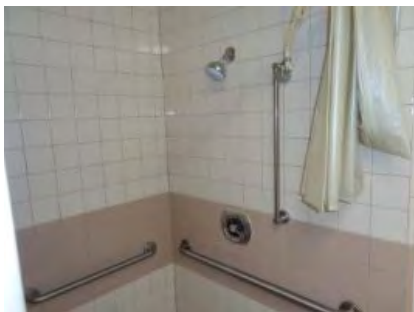
**Item Description:** Shower sprayer;

**Findings:** A hand held spray unit is not available.

**Recommendations:**  
Install a hand held sprayer on a hose, a minimum 59" long. Sprayer shall have a non-positive shut off.

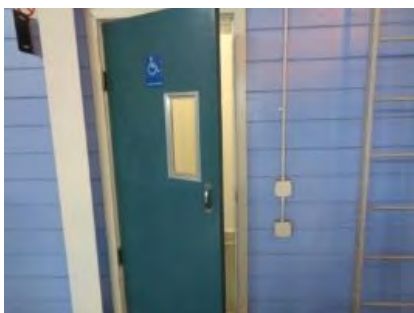
**Item Description:** Door Sign; Tactile wall sign

**Findings:** The existing door sign is not compliant. The required tactile wall sign is not provided at the restroom doorway.

**Recommendations:**  
Replace door sign with a 12" geometric door sign, in white to provide visual contrast with the dark color of the door. Provide a tactile wall sign, having Grade 2 Braille beneath raised text and a raised pictogram. Mount sign on the wall at the latch side.

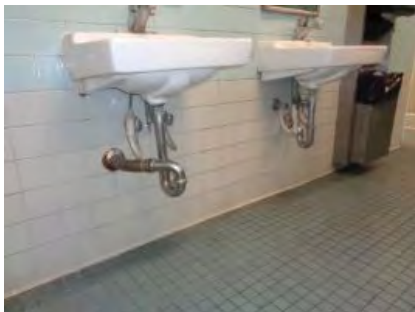
**Comment**      **CY-016**                      **Priority: 2**      **Estimated Direct Cost:**      \$75                      Maintenance

**Item Description:**      Lavatory Insulation;

**Findings:**      Insulation of pipes beneath lavatories is not provided.

**Recommendations:**  
Fully cover, wrap, or otherwise insulate all water lines, drains, valves and fittings. There shall also be no exposed sharp or abrasive elements under lavatory.

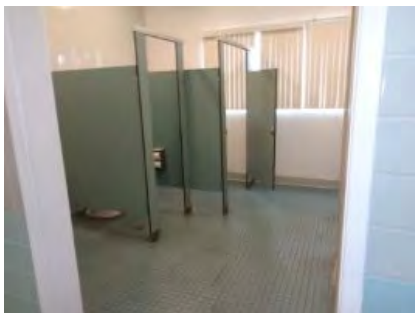
**Comment**      **CY-018**                      **Priority: 2**      **Estimated Direct Cost:**      \$95                      Maintenance

**Item Description:**      Stall Door;

**Findings:**      Stall door is not self-closing.

**Recommendations:**  
Replace self-closing hinges.

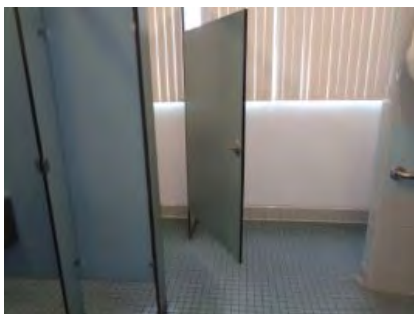
**Findings:** Door is missing the U-pull handle at the pull side.

**Recommendations:**  
Install a U-shaped pull handle below the latch.

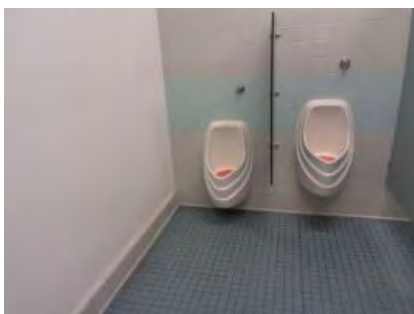
**Findings:** The accessible urinal is not accessible due to a rim height of 17-1/2".

**Recommendations:**  
Lower urinal to a rim height not greater than 17" AFF.

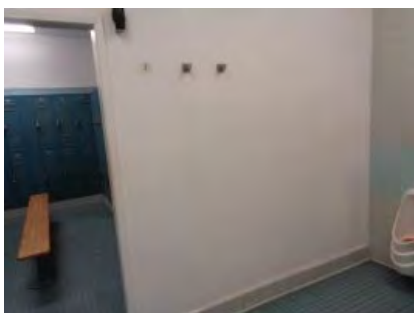
**Findings:** Two coat hooks are provided on the wall. Both coat hooks are outside of the allowable reach range at 72" AFF.

**Recommendations:**  
Provide one additional coat hook at the same area, no higher than 48" AFF.

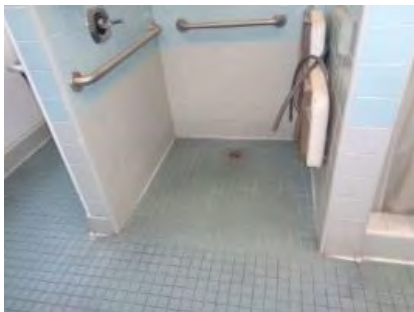
**Item Description:**      Floor drain; Shower sprayer; Shower seat

**Findings:** Floor slope at shower drain is greater than 2.1%. A hand held spray unit is not available. Folding seat does not collapse to within 6 inches of the wall.

**Recommendations:**  
Modify floor slope. Slope at drain shall not exceed 2.1%. Drain grate shall be flush with the finished floor. Install a hand held sprayer on a hose, a minimum 59" long. Sprayer shall have a non-positive shut off. Correct interference to allow seat to completely fold up.

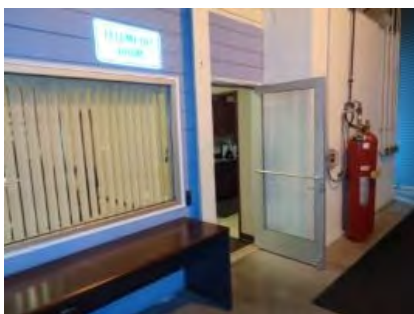
**Item Description:**      Smooth surface at door; Tactile room identification signs

**Findings:** Door stop at the push side of door interferes with the requirement for a smooth surface. Where room ID signs are provided, they do not conform to California sign requirements.

**Recommendations:**  
Remove door stop. Provide new room I.D. sign package with Grade 2 Braille. Signs shall be provided at interior rooms and spaces where the sign is not likely to change over time.

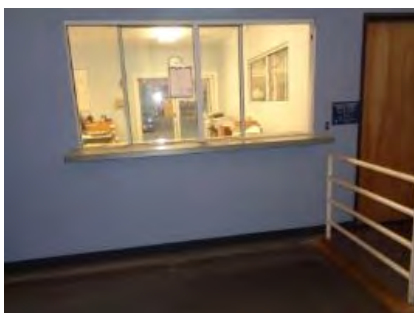
**Item Description:**      Counter height; Buzzer button

**Findings:** Counter is not accessible at 44-1/2" AFF to the counter surface. The forward reach to the buzzer is obstructed by the counter, railing and ramp.

**Recommendations:**  
Lower the counter to within the allowable height range of 28"-34" AFF. Relocate the buzzer to the left side of counter or mount onto the surface of counter, centered a minimum 20" from the right end of counter.

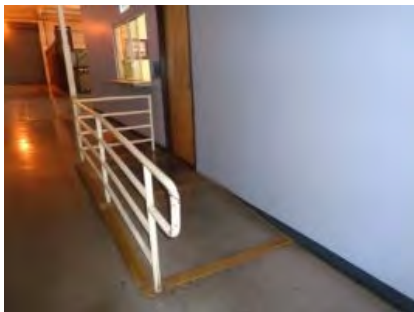
**Item Description:** Ramp Handrails; Ramp Handrails; Ramp slope

**Findings:** Handrails are not provided at both sides of ramp The existing handrail extension is not level. Slope of ramp is not uniform and measures 9.7% at the top.

**Recommendations:** Install handrail at wall, full length of ramp. Modify handrail extension to turn level over the level landing. Demolish ramp and rebuild using the least slope possible, not to exceed 8.33%. New ramp shall be 48" wide minimum.

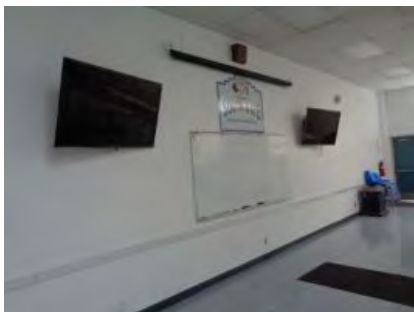
**Item Description:** Overhead obstructions;

**Findings:** Two wall-mounted TV's create an overhead obstruction. Both project on average 6" from the wall at less than 80" AFF.

**Recommendations:** Raise TV's to obtain a minimum vertical clearance of 80" to the lowest edge, or provide a barrier under each TV, such as a table, rail or other element. Barrier shall be cane-detectable within 27" of the floor.

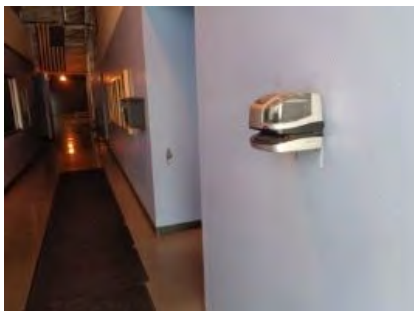
**Item Description:** Time clocks;

**Findings:** Two mail boxes and two time clocks project greater than 4" from the wall.

**Recommendations:** Provide a cane-detectable element below each protruding item. Cane-detectable element shall be equal in projection minus 4" and be detectable within 27" of the floor.

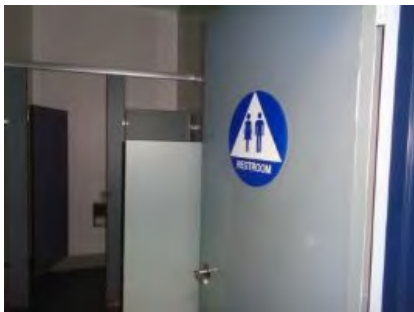
**Comment**      **CY-033**                      **Priority: 2**      **Estimated Direct Cost:**      \$75                      Maintenance

**Item Description:**      Signage;

**Findings:** The Unisex restroom is not wheelchair accessible.

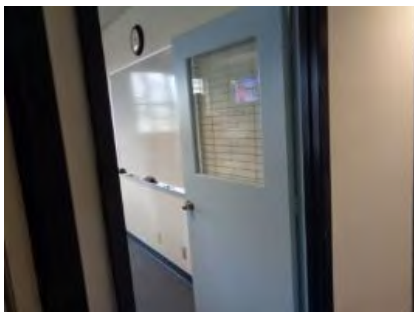
**Comment**      **CY-034**                      **Priority: 2**      **Estimated Direct Cost:**      \$95                      Maintenance

**Item Description:**      Door knobs;

**Findings:** Round door knob is not accessible, requiring tight grasping and twisting of the wrist.

Replace one round door knob with a lever handle. The end of lever shall return to within 1/2" of the surface of the door.

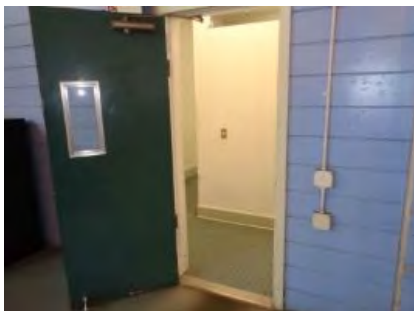
**Comment**      **CY-035**                      **Priority: 1**      **Estimated Direct Cost:**      \$1,140                      Maintenance

**Item Description:**      Automatic door closers;

**Findings:** All doors with automatic closers close too fast and/or require excessive force to open.

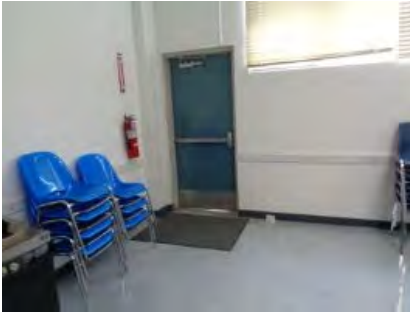
**Comment**      **CY-036**                      **Priority: 1**      **Estimated Direct Cost:**      \$600                      Maintenance

**Item Description:**      Tactile exits signs;

**Findings:** Tactile exit signs are not provided at grade level exit doors.

**Recommendations:**  
Provide tactile exit signs at each exit door leading to a grade-level exit, mounted at the latch side of single doors and preferably to the right of double doors. Signs shall have Grade 2 Braille beneath raised text stating "EXIT".

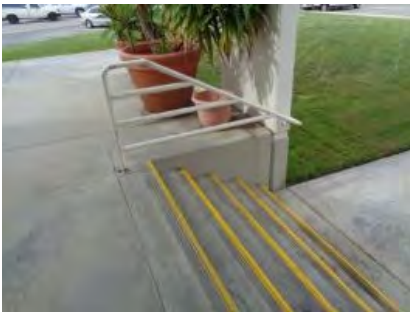
**Comment**      **CY-038**                      **Priority: 1**      **Estimated Direct Cost:**      \$1,000                      Contractor

**Item Description:**      Handrails; Handrails

**Findings:** The upper handrails turn level before the end of the flight. Extensions are not a minimum 12" level before turning down. Level handrail extensions are not provided at the bottom of stairs.

**Recommendations:**  
Modify handrails as needed to conform. Modify handrails to include lower extensions.

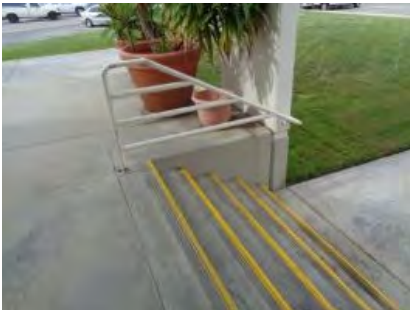
**Comment**      **CY-040**                      **Priority: 1**      **Estimated Direct Cost:**      \$190                      Maintenance

**Item Description:**      Warning stripes;

**Findings:** The stair tread warning stripes are not compliant for width.

**Recommendations:**  
Paint stripes to a width of 2"-4", the full width of treads.

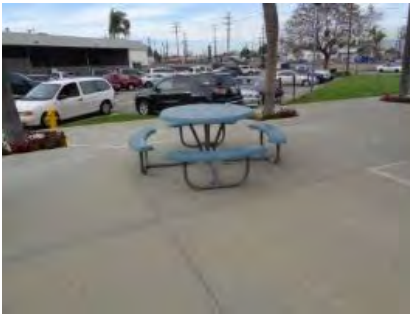
**Findings:** Table is not wheelchair accessible.

**Recommendations:**  
Remove one seat from table to accommodate one wheelchair user.

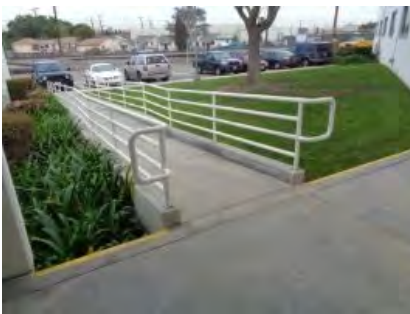
**Findings:** Handrail extensions at top of ramp do not extend in the same direction of the ramp. Landing is not compliant for length at 4'-9".

**Recommendations:**  
Modify handrail extensions to project level and straight over the top landing. Replace intermediate landing and the lower portion of the ramp. Landing length shall be 60" minimum.

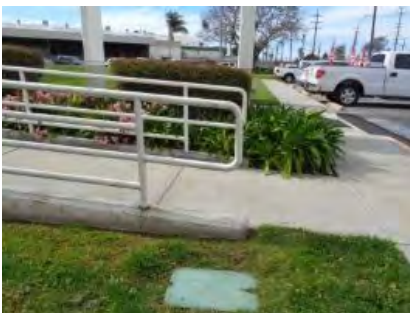
**Room/Spot:** Exterior  
Ramp

**Findings:** The lower 8 feet of ramp is not compliant for clear width at 47-1/2" between curbs. Ramp handrails are not provided for the full length of ramp.

**Recommendations:**  
Replace the lower portion of ramp. Ramp width shall be 48" minimum between curbs. Curbs shall extend the full length of ramp slope. Continue handrails to the bottom landing and turn extensions 90 degrees.

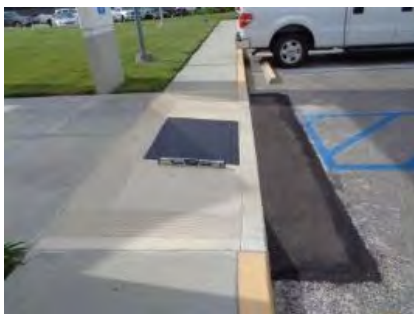
**Item Description:**      Curb ramp;

**Findings:** Curb ramp is not compliant, having a slope of 10.4% and side flare slopes greater than 22%.

**Recommendations:**  
Replace curb ramp.

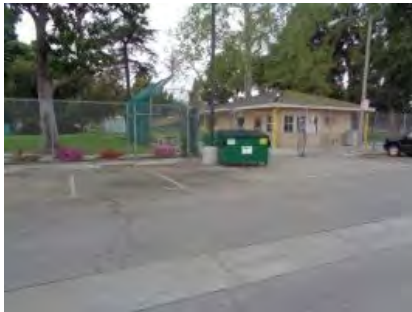
Item Description: Accessible Parking;

Findings: Accessible parking is not provided at the golf facility

Recommendations:  
Re-stripe and re grade parking lot to provide accessible stall and access aisle.

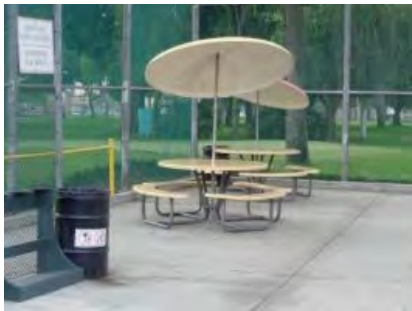
Item Description: Accessible seating;

Findings: Tables are provided at both sides of Club house. Accessible seating is not provided.

Recommendations:  
Modify tables as needed to provide wheelchair access. 5% of seating shall be accessible (1 in 20).

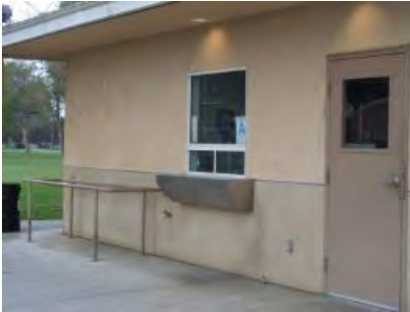
**Item Description:** Counter;

**Findings:** Counter height is not accessible at 38-1/2". Sales at the window have ceased and now sales only occur inside, but golfers may wish to use the counter for other reasons.

**Recommendations:**  
Lower counter to a height not greater than 34" AFF.

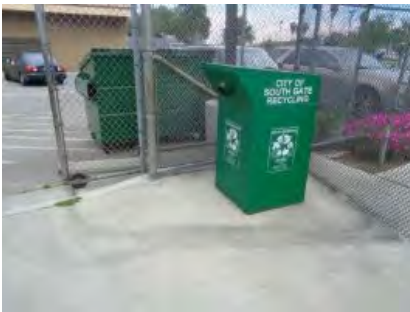
**Item Description:** Recycle Bin;

**Findings:** Recycle bin is not located on an accessible route. Slopes of 13% in front of bin.

**Recommendations:**  
Relocate recycle bin to a level area connecting to an accessible route.

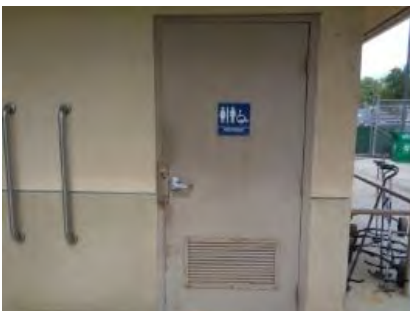
**Item Description:** Door sign;

**Findings:** The required geometric door sign has not been provided.

**Recommendations:**  
Install a Unisex geometric sign with a light color triangle over a dark circle, centered on door at 58"-60" AFF.

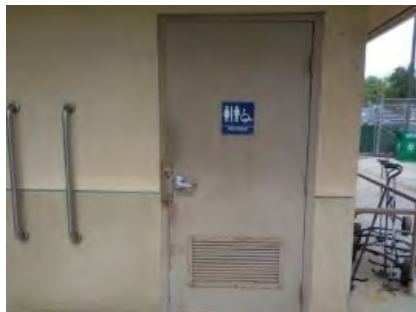
**Item Description:** Tactile wall sign; Door closer

**Findings:** The required tactile wall signs are not provided at the restroom doorway. Automatic door closer requires adjustment for opening force and closing speed.

**Recommendations:**  
Provide a tactile wall sign at doorway, having Grade 2 Braille beneath raised text and a raised pictogram. Adjust door closer to provide an operational effort of 5 lbf maximum and so that from an open position of 90 degrees, the time required to move the door to a position of 12 degrees from the latch is 5 seconds minimum.

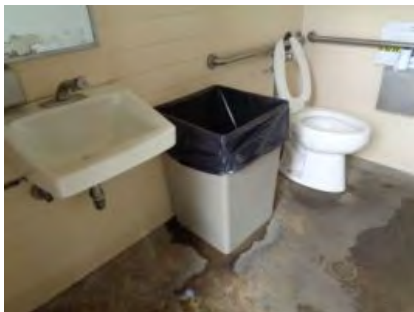
**Item Description:**    Loose waste can;

**Findings:**    Waste can blocks transfer space next to WC.

**Recommendations:**  
Remove waste can from restroom. Install a recessed wall-mounted waste can.

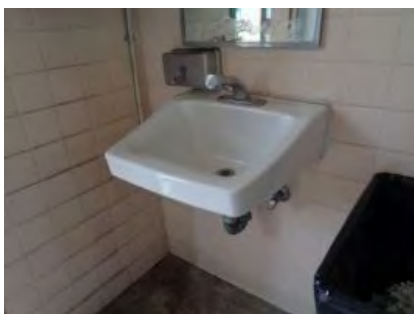
**Item Description:**    Lavatory faucet;

**Findings:**    Automatic self-closing faucet fails to remain open for a minimum of 10 seconds.

**Recommendations:**  
Adjust the metering of faucet to remain open for a minimum of 10 seconds.

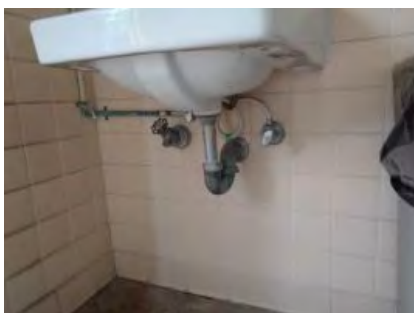
**Item Description:**    Lavatory Insulation; Hose bib

**Findings:**    Insulation beneath the lavatory is not complete. The hose bib mounted at wall, beneath lavatory, creates a sharp or abrasive element which can contact skin.

**Recommendations:**  
Cover, wrap, or otherwise insulate all water lines, drain, valves and fittings. There shall also be no exposed sharp or abrasive elements under lavatory. Recess hose bob into wall and provide a smooth plate over hose bib opening.

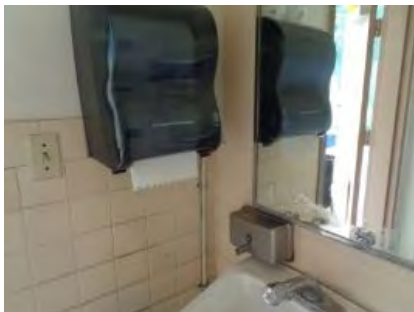
**Findings:** Mirror is not compliant for height at 40-1/2" to bottom edge.

**Recommendations:**  
Lower mirror. The lowest reflective edge shall be no higher than 40" AFF.

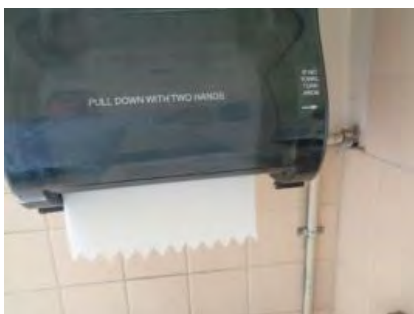
**Findings:** Dispenser is not accessible as it require use of two hands, and requires tight grasping and pinching. The side wheel for advancing paper requires twisting of the wrist.

**Recommendations:**  
Remove and replace paper towel dispenser. New dispenser shall not require use of both hands, or tight grasping, pinching or twisting of the wrist. Mount new dispenser not higher than 40" AFF to the highest operable part.

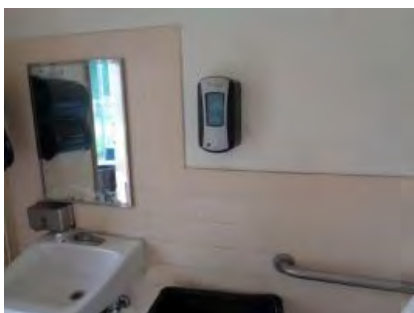
**Findings:** Soap dispenser is not accessible due to height.

**Recommendations:**  
Lower soap dispenser to a height not greater than 40" AFF to the highest operable part.

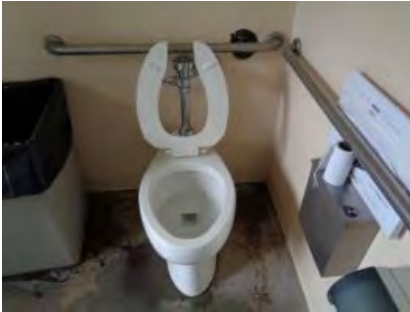
**Item Description:** WC location; Both grab bars; Toilet paper dispenser; Seat cover dispenser

**Findings:** The accessible WC is not compliant for location, centered 18-5/8" from the side wall. Both grab bars are not compliant for location. Dispenser is not compliant for location, centered 12-1/2" in front of the WC. Dispenser is not provided. Seat cover packaging is wedged behind grab bar and blocks use of grab bar.

Reset waste line to center WC 17"-18" from the side wall. Replace rear grab bar with a 42" bar to avoid clean-out at wall. Raise rear grab bar to provide a minimum hand clearance under grab bar of 1-1/2" over flush valve. Side grab bar shall project 52" from back wall. Relocate dispenser. Center toilet paper dispenser at 7"-9" in front of the WC. Install seat cover dispenser at lavatory wall, beneath rear grab bar.

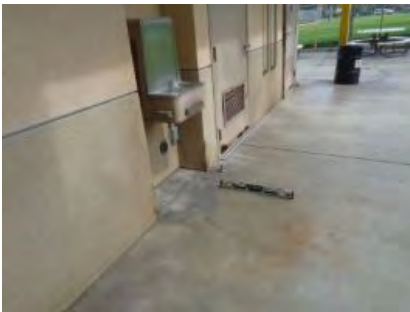
**Item Description:** Drinking Fountain; Drinking Fountain

**Findings:** A level ground area is not provided at DF, with slopes of 2.7%. A second DF for standing persons is not provided.

Replace concrete as needed to provide a level area, with slopes not to exceed 2.1% in any direction. Replace DF with a combination Hi/Lo DF.

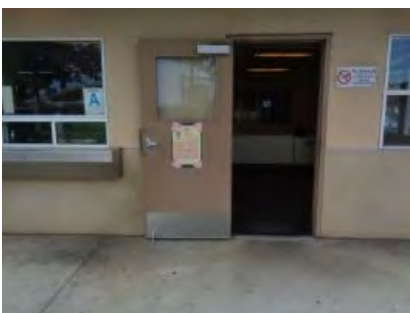
**Item Description:** Door stop;

**Findings:** Door stop at the push side of Club House door interferes with the requirement for a smooth door surface.

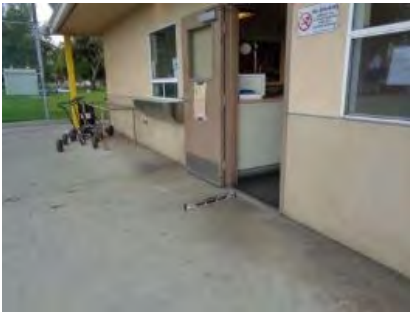
Club house Exterior

**Findings:** The exterior door landing is not level, having a slope of 5.9%.

**Recommendations:**  
Survey concrete area and create remediation concrete plans. The existing slope is far too high for a simple new slab.

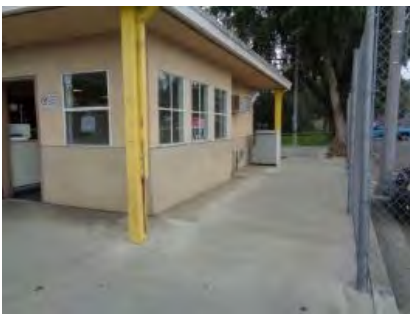
Club house Exterior

**Findings:** Cross slope at the North side of Club House is excessive, found to be as high as 4.1%.

**Recommendations:**  
Survey concrete area and create remediation concrete plans. The existing slope is far too high for a simple new slab.

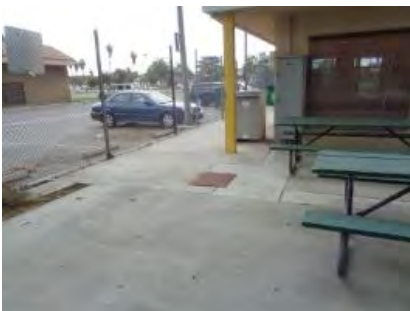
Club house Exterior

**Findings:** Metal plate in circulation path rises greater than 1/4".

**Recommendations:**  
Install vault box with flush cover.

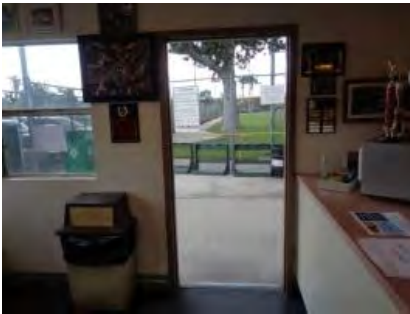
**Item Description:**      Tactile exit sign;

**Findings:**      Tactile exit sign is not provided at grade level exit door.

Provide tactile exit signs at door leading to a grade-level exit. Mount sign at the latch side of the door. Signs shall have Grade 2 Braille beneath raised text stating "EXIT".

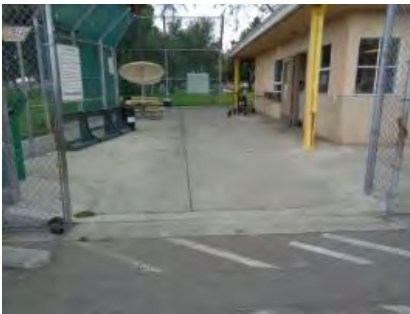
**Item Description:**      Detectable Warning Surface;

**Findings:**      Truncated domes are not provided at curb ramp.

Install truncated domes across the ramp surface, 36" deep in the direction of travel.

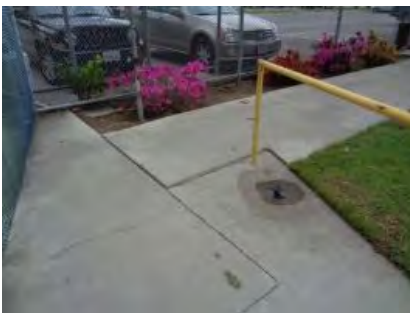
**Item Description:**      Concrete walkway;

**Findings:**      At area of the turn around the handrail, concrete section is depressed and the water valve obstructs the requirement for a level walking surface without changes in level.

Remove and replace concrete slab. Relocate water valve outside of the path of travel. Shorten railing, moving post away from turn to provide sufficient space for a mobility cart.

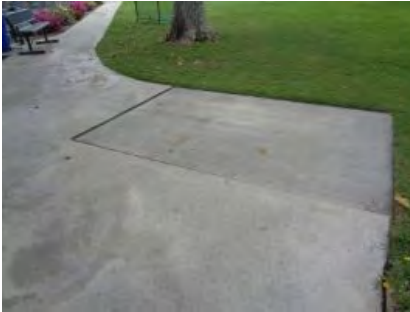
Path to Hole 1

**Findings:** New concrete surface is not even with surrounding concrete. Abrupt change in level is greater than 1/4".

**Recommendations:**  
Replace 4'X8' section of concrete.

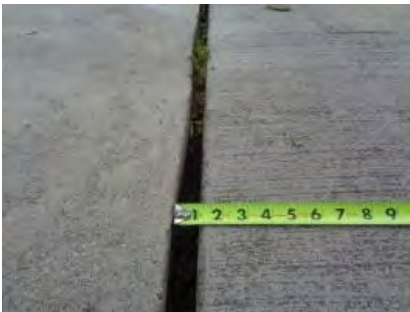
Path to Hole 1

**Findings:** Opening in slab joints are greater than 1/2".

**Recommendations:**  
After replacing slab, fill any openings 1/2" or greater with epoxy caulk.

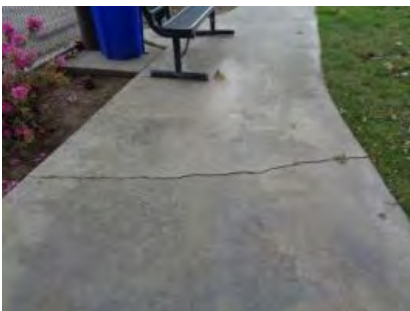
Path to Hole 1

**Findings:** Bench blocks the required width of the path of travel.

**Recommendations:**  
Relocate bench outside of the path of travel.

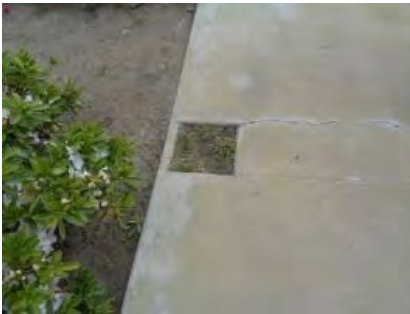
Path to Hole 1

**Findings:**    Two square holes in the path of travel restrict the width of the walkway.

**Recommendations:**  
Fill holes flush with concrete.

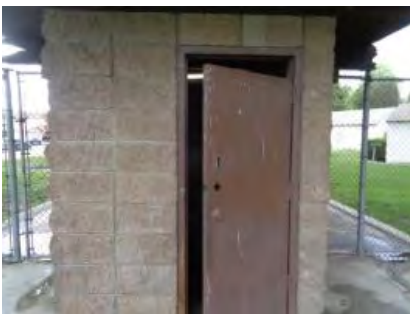
Course restroom at Hole 6

**Findings:**    The required geometric door sign has not been provided. The required tactile wall signs are not provided at the restroom doorway.

**Recommendations:**  
Install a Unisex geometric sign with a light color triangle over a dark circle, centered on door at 58"-60" AFF. Provide a tactile wall sign at doorway, having Grade 2 Braille beneath raised text and a raised pictogram.

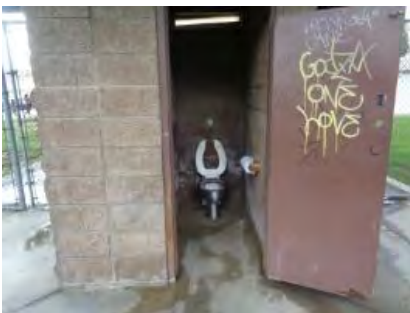
Course restroom at Hole 6

**Findings:**    Restroom is not accessible. A door handle or door pull is not provided at a compliant height, for either side of door.

**Recommendations:**  
Provide a sign indicating the location of the accessible restroom at the Club House. Sign shall have white text and a white ISA on a dark blue background. At both sides of door, add a handle or U-shape door pull, centered 34"-44" AFF.

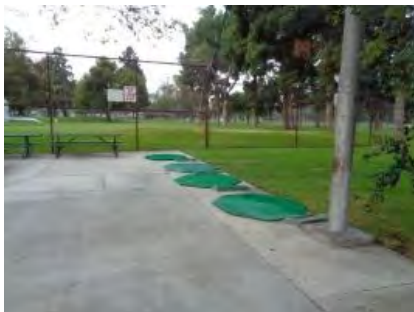
**Item Description:** Clear space;

**Findings:** An accessible driving range position has not been provided.

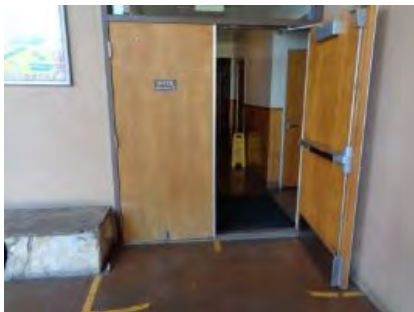
**Item Description:**    Door closers;

**Findings:** All doors with automatic closers require adjustment for opening force and closing speed.

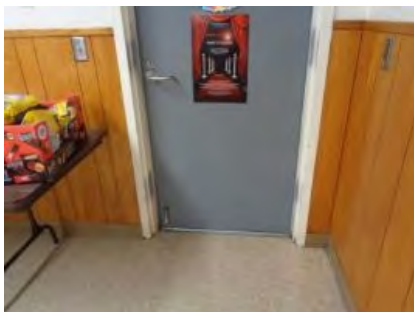
**Item Description:**    Door stops;

**Findings:** Door stops at the push side of doors interferes with the requirement for a smooth door surface.

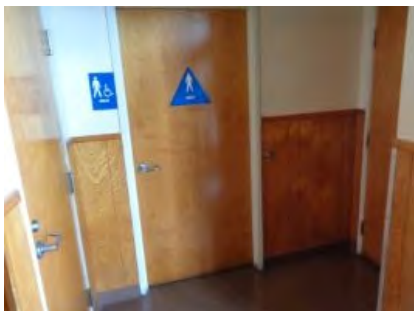
**Comment**    **GCH-005**                    **Priority: 2**            **Estimated Direct Cost:**    \$75                    Maintenance

**Item Description:**    Tactile wall sign;

**Findings:** The existing tactile wall sign is not compliant due to Braille spacing which does not conform to California Braille spacing requirements.

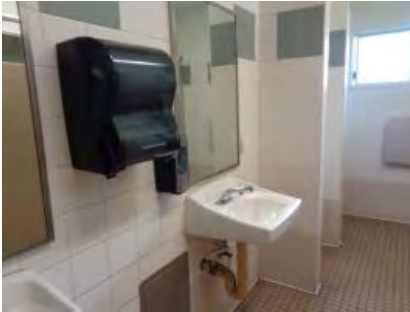
**Comment**      **GCH-006**      **Priority: 2**      **Estimated Direct Cost:**      \$1,800      Contractor

**Item Description:**      Mirror; Paper towel dispenser

**Findings:** Mirror height is not compliant at 51-1/4" AFF to the lowest edge. Dispensers are not accessible for height at 51" AFF.

**Recommendations:**  
Lower one mirror. The lowest reflective edge shall not be higher than 40" AFF. Lower one dispenser to position not higher than 40" AFF to the highest operable part.

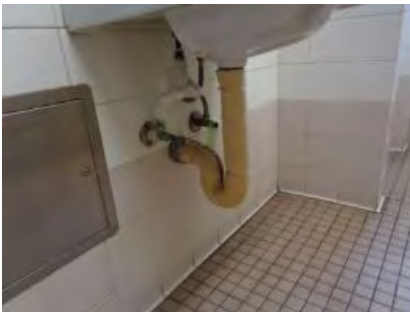
**Comment**      **GCH-008**      **Priority: 2**      **Estimated Direct Cost:**      \$75      Maintenance

**Item Description:**      Lavatory Insulation;

**Findings:** Insulation beneath lavatories is not properly completed.

**Recommendations:**  
Cover, wrap, or otherwise insulate all water lines, drains, valves and fittings. There shall also be no exposed sharp or abrasive elements under lavatories.

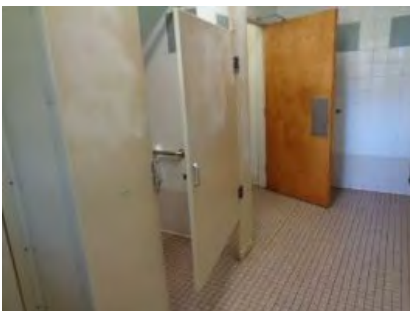
**Comment**      **GCH-009**      **Priority: 2**      **Estimated Direct Cost:**      \$95      Maintenance

**Item Description:**      Stall Door;

**Findings:** The accessible stall door is not self-closing.

**Recommendations:**  
Replace the self-closing hinges.

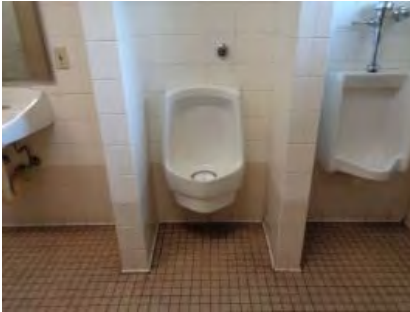
**Item Description:**    Urinal; Urinal Alcove

**Findings:** Urinal is not compliant, having a rim height of 21" AFF. The accessible urinal alcove is not accessible at 28-1/2" wide.

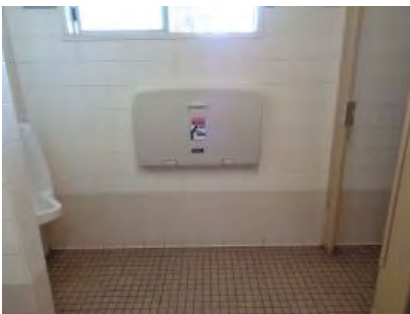
**Item Description:**    Baby changing table;

**Findings:** When baby changing table is deployed it blocks the required clear floor space at the urinal and stall door.

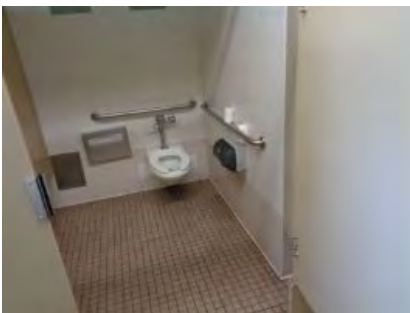
**Item Description:**    Stall Door; Toilet paper dispenser; Rear grab bar; Accessible stall width

**Findings:** Stall door is located directly in front of WC. Dispenser is not compliant for location, centered 11-1/2" in front of the WC. Grab bar is not compliant for location. Stall is not a minimum 60" wide, measuring at 58-1/2" wide.

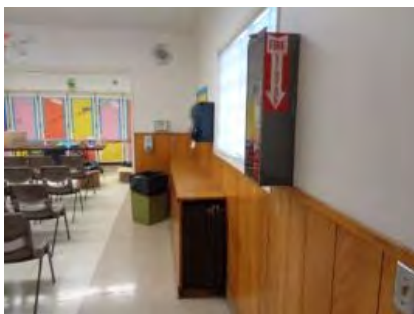
**Findings:**      FE cabinet projects greater than 4" into the circulation route.

**Recommendations:**  
Recess cabinet into the wall. Cabinet shall not project greater than 4" from wall surface.
