# City of South Gate

# Volume 2

## Appendix B Facilities Barrier Assessment Report

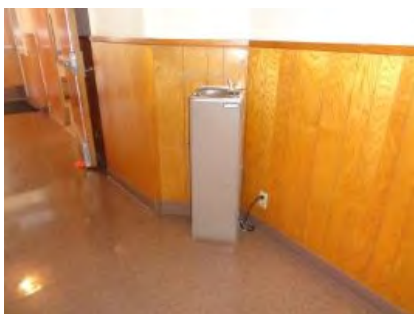
**Findings:**      DF is not accessible.

**Recommendations:**  
Provide an accessible Hi/Lo combination DF located within an alcove, or with pedestrian protection rails or wing walls.

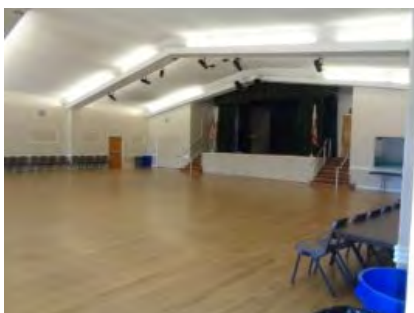
**Findings:**      An assistive listening system is required but was not found to be available.  
Signage is not provided at Auditorium or side lobbies to inform patrons of the availability of an assistive listening system.

**Recommendations:**  
Provide a permanent assistive listening system. Consult with a sound engineer as each system varies in advantages and disadvantages. Provide signs informing of the availability of the assistive listening systems. Signs shall state "Assistive-Listening System Available" and be posted in prominent places at or near the assembly area entrances. Assistive listening signs shall include the International Symbol of Access for Hearing Loss.

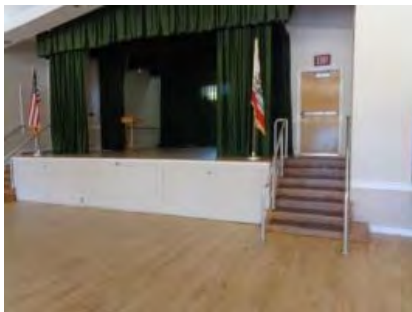
**Item Description:** Access to stage; Stage stair warning stripes; Handrail extensions

**Findings:** Vertical access is not provided from Assembly seating area to Performance area. Warning stripes are not provided at either stair. Handrail extensions at both stairs are not compliant, failing to project level 12" before turning down.

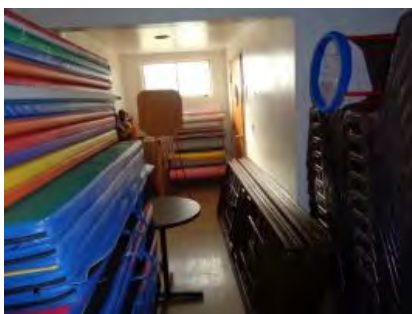
**Item Description:** Access;

**Findings:** Access to the restroom is blocked by stored tables and stacked floor pads.

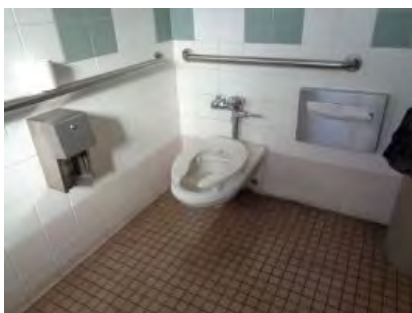
**Item Description:** WC Seat height; Toilet paper dispenser

**Findings:** Seat height with the existing raised seat is 16". Dispenser is not compliant for location, centered 11-1/2" in front of the WC.

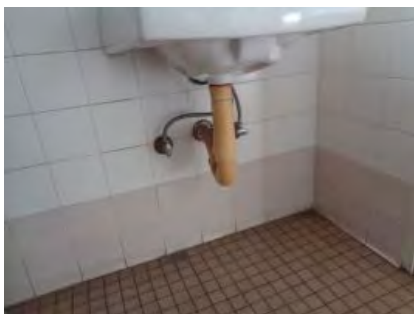
**Item Description:**    Lavatory Insulation;

**Findings:**    Insulation of pipes beneath lavatories is not complete.

Fully cover, wrap, or otherwise insulate all water lines, valves and fittings. There shall also be no exposed sharp or abrasive elements under lavatory.

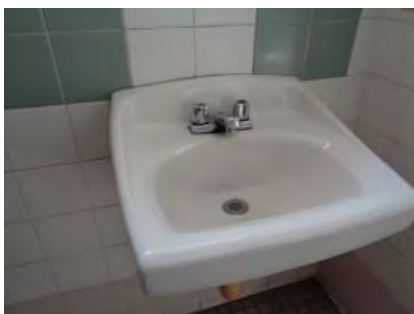
**Item Description:**    Lavatory faucet handles;

**Findings:**    Round handles are not accessible.

Replace round handles with lever handles.

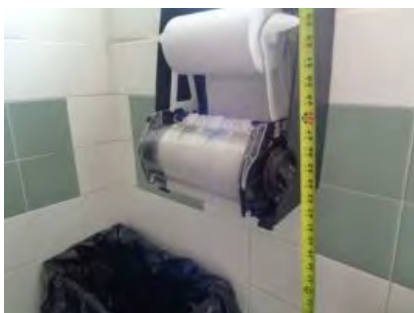
**Item Description:**    Paper towel dispenser;

**Findings:**    Dispenser is not accessible as use of both hands are required. The side wheel for advancing paper requires twisting of the wrist.

Remove and replace one paper towel dispenser. New dispenser shall not require tight grasping, pinching or twisting of the wrist. Mount new dispenser not higher than 40" AFF to the highest operable part.

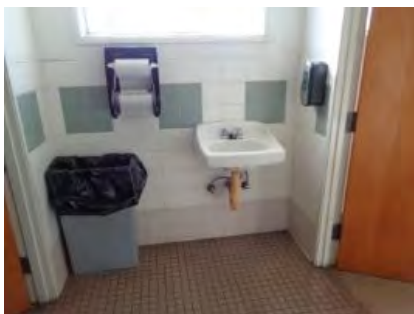
**Comment**      **GCH-030**      **Priority: 2**      **Estimated Direct Cost:**      \$60      Maintenance

**Item Description:**      Loose waste basket;

**Findings:** Loose waste basket interferes with the required clear floor space at paper towel dispenser. Loose waste basket can be moved and inadvertently block access to dispensers and fixtures.

**Recommendations:**  
Locate waste basket at another location, away from clear floor spaces required at fixtures and dispensers. Provide a wall clip or floor bracket to keep waste basket in place.

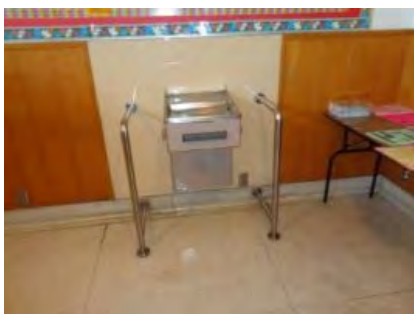
**Comment**      **GCH-031**      **Priority: 3**      **Estimated Direct Cost:**      \$625      Contractor

**Item Description:**      Drinking fountain;

**Findings:** Spout outlet is not compliant for height at 36-1/4".

**Recommendations:**  
Lower DF. Spout height shall be not higher than 36" AFF.

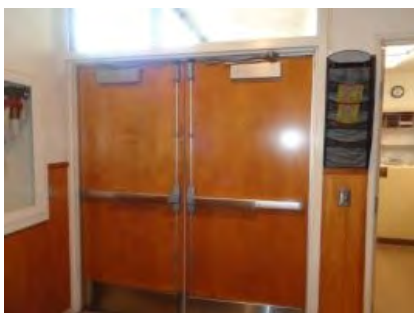
**Comment**      **GCH-032**      **Priority: 3**      **Estimated Direct Cost:**      \$75      Maintenance

**Item Description:**      Pamphlet rack;

**Findings:** The pamphlet rack next to door is not accessible, having shelves outside of the accessible reach range.

**Recommendations:**  
Rack can remain as long as the printed material is also provided at wheelchair height. Provide another rack with the lowest reach not lower than 15" AFF and the highest reach not greater than 48" AFF.

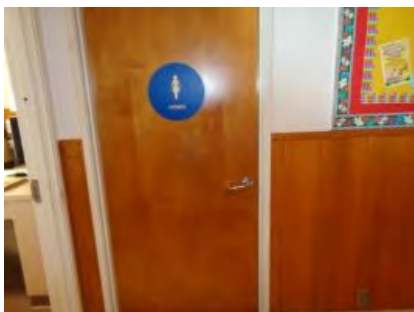
**Item Description:**      Tactile wall sign;

**Findings:**      The required tactile wall sign is not provided.

**Recommendations:**  
Provide one new tactile wall sign having Grade 2 Braille beneath raised text and a raised pictogram. Mount sign on the wall, at the latch side of door, centered at 56" AFF.

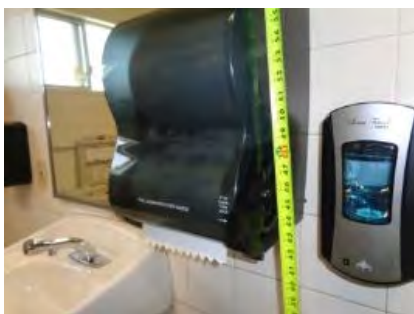
**Item Description:**      Paper towel dispenser;

**Findings:**      Dispensers are not accessible as use of both hands is required. The side wheel for advancing paper requires twisting of the wrist.

**Recommendations:**  
Remove and replace one paper towel dispenser. New dispenser shall not require tight grasping, pinching or twisting of the wrist. Mount new dispenser not higher than 40" AFF to the highest operable part.

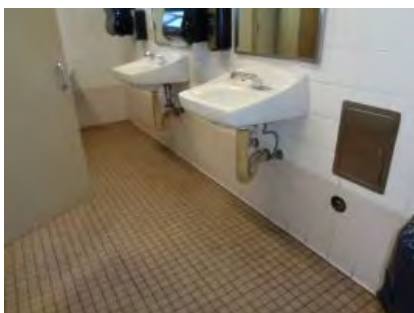
**Item Description:**      Lavatory Insulation; Stall Door

**Findings:**      Insulation beneath lavatories is not properly completed. The accessible stall door is not self-closing.

**Recommendations:**  
Cover, wrap, or otherwise insulate all water lines, drains, valves and fittings. There shall also be no exposed sharp or abrasive elements under lavatories. Replace the self-closing hinges.

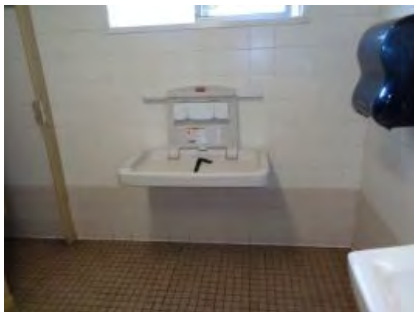
**Comment**      **GCH-037**      **Priority: 2**      **Estimated Direct Cost:**      \$550      Contractor

**Item Description:**      Baby changing table;

**Findings:**      When baby changing table is deployed it blocks the required clear floor space at the stall door.

**Recommendations:**  
Remove baby changing table.

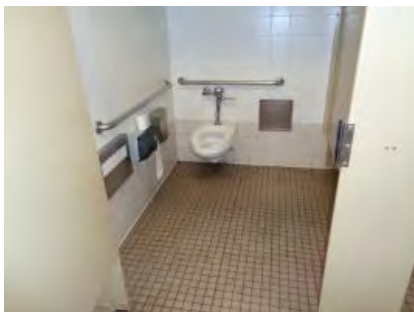
**Comment**      **GCH-038**      **Priority: 2**      **Estimated Direct Cost:**      \$6,000      Contractor

**Item Description:**      Stall Door; Rear grab bar; Accessible stall width

**Findings:**      Stall door is located directly in front of WC. Grab bar is not compliant for location. Stall is not a minimum 60" wide, measuring at 58-1/2" wide.

**Recommendations:**  
The door opening shall be 4 inches maximum from the side partition farthest from the water closet. Reset rear grab bar location per detail D033. Move partition panel as needed to provide a minimum stall width of 60".

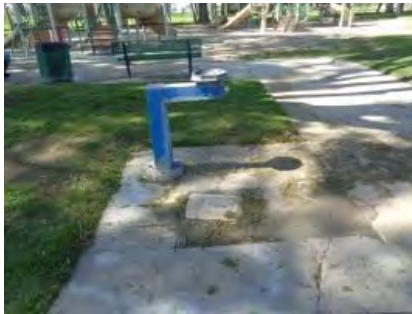
**Comment**    **GTL-001**                    **Priority: 3**            **Estimated Direct Cost:**    \$5,120                    Contractor

**Item Description:**    Drinking fountain; Drinking fountain

**Findings:** Ground space at and adjoining the DF is not a firm and continuous surface, DF is not accessible. Spout angle is 45 degrees from the front edge. Push button is recessed.

**Recommendations:**  
Provide new concrete at DF. Reset water vault cover flush with new concrete. Remove and replace with a new compliant DF conforming to CBC 602.1

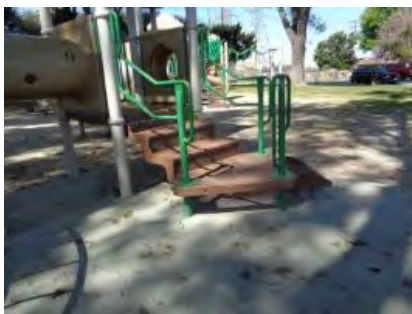
**Comment**    **GTL-003**                    **Priority: 3**            **Estimated Direct Cost:**    \$190                    Maintenance

**Item Description:**    Contrasting stripes;

**Findings:** The required contrasting stripes are not provided at transfer steps.

**Recommendations:**  
Provide contrasting stripes in white. The stripes shall be a minimum of 2 inches wide to a maximum of 4 inches wide placed parallel to, and not more than 1 inch from, the nose of the step or upper approach. The stripes shall extend the full width of steps.

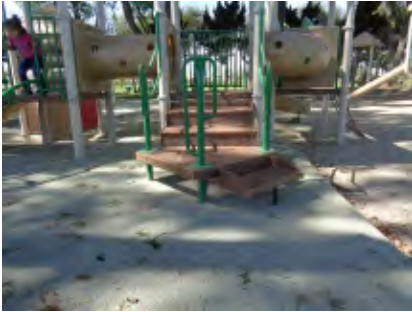
**Comment**      **GTL-004**      **Priority: 3**      **Estimated Direct Cost:**    \$10,000      Contractor

**Item Description:**    Transfer platform;

**Findings:** A transfer system is not provided at the larger elevated play structure.

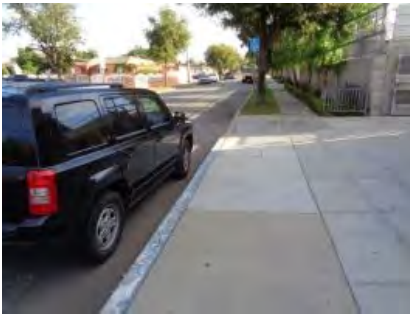
**Comment** HRC-001 **Priority:** 1 **Estimated Direct Cost:** \$6,020 **Contractor**

**Item Description:** Accessible stall ; Stall sign

**Findings:** The accessible parking stall is not compliant for a conventional Caltrans accessible stall. Stall sign is not next to the stall. Sign is missing the additional sign stating "MINIMUM FINE \$250".

**Recommendations:** Reconstruct parking stall to include a 5 foot setback and curb ramp behind the stall. Relocate stall sign per Caltrans detail. Add minimum fine sign below the existing ISA sign.

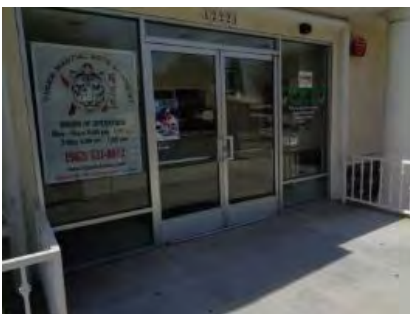
**Comment** HRC-003 **Priority:** 1 **Estimated Direct Cost:** \$1,140 **Maintenance**

**Item Description:** Door closers;

**Findings:** All doors with automatic closers require adjustment for opening force and closing speed.

**Recommendations:** Adjust all door closers to provide an operational effort of 5 lbf maximum and so that from an open position of 90 degrees, the time required to move the door to a position of 12 degrees from the latch is 5 seconds minimum.

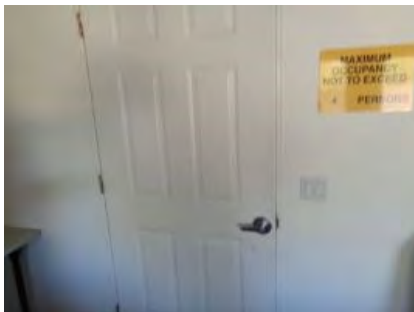
**Comment**     **HRC-004**     **Priority: 2**     **Estimated Direct Cost:**     \$1,200     Maintenance

**Item Description:**     Room Identification signs;

**Findings:**     The required tactile room I.D. signs are not provided at various rooms.     I.D. signs for interior rooms or spaces are required.

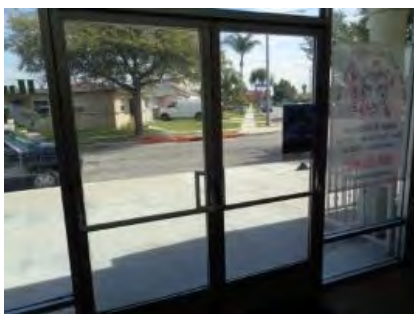
**Comment**     **HRC-005**     **Priority: 1**     **Estimated Direct Cost:**     \$600     Maintenance

**Item Description:**     Tactile exit signs;

**Findings:**     Tactile exit signs are not provided at all grade level exit doors and exterior gates.

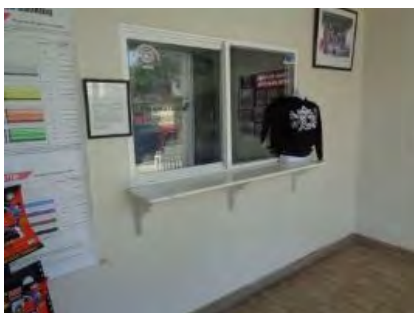
**Comment**     **HRC-006**     **Priority: 3**     **Estimated Direct Cost:**     \$550     Contractor

**Item Description:**     Counter;

**Findings:**     Reception counter is not accessible at 41-1/4" AFF.

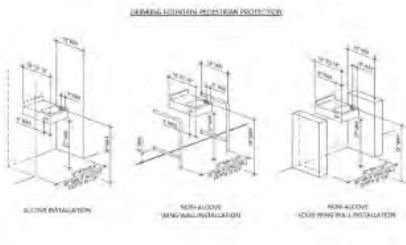
**Comment** HRC-007 **Priority:** 3 **Estimated Direct Cost:** \$5,000 **Contractor**  
**Item Description:** Drinking fountain;

**Findings:** A minimum of 2 drinking fountains is not provided.

**Recommendations:**  
Replace existing DF with a Combination Hi/Lo model, set into an alcove or at the existing location, add a wing rail at the right side

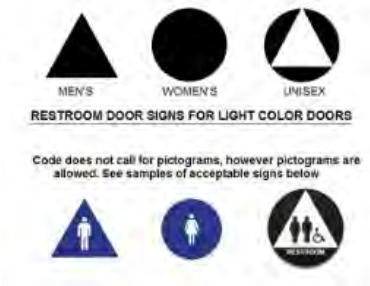
**Comment** HRC-009 **Priority:** 1 **Estimated Direct Cost:** \$75 **Maintenance**  
**Item Description:** Door Signage;

**Findings:** The existing Unisex geometric door sign is not compliant as the two geometric shapes do not have contrasting colors .

**Recommendations:**  
Provide a Unisex geometric door sign having a light color triangle over a dark circle, centered on the door at 58"-60" AFF.

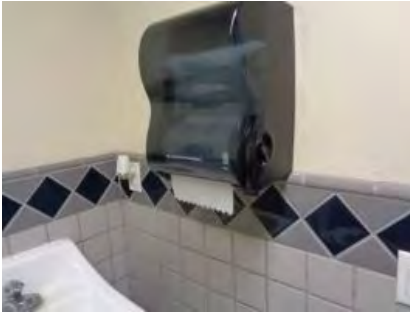
**Item Description:** Paper towel dispenser;

**Findings:** Dispenser is not accessible due to height. Dispenser is not compliant as it requires use of two hands and requires tight grasping and pinching. The side wheel for advancing paper requires twisting of the wrist.

**Recommendations:**  
Remove and replace paper towel dispenser. New dispenser shall not require tight grasping, pinching or twisting of the wrist, or use of two hands. Mount new dispenser not higher than 30" AFF to the highest operable part.

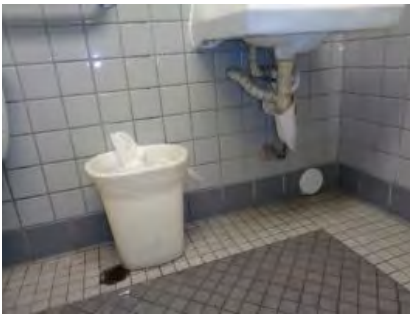
**Item Description:** Lavatory Insulation; Loose waste basket

**Findings:** Insulation beneath the lavatory is not complete. The loose waste can could move and block access to fixtures and dispensers.

**Recommendations:**  
Reset drain insulation and secure. Cover, wrap, or otherwise insulate all water lines, valves and fittings. There shall also be no exposed sharp or abrasive elements under lavatory. Remove loose waste can and install a semi-recessed wall waste receptacle.

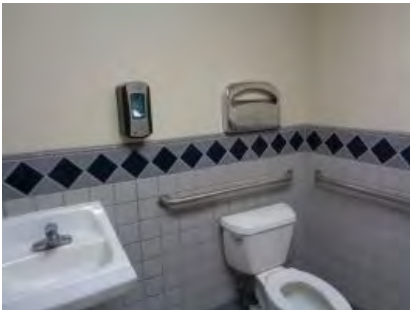
**Item Description:** Soap Dispenser; Seat cover dispenser

**Findings:** Dispenser is not accessible due to a height of 50". Dispenser is not accessible due to height and location.

**Recommendations:**  
Lower soap dispenser to a height not greater than 40" AFF to the highest operable part. Relocate dispenser to below the rear grab bar.

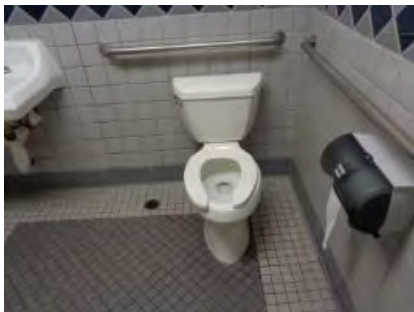
**Item Description:** WC location; Side grab bar

**Findings:** The accessible WC is not compliant for location, centered 18-1/2" from the side wall. Side grab bar location is not compliant.

**Recommendations:**  
Reset waste line to center WC 17"-18" from the side wall. Relocate side grab bar.

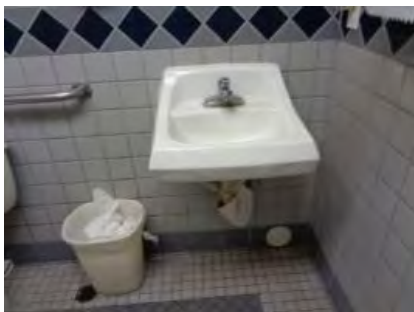
**Item Description:** Lavatory location;

**Findings:** Lavatory is not centered a minimum 18" from the side wall.

**Recommendations:**  
Relocate lavatory.

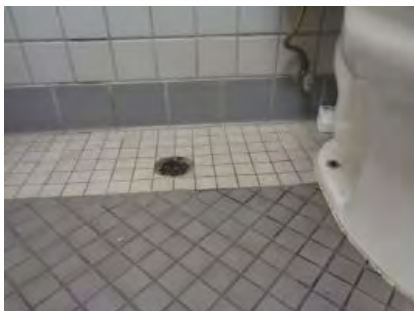
**Item Description:** Floor drain;

**Findings:** Drain grate is not level with the floor.

**Recommendations:**  
Raise drain grate level with floor surface.

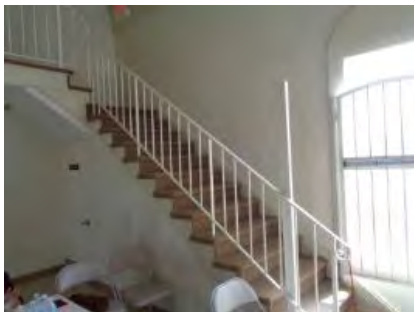
**Item Description:** Handrails;

**Findings:** Handrails do not provide a compliant gripping surface. Handrails are not provided at both sides of stairs. Handrail extensions are not provided.

Replace handrails. Handrails shall have a circular cross section with the outside diameter 1-1/4" - 2", or a non-circular cross section with a perimeter dimension of 4 inches MIN and 6-1/4 inches MAX, and a cross-section dimension of 2-1/4 inches MAX.

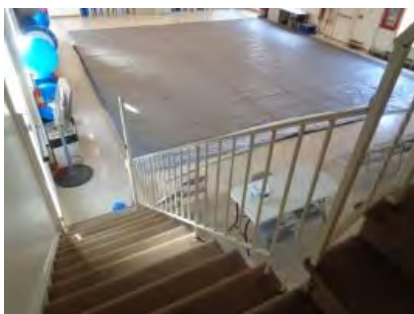
**Item Description:** Guard rails;

**Findings:** A guard rail is not provided along the open side of the stairs.

Add a guard rail at the open side of each stair.

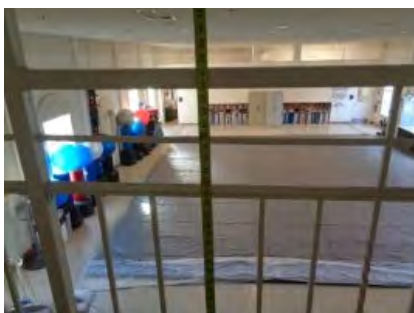
**Item Description:** Guard rails;

**Findings:** The existing guard rail is not a minimum 42" high.

Add a 1 inch square tubing, or similar, across the top of the existing guard rail.

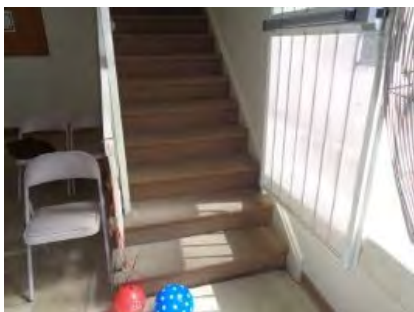
**Comment**     **HRC-022**     **Priority: 1**     **Estimated Direct Cost:**     \$190     Maintenance

**Item Description:**     Warning stripes;

**Findings:**     Warning stripes are not provided at either stair.

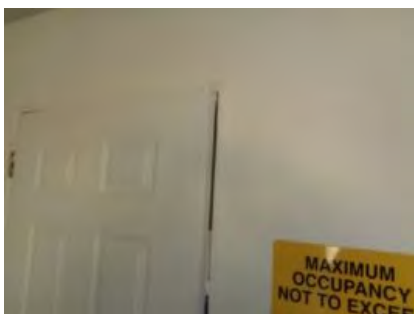
**Comment**     **HRC-023**     **Priority: 2**     **Estimated Direct Cost:**     \$75     Maintenance

**Item Description:**     Door;

**Findings:**     Door sticks at door frame, increasing the force required to open the door.

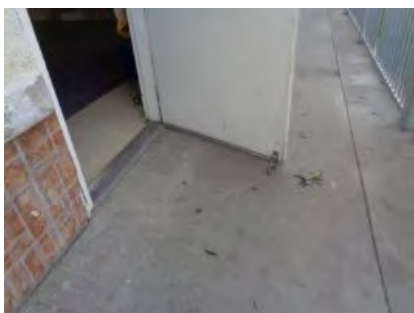
**Comment**     **HRC-024**     **Priority: 1**     **Estimated Direct Cost:**     \$95     Maintenance

**Item Description:**     Door stops;

**Findings:**     Door stops at the push side of doors interferes with the requirement for a smooth door surface.

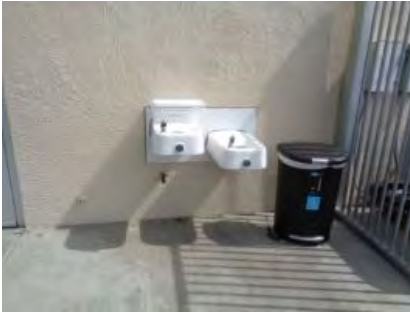
**Findings:**    DF's are not located within an alcove.

**Recommendations:**  
Add pedestrian protection with a wing rail added to the left side.

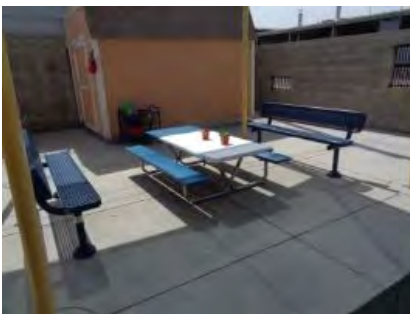
**Findings:**    Fixed seating is provide at table.    WC seating is not provided.

**Recommendations:**  
Extend table top as needed to provide a minimum 19" deep knee space under table.

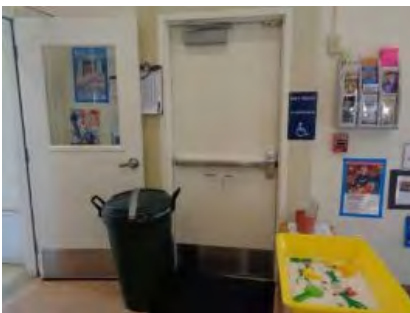
**Findings:**    The requires 18" clearance beyond the door latch is not provided due to tables.

**Recommendations:**  
Move tables away from closest edge of door for a minimum 18 ".

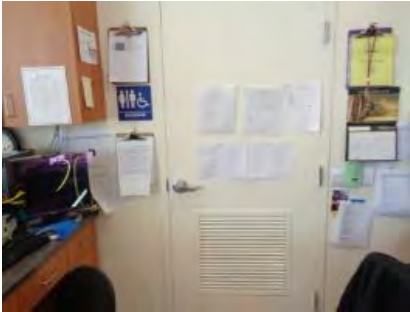
**Comment**      **HRC-028**      **Priority: 2**      **Estimated Direct Cost:**      \$75      Maintenance

**Item Description:**      Door Signage;

**Findings:** The required Unisex geometric door sign is not provided at door.

**Recommendations:**  
Provide a Unisex geometric door sign having a light color triangle over a dark circle, centered on the door at 58"-60" AFF.

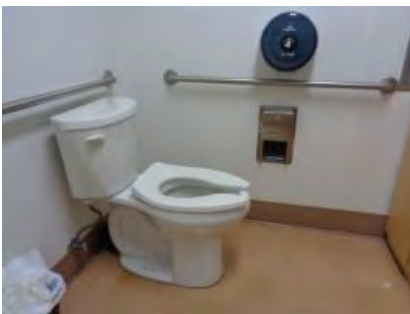
**Comment**      **HRC-029**      **Priority: 2**      **Estimated Direct Cost:**      \$600      Contractor

**Item Description:**      Toilet paper dispenser;

**Findings:** Toilet paper dispenser over grab bar interferes with the required clear space over grab bar.

**Recommendations:**  
Remove and/or relocate dispenser. Toilet paper dispenser shall be centered 7"-9" in front of WC.

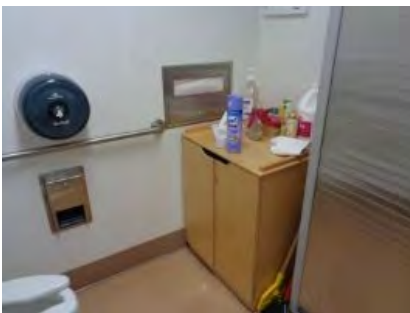
**Comment**      **HRC-030**      **Priority: 2**      **Estimated Direct Cost:**      \$60      Maintenance

**Item Description:**      Clear floor space;

**Findings:** Cabinets within restroom interfere with the required 60" clear radius for wheelchair maneuverability.

**Recommendations:**  
Remove cabinets.

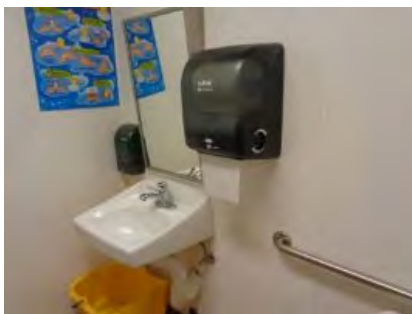
**Item Description:** Paper towel dispenser;

**Findings:** Dispenser is not accessible due to height. Dispenser is not compliant as it requires use of two hands and requires tight grasping and pinching. The side wheel for advancing paper requires twisting of the wrist.

**Recommendations:**  
Remove and replace paper towel dispenser. New dispenser shall not require two hands or tight grasping, pinching or twisting of the wrist. Mount new dispenser not higher than 30" AFF to the highest operable part.

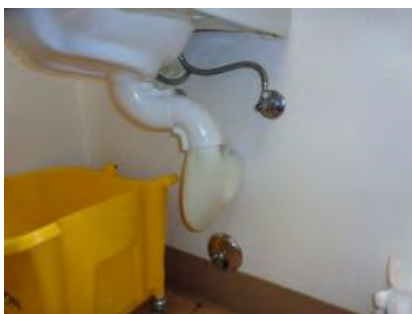
**Item Description:** Lavatory Insulation;

**Findings:** Insulation beneath the lavatory is not complete.

**Recommendations:**  
Cover, wrap, or otherwise insulate all water lines, valves and fittings. There shall also be no exposed sharp or abrasive elements under lavatory.

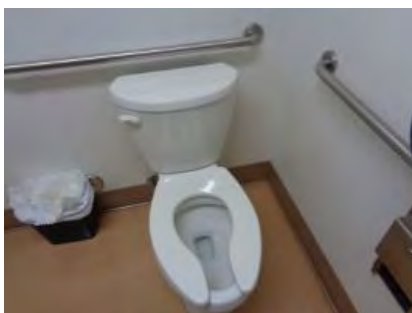
**Item Description:** WC location;

**Findings:** The accessible WC is not compliant for location, centered 18-5/8" from the side wall.

**Recommendations:**  
Reset waste line to center WC 17"-18" from the side wall.

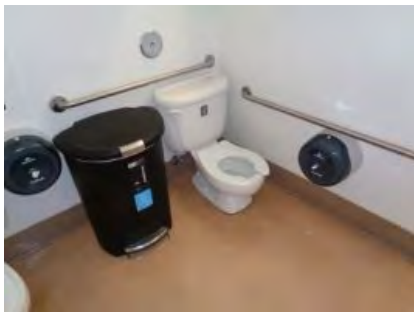
**Item Description:**      Loose waste can;

**Findings:**      Location of the loose waste can blocks the side transfer space next to WC.

**Recommendations:**  
Relocate waste can away from WC's.

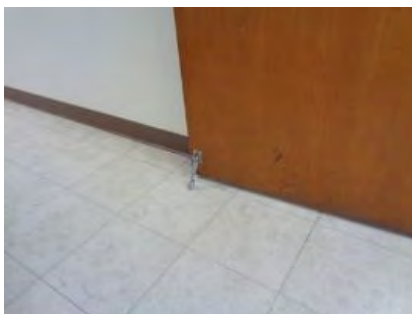
**Comment** MA-001 **Priority:** 1 **Estimated Direct Cost:** \$1,235 **Maintenance**

**Item Description:** Door stops; Door closers

**Findings:** Door stops at the push side of doors interfere with the requirement for a smooth door surface. All doors with automatic closers require adjustment for opening force and closing speed.

**Recommendations:** Remove all door stops throughout facility. Adjust all door closers to provide an operational effort of 5 lbf maximum and so that from an open position of 90 degrees, the time required to move the door to a position of 12 degrees from the latch is 5 seconds minimum.

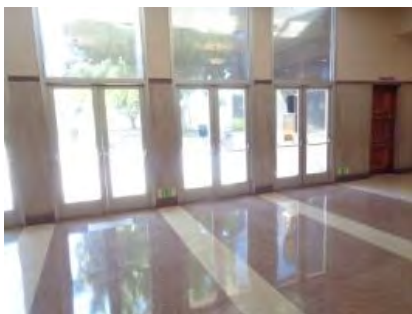
**Comment** MA-003 **Priority:** 1 **Estimated Direct Cost:** \$600 **Maintenance**

**Item Description:** Tactile exit signs;

**Findings:** Tactile exit signs are not provided at all grade level exit doors.

**Recommendations:** Provide tactile exit signs at each exit door and exit gate, where exit doors and gates lead to a grade-level exit. Mount signs at the latch side of the single doors and preferably to the right of double doors. Signs shall have Grade 2 Braille beneath raised text stating "EXIT".

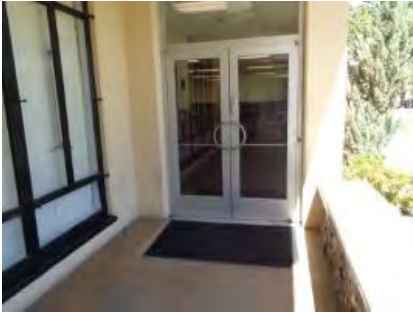
**Item Description:** Room Identification signs;

**Findings:** The required tactile room I.D. signs are not provided at various rooms.

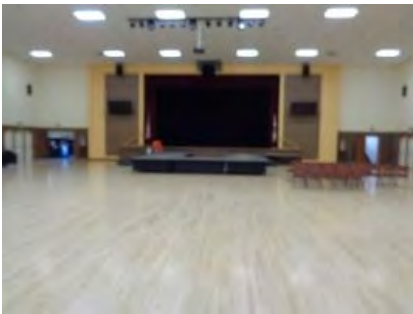
**Item Description:** Assistive Listening Devices;

**Findings:** An assistive listening system is required but was not found to be available.

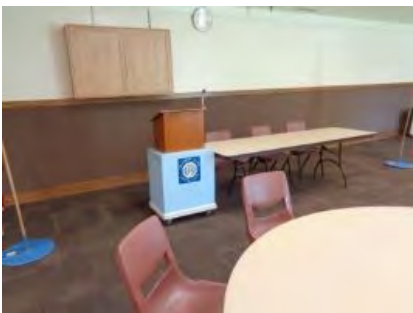
**Item Description:** Assistive Listening Devices;

**Findings:** An assistive listening system is required but was not found to be available.

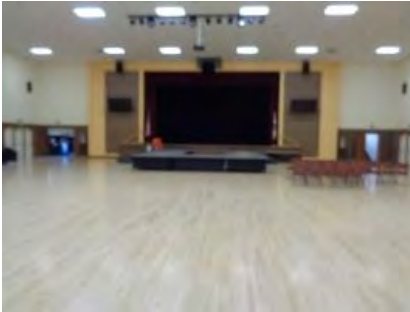
**Item Description:** Signage;

**Findings:** Signage is not provided at each assembly area to inform patrons of the availability of the assistive listening system.

**Recommendations:**  
Provide signs informing of the availability of the assistive listening systems. Signs shall state "Assistive-Listening System Available" and be posted in a prominent place at or near the assembly area entrance. Assistive listening signs shall include the International Symbol of Access for Hearing Loss.

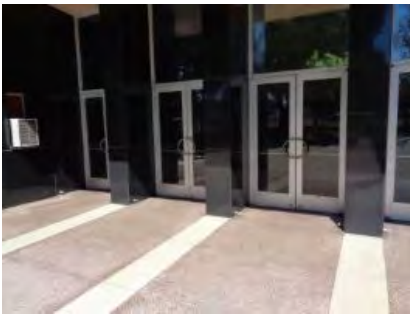
**Item Description:** Exterior entrance doors;

**Findings:** There are five sets of exterior double doors. Each door leaf provides 27" clear width. All doors are in-accessible.

**Recommendations:**  
Alter one pair of doors to provide a single door leaf a minimum 36" wide. Provide an ISA sign over the door at both the interior and exterior side of door.

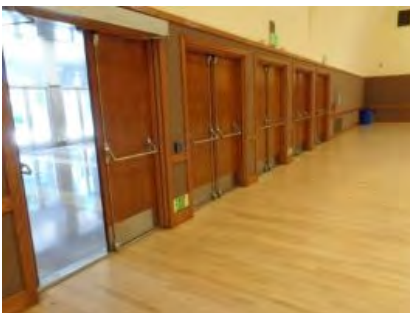
**Item Description:** Interior entrance doors;

**Findings:** There are five sets of interior double doors. The East doors have an existing power-assist operator. The power assist operator is not functional due to vertical latch rods which prevent doors from opening.

**Recommendations:**  
Remove vertical latch rods at doors and provide another method for locking doors.

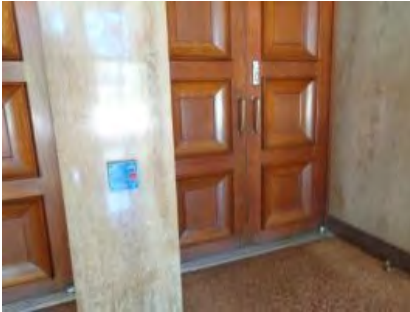
**Item Description:** Power-assist door actuators;

**Findings:** The existing power door control buttons, located at either side of doors are not compliant for size and the required additional lower push plates centered at 7"-8" above the floor are not provided.

**Recommendations:**  
Provide new push plates or vertical actuation bars at both sides of doors. A single activation shall open both doors at the same time.

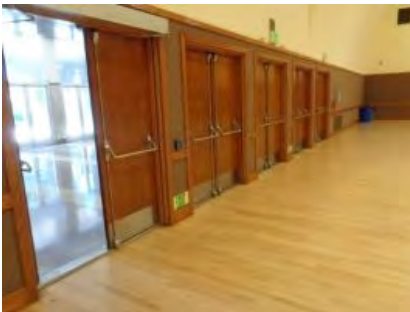
**Item Description:** Power-assist door signage;

**Findings:** Signage is not provided over the power-assist doors.

**Recommendations:**  
Provide four 6"X6" ISA signs. One over each power door, at both sides.

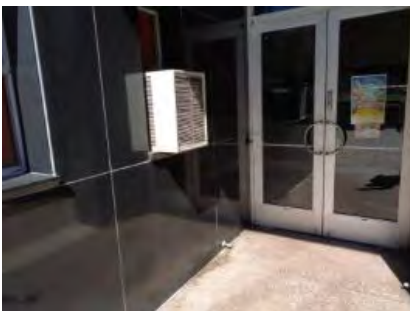
**Item Description:** Protrusion ;

**Findings:** Air conditioner projects 8" from wall into circulation path.

**Recommendations:**  
Relocate air conditioner to another wall or up to provide a clear vertical height of 80" minimum.

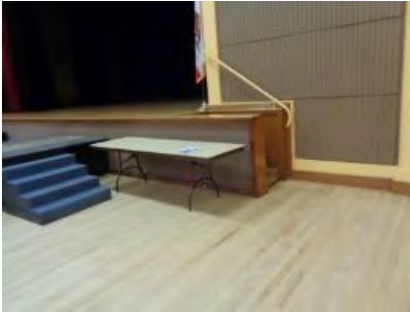
**Item Description:** Stairs to stage; Stair handrails

**Findings:** Stairs are not compliant at 22-1/2" wide. Handrails are not provided at both sides of stairs.

**Recommendations:**  
Modify stairs to provide a minimum stair width of 36". Provide compliant handrails at both sides of stairs.

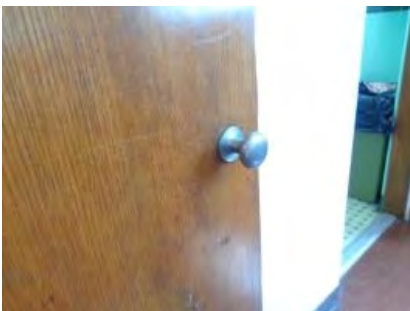
**Item Description:** Door knobs;

**Findings:** Round door knobs are not accessible.

**Recommendations:**  
Replace all round door knobs with lever handles. The end of levers shall return to within 1/2" of the door surface.

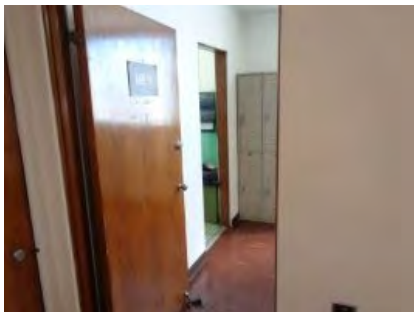
**Findings:** Doorway leading to the Men's restroom is not identified with the required geometric sign.

**Recommendations:**  
Provide a light color geometric (triangle) sign centered on the door at 58"-60" AFF.

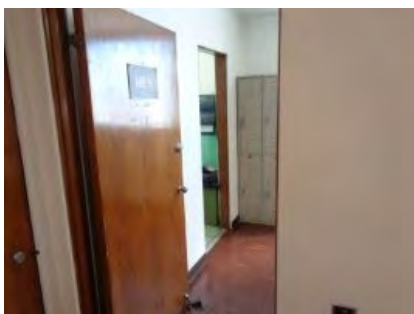
**Findings:** The required tactile wall sign is not provided at doorway.

**Recommendations:**  
Provide one tactile wall sign having Grade 2 Braille beneath raised text and a raised pictogram. Mount sign on the wall, at the latch side of door, centered at 56" AFF.

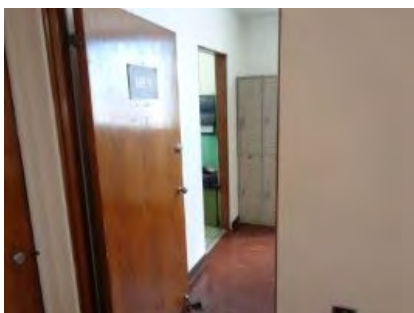
**Findings:** Door stop at the push side of Men's door interferes with the requirement for a smooth surface.

**Recommendations:**  
Remove door stop.

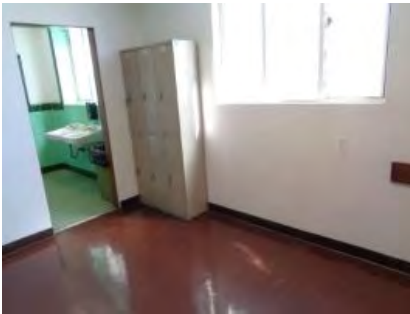
**Item Description:** Locker room bench;

**Findings:** A compliant accessible bench has not been provided at lockers.

Provide one accessible bench. Accessible bench shall have a back support or be affixed to a wall along its long dimension. Bench back support shall be 48 inches long minimum with a seat 20"-24" deep.

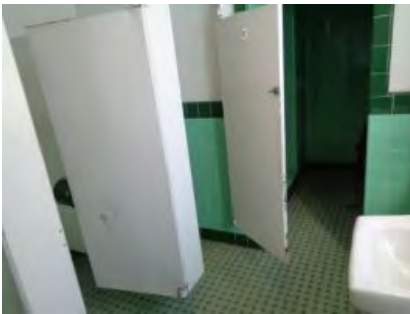
**Item Description:** Restroom;

**Findings:** Restroom is not accessible, including showers.

Remodel restroom and shower area to provide accessibility.

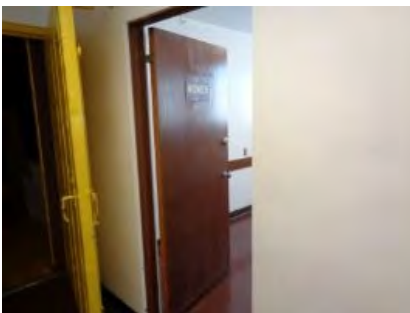
**Item Description:** Door Signage; Tactile wall signage

**Findings:** Doorway leading to the Women's restroom is not identified with the required geometric sign. The required tactile wall sign is not provided at doorway.

Provide a light color geometric (circle) sign centered on the door at 58"-60" AFF. Provide one tactile wall sign having Grade 2 Braille beneath raised text and a raised pictogram. Mount sign on the wall, at the latch side of door, centered at 56" AFF.

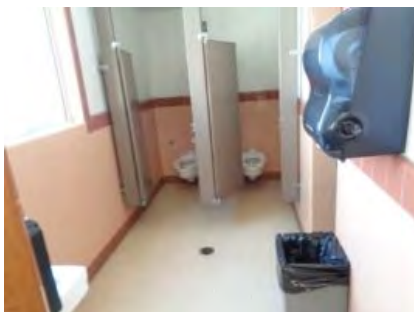
**Findings:** Restroom is not accessible, including showers.

**Recommendations:**  
Remodel restroom and shower area to provide accessibility.

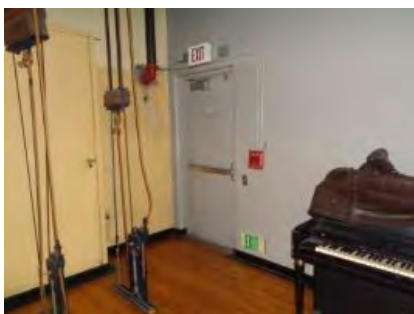
**Findings:** Tactile exit signs are not provided at all grade level exit doors.

**Recommendations:**  
Provide tactile exit signs at each exit door. Mount signs at the latch side of the single doors. Signs shall have Grade 2 Braille beneath raised text stating "EXIT STAIR DOWN".

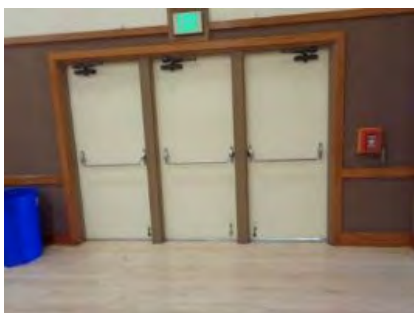
**Findings:** Door stops at Auditorium side exit doors interfere with the requirement for a smooth surface at the push side of accessible doors.

**Recommendations:**  
Remove all door stops.

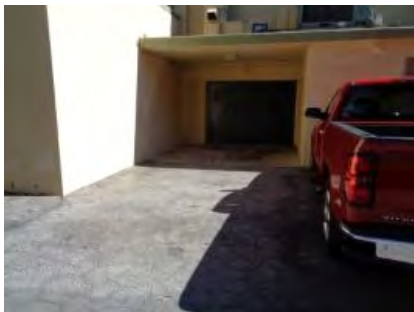
**Item Description:** Truncated domes;

**Findings:** A flush transition occurs outside of the three exit doors at the N/W side of Auditorium. A detectable warning surface has not been provided.

**Recommendations:**  
Install truncated dome mats over the concrete, across the full length of the transition between the concrete walkway and vehicular area. Domes shall be 36" deep in the direction of travel.

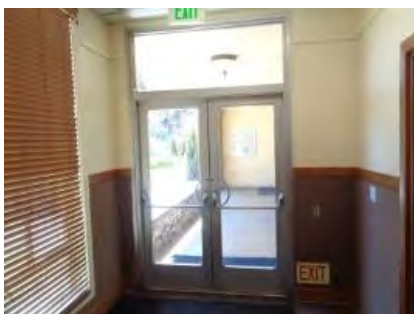
**Item Description:** Door width;

**Findings:** The double glass doors are not compliant for width. Each door leaf is 27" wide.

**Recommendations:**  
Replace doors with one leaf at least 36" wide.

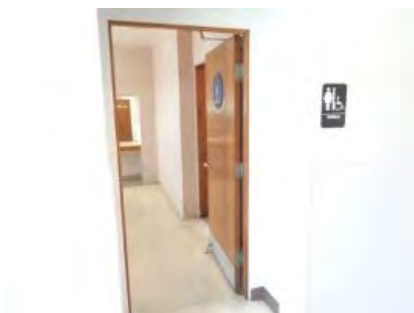
**Item Description:** Braille dimensions;

**Findings:** Tactile signs at both restroom doorways have a federal Braille font which does not conform to California Braille requirements.

**Recommendations:**  
Replace both restroom tactile signs. Braille shall have spacing of 0.10" between dots within the same cell.

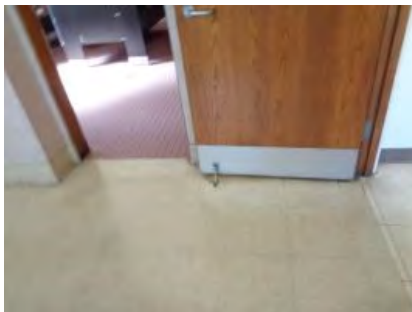
**Findings:** Door stops at both restroom doors interfere with the requirement for a smooth surface at the push side of accessible doors.

**Recommendations:**  
Remove all door stops.

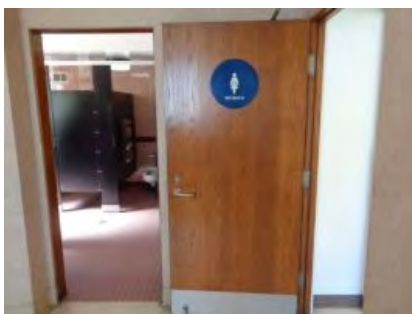
**Findings:** The geometric door signs are mounted too high and fail to provide the required color contrast with the color of doors.

**Recommendations:**  
Replace each restroom door sign with a light color sign (white). Center signs on doors at 58"-60" AFF.

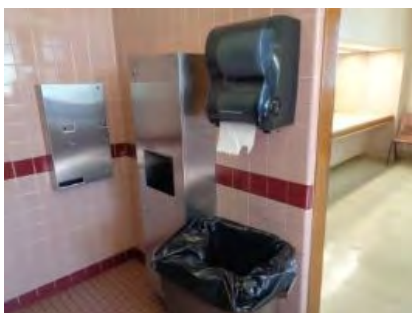
**Item Description:** Paper towel dispenser; Loose waste basket

**Findings:** Dispenser is not accessible as it requires use of two hands, and requires tight grasping and pinching. The side wheel for advancing paper requires twisting of the wrist. Loose waste basket interferes with the required clear floor space at paper towel dispenser. Loose waste basket can be moved and inadvertently block access to dispensers and fixtures.

**Recommendations:**  
Remove and replace one paper towel dispenser. New dispenser shall not require tight grasping, pinching or twisting of the wrist. Mount new dispenser not higher than 40" AFF to the highest operable part. Locate waste basket at another location, away from clear floor spaces required at fixtures and dispensers. Provide a wall clip or floor bracket to keep waste basket in place.

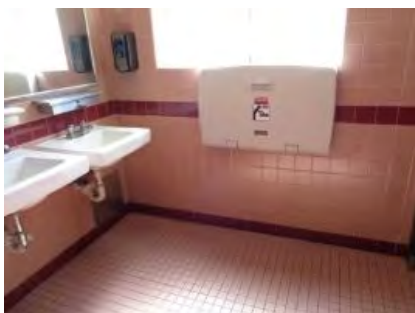
**Findings:** When baby changing table is deployed it blocks the required clear floor space at the lavatory.

**Recommendations:**  
Relocate baby changing table to a clear area where it will not block an accessible route or the floor space at a fixture or dispenser.

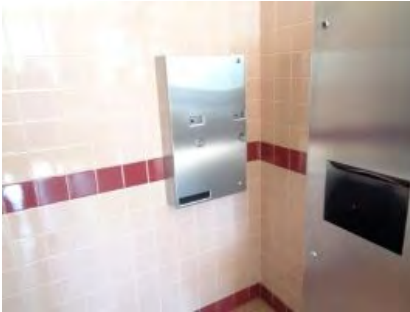
**Findings:** Dispenser is not accessible. Operable parts require tight grasping, pinching and twisting of the wrist

**Recommendations:**  
Remove and replace dispenser. All controls shall be located no higher than 40" AFF.

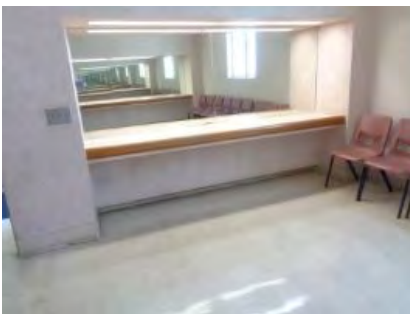
**Findings:** The counters are not accessible. Knee space provided is only 26-5/8".

**Recommendations:**  
Raise counters as needed to provide a minimum knee space height of 27". Counter surface shall not exceed 34" AFF.

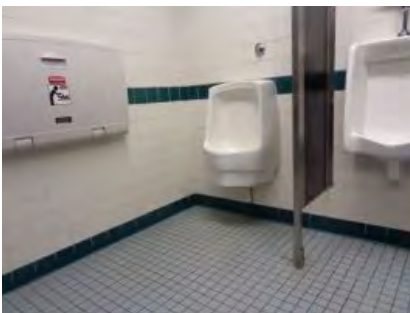
**Findings:** When baby changing table is deployed it blocks the required clear floor space at the accessible lavatory. Urinal rim height is not compliant at 21-1/2" AFF.

**Recommendations:**  
Remove baby changing table. Insufficient space is provided within the restroom for a baby changing table. Lower fixture. The rim shall not be higher than 17" AFF.

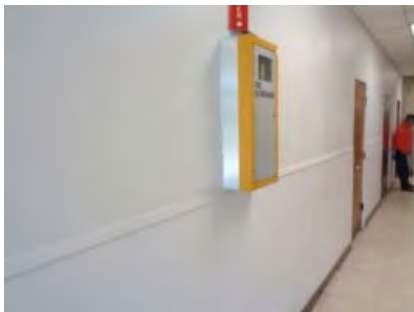
**Item Description:**      Fire extinguisher cabinet;

**Findings:**      FE cabinet projects greater than 4" into the circulation route.

**Recommendations:**  
Recess cabinet deeper into the wall. Cabinet shall not project greater than 4" from wall surface.

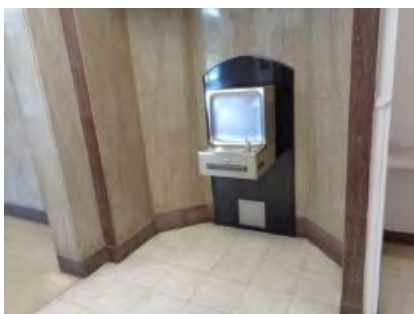
**Item Description:**      Water fountain;

**Findings:**      WF is not a Hi/Lo model.

**Recommendations:**  
Install a combination Hi/Lo DF.

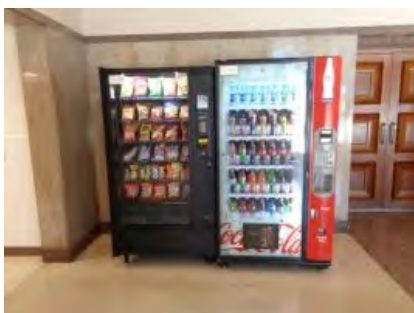
**Item Description:**      Vending machine;

**Findings:**      Coke and snack vending machines are not accessible, due to height of the highest operable part. 48-3/4 (coke), 58-3/8" (snack).

**Recommendations:**  
Notify vending contractor to reset height of coke machine and to replace the snack machine. Any vending machines shall have all operable parts within 48" of the floor.

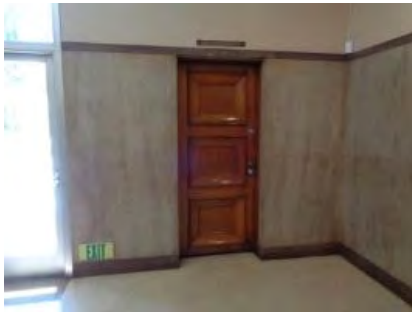
**Item Description:** Round door knobs;

**Findings:** The office doors of the Park Superintendent and Park Director both have round door knobs, which are not accessible.

**Recommendations:**  
Replace all round door knobs with lever handles. The end of levers shall return to within 1/2" of the door surface.

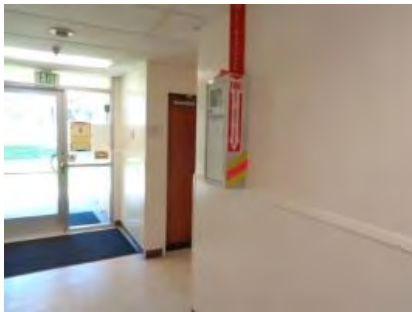
**Item Description:** Fire extinguisher cabinet;

**Findings:** FE cabinet projects greater than 4" into the circulation route.

**Recommendations:**  
Recess cabinet into the wall. Cabinet shall not project greater than 4" from wall surface.

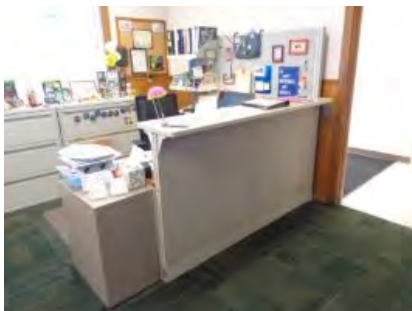
**Item Description:** Service counter;

**Findings:** Counter height is not accessible.

**Recommendations:**  
Lower all or a 36" minimum portion of the counter to an accessible height of 28"-34" AFF.

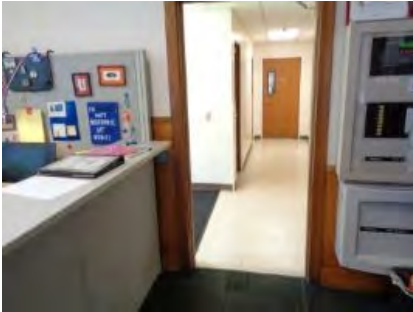
**Item Description:**      Door clearance;

**Findings:**      The required 12" strike-side clearance at door is not provided.

**Recommendations:**  
Remove either the latch or the closer to eliminate the requirement

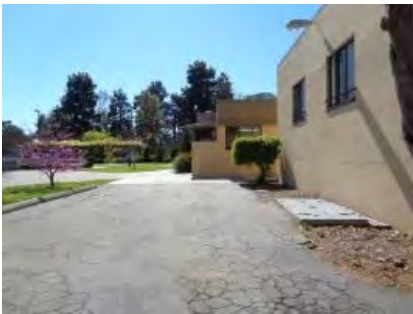
**Item Description:**      Truncated domes;

**Findings:**      A flush transition occurs outside of the Kitchen at the N/E side of building between the pedestrian walkway and the vehicular drive. A cane detectable warning surface has not been provided.

**Recommendations:**  
Install a curb or truncated dome mats over the concrete, across the full length of the transition between the concrete walkway and vehicular area. Domes shall be 36" deep in the direction of travel.

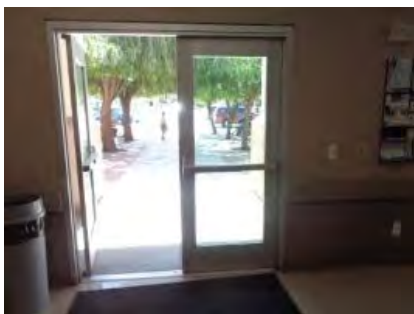
**Item Description:** Door stops;

**Findings:** Door stops at the push side of doors interferes with the requirement for a smooth door surface.

**Recommendations:**  
Remove all door stops throughout facility.

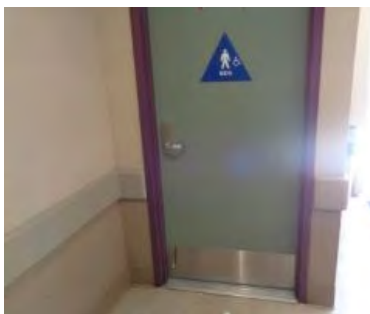
**Item Description:** Door closers;

**Findings:** All doors with automatic closers require adjustment for opening force and closing speed.

**Recommendations:**  
Adjust all door closers to provide an operational effort of 5 lbf maximum and so that from an open position of 90 degrees, the time required to move the door to a position of 12 degrees from the latch is 5 seconds minimum.

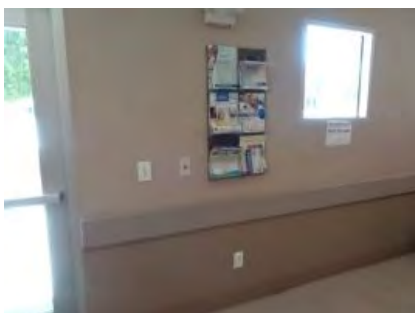
**Item Description:**      Brochure rack;

**Findings:**      Wall-mounted rack is not accessible due to excessive height.

Add a second brochure rack having the same informational brochures within 15" and 48" of the floor.

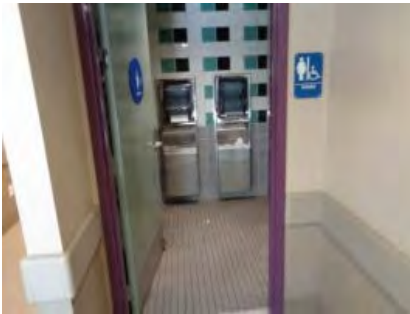
**Item Description:**    Strike-side clearance at door;

**Findings:** The required 12" strike-side clearance at entrance door of restroom is not provided.

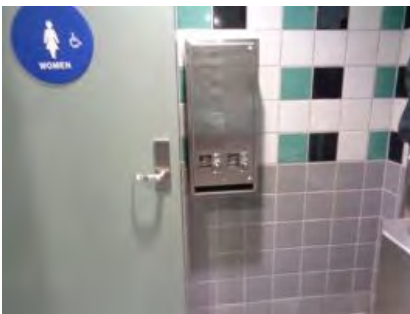
**Item Description:**    Sanitary napkin dispenser;

**Findings:** Clear floor space for dispenser overlaps the required clear floor space for the door. Dispenser controls are not accessible.

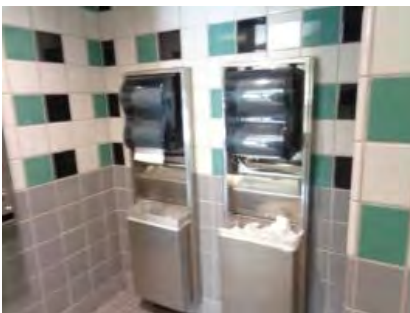
**Item Description:**    Paper towel dispensers;

**Findings:** Dispensers are not accessible due to height. Dispensers are not compliant both require use of two hands and require tight grasping and pinching. The side wheel for advancing paper requires twisting of the wrist.

Remove and replace one paper towel dispenser. New dispenser shall not require tight grasping, pinching or twisting of the wrist. Mount new dispenser not higher than 40" AFF to the highest operable part.

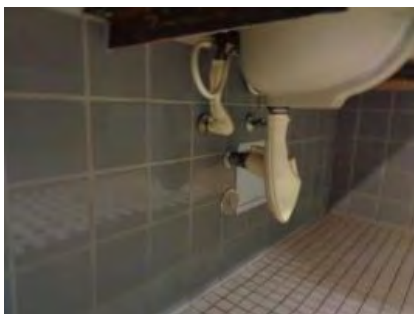
**Item Description:** Lavatory Insulation;

**Findings:** Insulation beneath the lavatory is not complete.

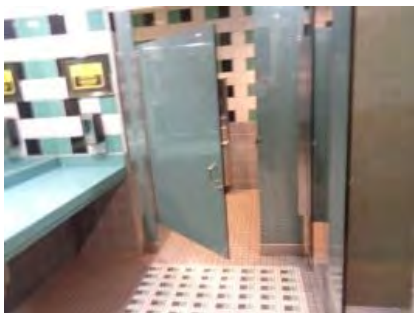
**Comment**      **MTSC-011**      **Priority: 2**      **Estimated Direct Cost:**      \$95      Maintenance

**Item Description:** Stall Door;

**Findings:** Stall door swings into the required clear floor space at the soap dispenser.

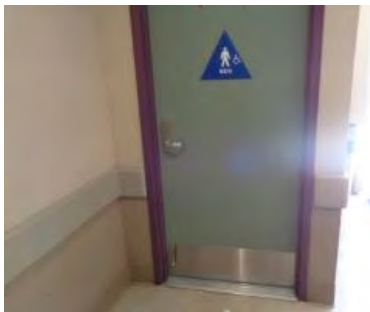
**Comment**      **MTSC-017**      **Priority: 2**      **Estimated Direct Cost:**      \$260      Contractor

**Item Description:**      Strike-side clearance at door; Tactile wall sign

**Findings:** The required 12" strike-side clearance at entrance door of restroom is not provided. The required tactile wall sign is not provided at each restroom doorway.

**Recommendations:**  
Remove lever handle and cover hole in door with a push plate. At the pull side of door install a U-shaped door pull centered 34"-44" AFF. Provide a tactile wall sign, having Grade 2 Braille beneath raised text and a raised pictogram.

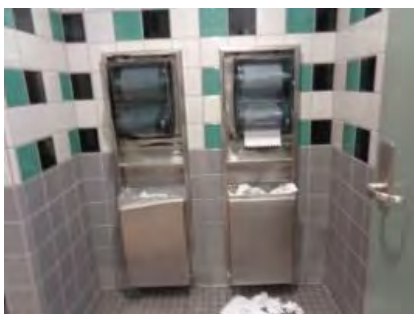
**Comment**      **MTSC-019**      **Priority: 2**      **Estimated Direct Cost:**      \$1,200      Contractor

**Item Description:**      Paper towel dispensers;

**Findings:** Dispensers are not accessible due to height. Dispensers are not compliant both require use of two hands and require tight grasping and pinching. The side wheel for advancing paper requires twisting of the wrist.

**Recommendations:**  
Remove and replace one paper towel dispenser. New dispenser shall not require tight grasping, pinching or twisting of the wrist. Mount new dispenser not higher than 40" AFF to the highest operable part.

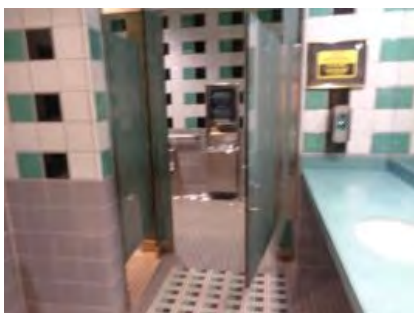
**Comment**      **MTSC-020**      **Priority: 2**      **Estimated Direct Cost:**      \$190      Maintenance

**Item Description:**      Stall Door; Stall Door

**Findings:** Stall door swings into the required clear floor space at the soap dispenser. The accessible stall door is not self-closing.

**Recommendations:**  
Reverse the door swing to swing into the accessible stall. Replace the self-closing hinges.

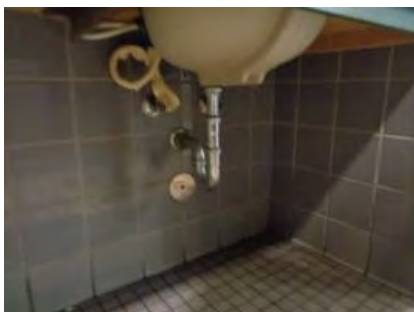
**Comment**      **MTSC-021**      **Priority: 2**      **Estimated Direct Cost:**      \$75      Maintenance

**Item Description:**      Lavatory Insulation;

**Findings:**      Insulation beneath the lavatories is not complete.

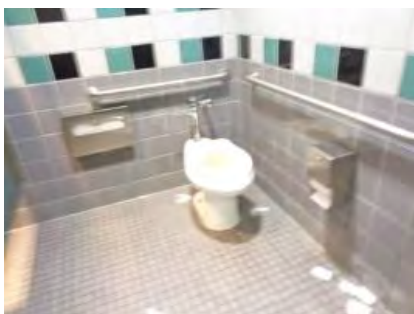
**Comment**      **MTSC-023**      **Priority: 2**      **Estimated Direct Cost:**      \$1,000      Contractor

**Item Description:**      Rear grab bar;

**Findings:**      Rear grab bar is not compliant for location.

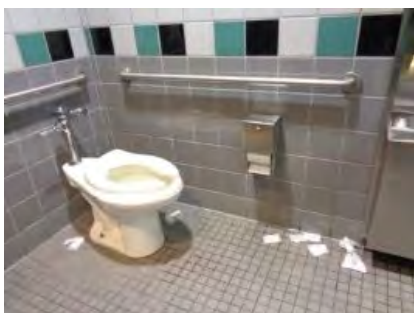
**Comment**      **MTSC-024**      **Priority: 2**      **Estimated Direct Cost:**      \$5,000      Contractor

**Item Description:**      WC location; Toilet paper dispenser; Paper towel dispenser in stall

**Findings:**      The accessible WC is not compliant for location, centered 15-3/4" from the side wall. Dispenser is not compliant for location, centered 11-1/2" in front of the WC. Dispenser is not accessible due to height. Dispenser is not compliant as it requires use of two hands and requires tight grasping and pinching. The side wheel for advancing paper requires twisting of the wrist.

Reset waste line to center WC at 17"-18" from the side wall. Relocate dispenser. Center toilet paper dispenser at 7"-9" in front of the WC. Remove and replace paper towel dispenser. New dispenser shall not require tight grasping, pinching or twisting of the wrist. Mount new dispenser not higher than 40" AFF to the highest operable part.
