# City of South Gate

# Volume 2

## Appendix B Facilities Barrier Assessment Report

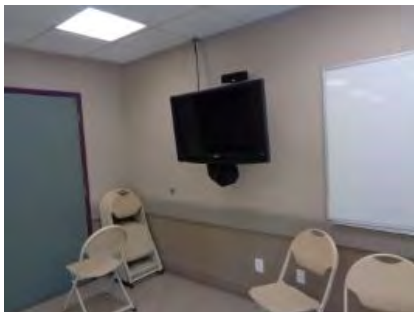
**Comment**      **MTSC-027**      **Priority: 2**      **Estimated Direct Cost:**      \$95      Maintenance

**Item Description:**      Wall-mounted television;

**Findings:**      Television projects greater than 4" from the wall, at a height of 54-1/2" AFF to the lowest edge. Projection measured at 17-1/2".

**Recommendations:**  
Provide a rail or other element below the television, projecting a minimum of 15" from the wall, at a height not greater than 27" AFF, to serve as a cane-detectable element.

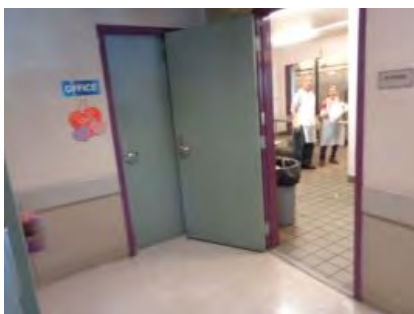
**Comment**      **MTSC-028**      **Priority: 2**      **Estimated Direct Cost:**      \$190      Maintenance

**Item Description:**      Door Interference;

**Findings:**      Kitchen door when open interfere with access of office .

**Recommendations:**  
Reverse the kitchen door swing to swing into the kitchen.

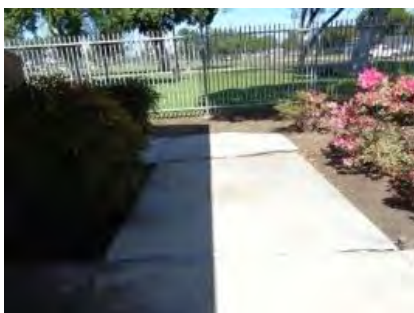
**Comment**      **MTSC-029**      **Priority: 1**      **Estimated Direct Cost:**      \$900      Contractor

**Item Description:**      Concrete walkway;

**Findings:**      Raised slabs create excessive cross slope and abrupt edges greater than 1/4", at N/E corner of building.

**Recommendations:**  
Remove and replace concrete.

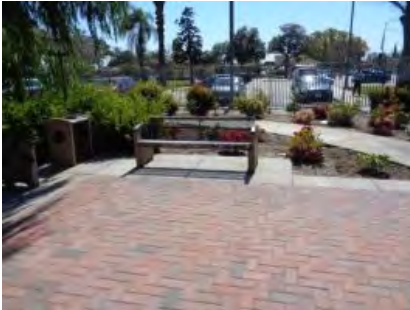
**Comment**      **MTSC-030**      **Priority: 3**      **Estimated Direct Cost:**      \$120      Contractor

**Item Description:**      Wheelchair Seating;

**Findings:**      Wheelchair seating is not provided next to bench seating.

**Recommendations:**  
Provide a level concrete pad next to the central bench. Pad shall be a minimum 36" wide and 48" deep.

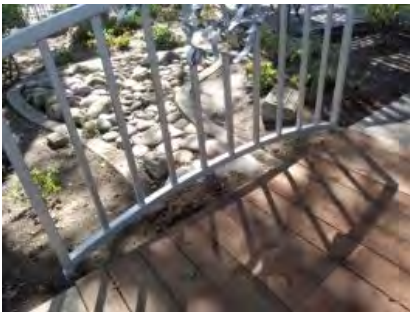
**Comment**      **MTSC-031**      **Priority: 1**      **Estimated Direct Cost:**      \$750      Contractor

**Item Description:**      Bridges;

**Findings:**      Space under railing at both sides of both bridges allows for passage of a sphere greater than 4", measured at 6".

**Recommendations:**  
Weld in matching square metal tubing to close opening height to less than 4".

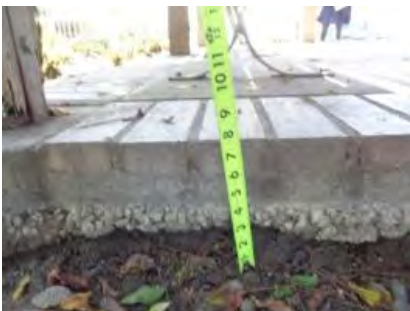
**Comment**      **MTSC-032**      **Priority: 1**      **Estimated Direct Cost:**      \$190      Maintenance

**Item Description:**      Drop-off at walkway edges;

**Findings:**      Abrupt changes in level greater than 4" occur at various areas of paths.

**Recommendations:**  
Backfill planter areas with soil as needed to raise the adjoining areas of walkways to within 4" of the walkway elevation.

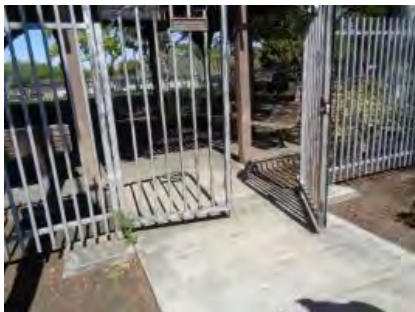
**Comment**      **MTSC-033**      **Priority:** 1      **Estimated Direct Cost:** \$190      Maintenance

**Item Description:** Double gate; Double gate

**Findings:** Surface of gates at the push side are not smooth. Vertical latching rod is not accessible and both gates must be moved in unison to pass through.

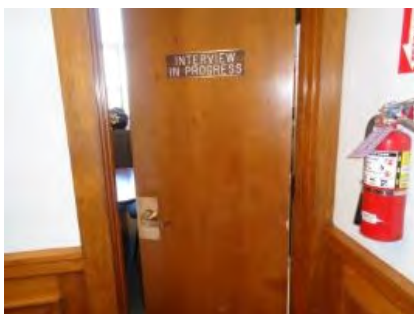
**Comment**      **PD-004**                      **Priority: 1**      **Estimated Direct Cost:**      \$1,140                      Maintenance  
**Item Description:**      Door closers;

**Findings:** All doors with automatic closers require adjustment for opening force and closing speed.

**Recommendations:**  
Adjust all door closers to provide an operational effort of 5 lbf maximum and so that from an open position of 90 degrees, the time required to move the door to a position of 12 degrees from the latch is 5 seconds minimum. Detention and security doors are not required to comply.

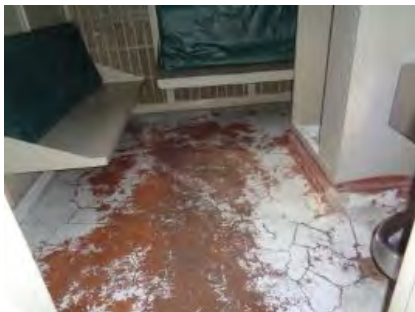
**Item Description:** Wheelchair access;

**Findings:** Insufficient space within cell is provided for the required wheelchair turning radius of 60" minimum.

**Recommendations:**  
Modify cell as needed to provide wheelchair maneuverability.

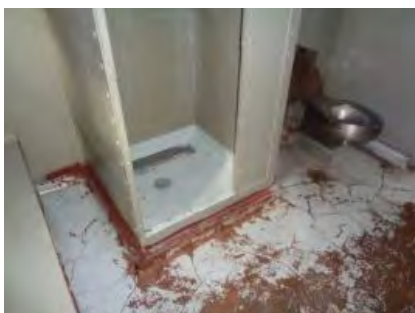
**Item Description:** Shower;

**Findings:** Shower is not accessible due to raised threshold and width of opening.

**Recommendations:**  
Modify shower to provide access per 11B-608.

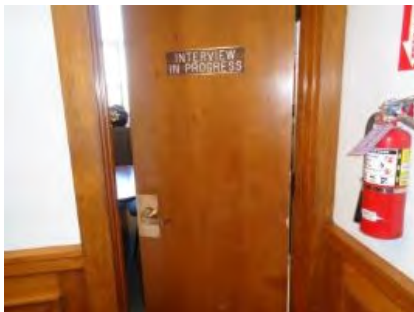
**Comment** PD-022 **Priority:** 2 **Estimated Direct Cost:** \$2,250 **Contractor**

**Item Description:** Door;

**Findings:** Door to the Interview room is not accessible, having a clear width of 29".

**Recommendations:**  
Room shall be accessible with a door providing a minimum clear width of 32". Replace door and door frame with a 36" door.

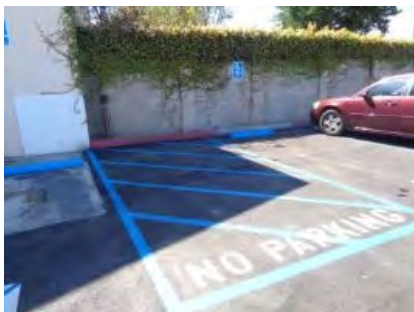
**Comment** PD-023 **Priority:** 1 **Estimated Direct Cost:** \$900 **Contractor**

**Item Description:** Accessible Parking; Signs; Striping

**Findings:** 45 stalls are provided. Two accessible stalls are required and four have been provided. The required additional stall signs stating "MINIMUM FINE \$250" have not been posted. Diagonal stripes within access aisles do not provide the required visual contrast with the parking surface.

**Recommendations:**  
No action required, however, the number of accessible stalls may be reduced by half if desired. Below each stall sign, provide the additional minimum fine sign. Restripe access aisle diagonal stripes in white. Border shall remain blue. Stripes shall be interrupted at area of the words "NO PARKING".

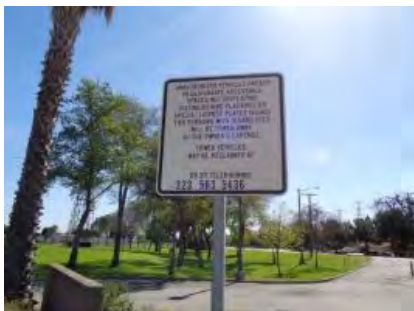
**Comment** PD-025 **Priority:** 1 **Estimated Direct Cost:** \$500 **Contractor**

**Item Description:** Tow-away Sign;

**Findings:** The required tow-away warning sign is not provided.

**Recommendations:**  
Provide one a CALTRANS R-100B tow sign within direct view of the stalls, or at the entrance to parking. The blank spaces for vehicle reclaiming information shall be filled-in and made a permanent part of the sign in lettering a minimum 1 inch high.

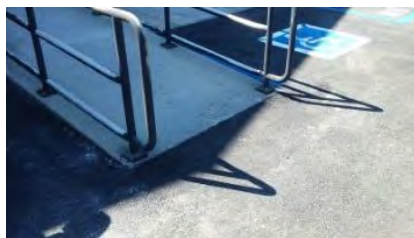
**Comment**    **PD-027**    **Priority: 1**    **Estimated Direct Cost:**    \$288    Maintenance  
**Item Description:**    Ramp;

**Findings:** Truncated domes are not provided at transition between the pedestrian ramp and the vehicular way.

**Recommendations:**  
Install a 3'X4' truncated dome mat over the ramp surface, next to the asphalt joint.

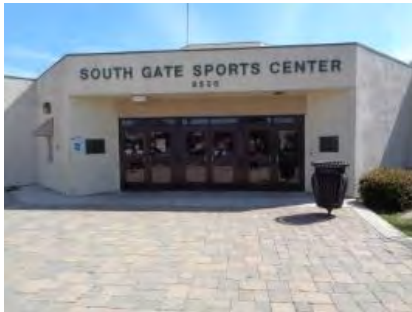
**Comment SC-001**      **Priority: 1**      **Estimated Direct Cost:** \$150      Maintenance

**Item Description:** Signage;

**Findings:** Only the left pair of doors are unlocked for entry.

**Recommendations:**  
Provide an ISA sign over each of the two left doors.

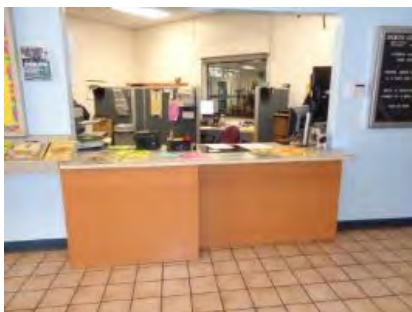
**Comment SC-002**      **Priority: 3**      **Estimated Direct Cost:** \$950      Contractor

**Item Description:** Counter height;

**Findings:** Counter height is not accessible at 34-5/8".

**Recommendations:**  
Lower counter to a height not to exceed 34" AFF.

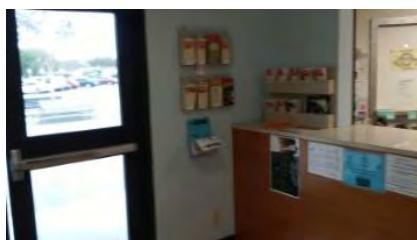
**Comment**      **SC-003**                      **Priority: 3**      **Estimated Direct Cost:**      \$60                      Maintenance  
**Item Description:**      Pamphlet rack;

**Findings:** Pamphlets are not accessible due to height.

**Recommendations:**  
 Provide the same printed material at an accessible height , not greater than 48" AFF.

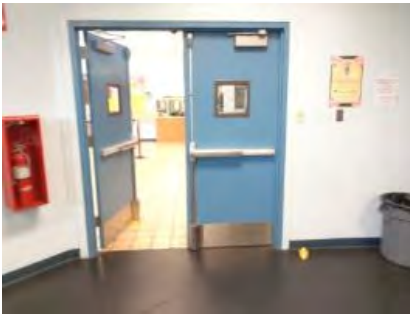
**Item Description:** Tactile exit signs;

**Findings:** Tactile exit signs are not provided at interior rooms having access to a corridor or hallway leading to an exit door.

**Recommendations:**  
Provide a tactile exit sign at each interior room doorway leading to an exit by means of a hallway or corridor. Sign shall state "EXIT ROUTE".

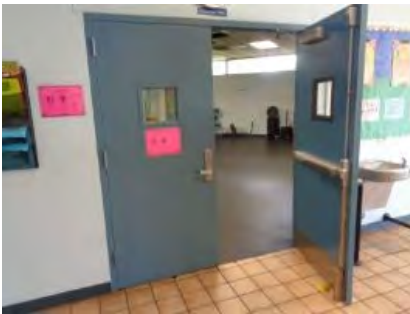
**Item Description:** Room Identification signs;

**Findings:** The required tactile room I.D. signs are not provided at various rooms. I.D. signs for interior rooms or spaces are required.

**Recommendations:**  
Provide a sign package for all rooms where the use or name of the rooms are not likely to change over time. Signs shall have Grade 2 Braille below raised text.

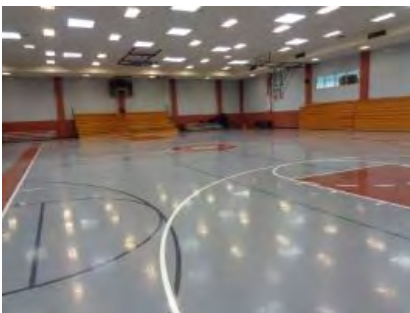
**Item Description:** Assistive Listening Devices;

**Findings:** An assistive listening system is required but was not found to be available.

**Recommendations:**  
Provide a portable or permanent assistive listening system. Consult with a sound engineer as each system varies in advantages and disadvantages.

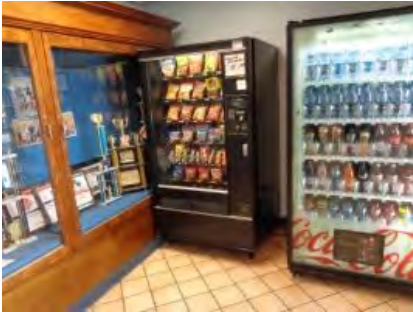
**Comment**      **SC-010**                      **Priority: 3**              **Estimated Direct Cost:**      \$2,500                      Contractor

**Item Description:**      Vending machines;

**Findings:**      The snack vendor is not accessible due to height of operable parts.

**Recommendations:**  
Notify vending contractor to replace the snack machine. Any vending machines shall have all operable parts within 48" of the floor

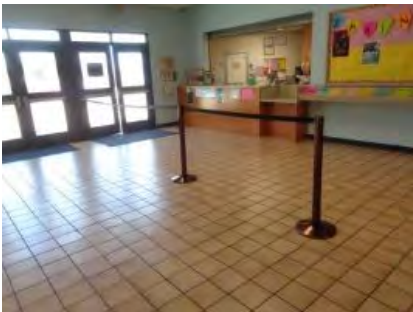
**Comment**      **SC-011**                      **Priority: 1**              **Estimated Direct Cost:**      \$250                      Maintenance

**Item Description:**      Queue barrier;

**Findings:**      The queue barrier straps are not cane detectable.

**Recommendations:**  
Add a second row of straps, no higher than 27" AFF.

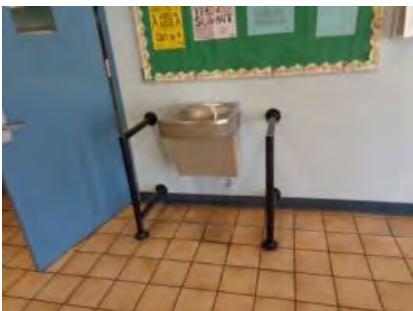
**Comment**      **SC-012**                      **Priority: 3**              **Estimated Direct Cost:**      \$2,500                      Contractor

**Item Description:**      Drinking fountain;

**Findings:**      WF is not a Hi/Lo model.

**Recommendations:**  
Install a combination Hi/lo DF.

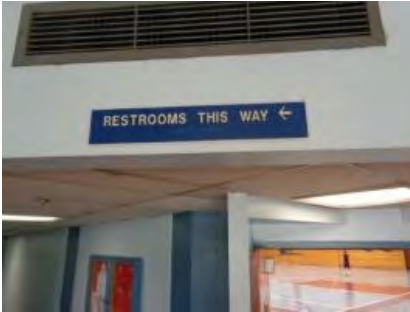
**Item Description:** Restroom Sign;

**Findings:** Signs that give direction to accessible site elements shall also display the ISA. Lobby sign is not compliant.

**Recommendations:**  
Add an ISA next to the existing sign. Isa shall be white on a dark blue background.

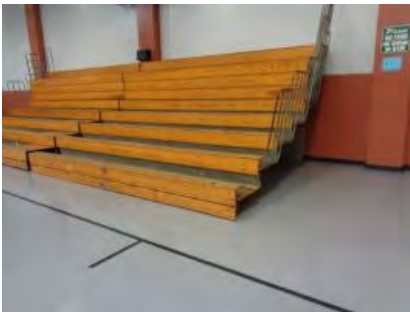
**Item Description:** Accessible seating;

**Findings:** Bleacher seating is not accessible.

**Recommendations:**  
Modify the first row of each bleacher section to provide one wheelchair seating space.

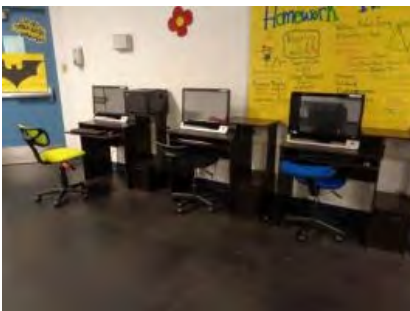
**Item Description:** Computer desks;

**Findings:** Desks fail to provide compliant knee space.

**Recommendations:**  
Provide one computer desk having knee space 27" high MIN.

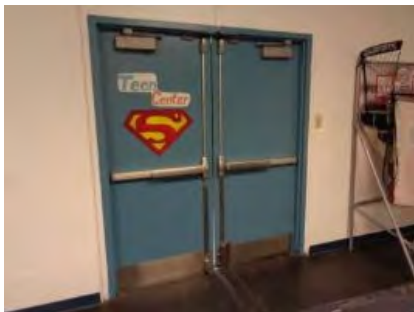
**Comment**      **SC-016**                      **Priority: 1**      **Estimated Direct Cost:**      \$95                      Maintenance

**Item Description:**      Doors;

**Findings:** All doors fail to provide a smooth surface at the bottom 10" of each door, due to vertical latch rods.

**Recommendations:**  
Modify doors to cover vertical latch rods while providing a smooth surface across the bottom 10" of each door. Remove door stop.

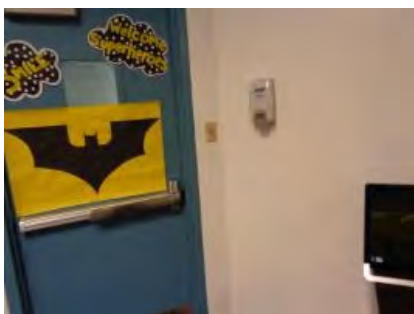
**Comment**      **SC-017**                      **Priority: 3**      **Estimated Direct Cost:**      \$285                      Maintenance

**Item Description:**      Wall dispenser; Light switch

**Findings:** Hand sanitizer dispenser located near entrance doors is not accessible at 52 -1/2" Light switch is not compliant for height at 56" to the top of the box.

**Recommendations:**  
Lower dispenser to a height not greater than 48" AFF to the highest operable part. Lower light switch box. The top of the box shall not be higher than 48" AFF.

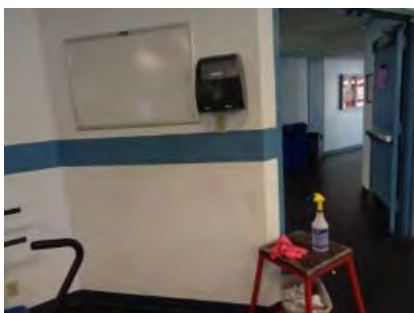
**Comment**      **SC-019**                      **Priority: 2**      **Estimated Direct Cost:**      \$600                      Maintenance

**Item Description:**      Paper towel dispenser;

**Findings:** Paper towel dispenser located near entrance doors is not accessible at 58"

**Recommendations:**  
Lower dispenser to a height not greater than 48" AFF to the highest operable part.

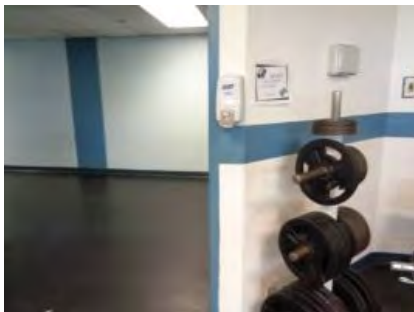
**Comment**      **SC-020**                      **Priority: 3**      **Estimated Direct Cost:**      \$95                      Maintenance

**Item Description:**      Wall dispenser;

**Findings:** Hand sanitizer dispenser located near entrance doors is not accessible at 52 -1/2"

**Recommendations:**  
Lower dispenser to a height not greater than 48" AFF to the highest operable part.

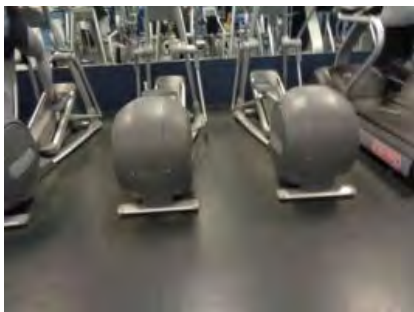
**Comment**      **SC-021**                      **Priority: 3**      **Estimated Direct Cost:**      \$2,000                      Maintenance

**Item Description:**      Clear floor space;

**Findings:** A clear floor space positioned for transfer or for use by an individual seated in a wheelchair is not provided at all types of exercise equipment. Clear floor space shall be 30"X48".

**Recommendations:**  
Modify layout of equipment. One clear floor space is permitted to be shared between two pieces of exercise equipment. Only one of each type of exercise equipment is required to be accessible.

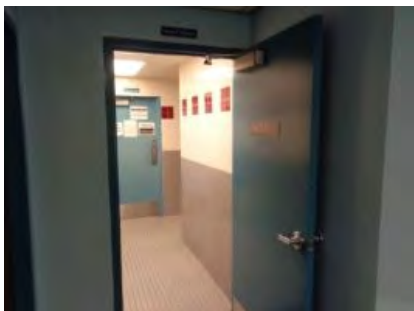
**Comment**      **SC-022**                      **Priority: 2**      **Estimated Direct Cost:**      \$150                      Maintenance

**Item Description:**      Signage; Tactile wall sign

**Findings:** The doorway leading to the Women's restroom is not identified with the required geometric sign. The required tactile wall signs are not provided at the restroom doorway.

**Recommendations:**  
Install a dark 12" geometric sign (circle), centered on door at 58"-60" AFF. Provide a tactile wall sign at each doorway, having Grade 2 Braille beneath raised text and a raised pictogram.

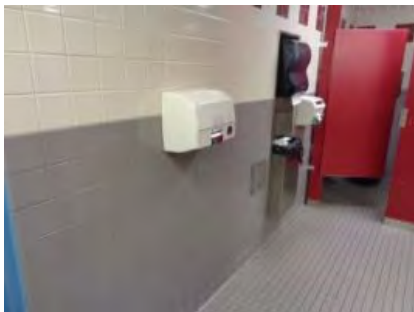
**Comment**      **SC-024**                      **Priority: 2**      **Estimated Direct Cost:**      \$600                      Contractor

**Item Description:**      Blow dryers;

**Findings:** Two wall-mounted blow dryers project more than 4" from the wall, measured at 7".

**Recommendations:**  
Recess blow dryers into the wall . Final projection from wall shall not be greater than 4".

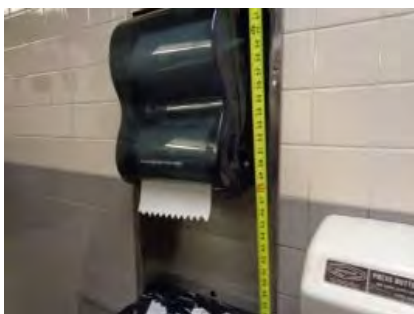
**Comment**      **SC-025**                      **Priority: 2**      **Estimated Direct Cost:**      \$600                      Contractor

**Item Description:**      Paper towel dispensers;

**Findings:** Dispensers are not accessible as they both require use of two hands, and require tight grasping and pinching. The side wheel for advancing paper requires twisting of the wrist.

**Recommendations:**  
Remove and replace one paper towel dispenser. New dispenser shall not require use of both hands, or tight grasping, pinching or twisting of the wrist. Mount new dispenser not higher than 40" AFF to the highest operable part.

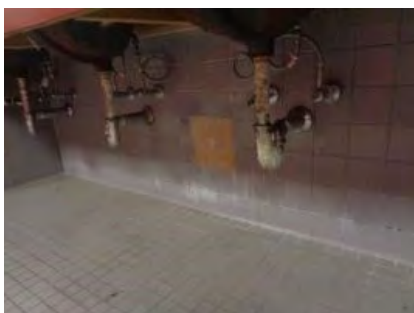
**Comment**      **SC-026**                      **Priority: 2**      **Estimated Direct Cost:**      \$75                      Maintenance

**Item Description:**      Lavatory Insulation;

**Findings:** Insulation beneath the lavatories is not provided.

**Recommendations:**  
Cover, wrap, or otherwise insulate all water lines, drains, valves and fittings. There shall also be no exposed sharp or abrasive elements under lavatories.

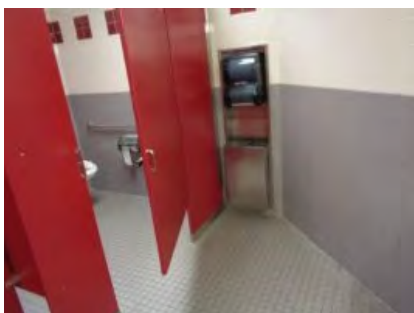
**Findings:** The accessible stall door is not self-closing. Accessible stall door is missing the required U-pull handle at the pull side.

Replace the self-closing hinges. Install a U-shaped pull handle below the latch.

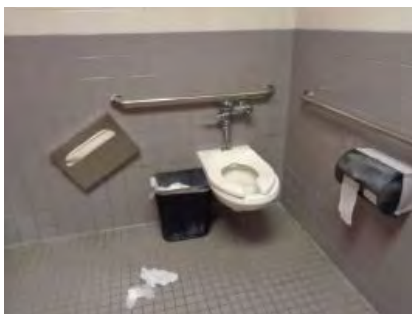
**Item Description:** WC Seat height; Rear grab bar; Seat cover dispenser; Side grab bar; Loose waste basket

**Findings:** The accessible WC seat height is not compliant at 16-3/4" AFF. Proper hand clearance is not provide below the rear grab bar. Seat cover dispenser is loose at wall. Side grab bar is not compliant for location. Waste basket interferes with the required transfer space next to the WC.

Install a 2" high raised seat. Seat height shall be 17"-19". Raise grab bar as needed to provide 1-1/2" clearance above the flush valve. Re-attach dispenser. Relocate side grab bar to project a minimum 54" from the back wall. Remove loose waste basket from stall.

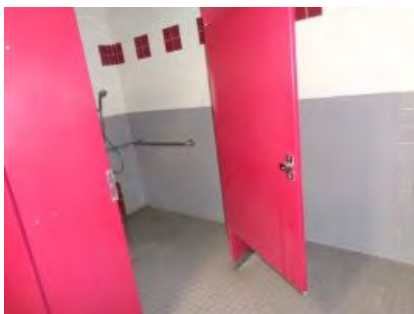
**Comment**      **SC-038**                      **Priority: 2**              **Estimated Direct Cost:**      \$190                      Maintenance

**Item Description:**      Shower stall door; Shower stall door

**Findings:** Stall door is not self closing Accessible shower door is missing a U-pull handle at the pull side.

**Recommendations:**  
Replace the self-closing hinges. Install a U-shaped pull handle below the latch.

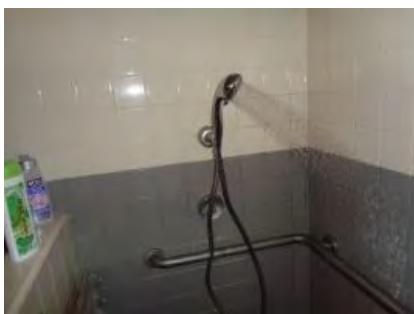
**Comment**      **SC-040**                      **Priority: 2**              **Estimated Direct Cost:**      \$95                      Maintenance

**Item Description:**      Shower sprayer;

**Findings:** The hand held spray unit is not compliant, missing the required non-positive shut-off.

**Recommendations:**  
Sprayer shall have a non-positive shut off valve on the sprayer.

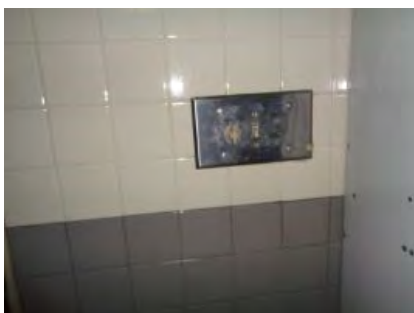
**Comment**      **SC-041**                      **Priority: 3**              **Estimated Direct Cost:**      \$0                      Maintenance

**Item Description:**      Sauna controls;

**Findings:** Sauna controls at wall are not accessible, requiring tight grasping and twisting of the wrist.

**Recommendations:**  
Sauna is not in operation. If operation is resumed, accessible controls will need to be added.

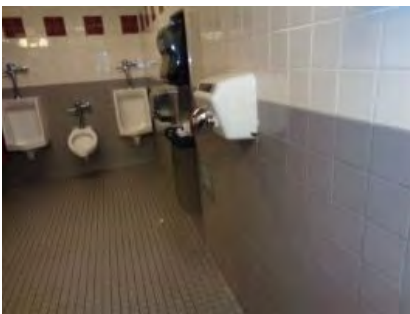
**Item Description:** Blow dryers;

**Findings:** Two wall-mounted blow dryers project more than 4" from the wall, measured at 7".

**Recommendations:**  
Recess blow dryers into the wall . Final projection from wall shall not be greater than 4".

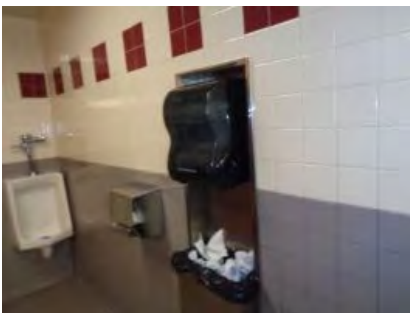
**Item Description:** Paper towel dispensers;

**Findings:** Dispensers are not accessible as they both require use of two hands, and require tight grasping and pinching. The side wheel for advancing paper requires twisting of the wrist.

**Recommendations:**  
Remove and replace one paper towel dispenser. New dispenser shall not require use of both hands, or tight grasping, pinching or twisting of the wrist. Mount new dispenser not higher than 40" AFF to the highest operable part.

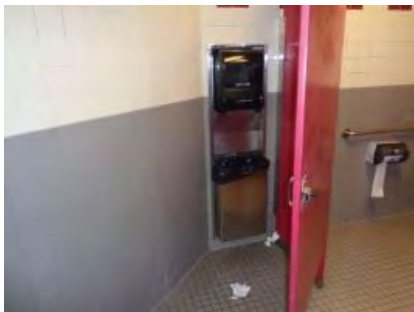
**Comment**      **SC-050**                      **Priority: 2**              **Estimated Direct Cost:**      \$190                      Maintenance

**Item Description:**      Stall Door; Stall Door

**Findings:** The accessible stall door is not self-closing. Accessible stall door is missing the required U-pull handle at the pull side.

**Recommendations:**  
Replace the self-closing hinges. Install a U-shaped pull handle below the latch.

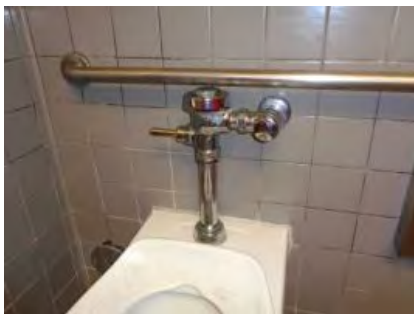
**Comment**      **SC-052**                      **Priority: 2**              **Estimated Direct Cost:**      \$2,375                      Contractor

**Item Description:**      WC flush handle; Rear grab bar; Side grab bar

**Findings:** The WC flush handle is located at the wall side of WC and not at the wide side. Proper hand clearance is not provide below the rear grab bar. Side grab bar is not compliant for location.

**Recommendations:**  
Install a new flush valve with an automatic sensor, having a manual over-ride on top of valve. Raise grab bar as needed to provide 1-1/2" clearance above the flush valve. Relocate side grab bar to project a minimum 54" from the back wall.

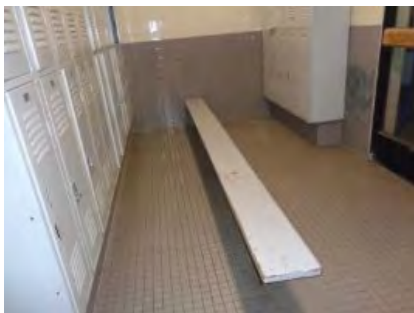
**Comment**      **SC-055**                      **Priority: 3**              **Estimated Direct Cost:**      \$1,150                      Contractor

**Item Description:**      Accessible lockers; Accessible benches

**Findings:** 82 lockers are provided. A minimum 5% shall be accessible with accessible benches. 80 lockers are available. No accessible locker benches have been provided. Five percent of all lockers shall be accessible with accessible benches.

**Recommendations:**  
Identify a minimum of 5 lockers as accessible and provide compliant benches. Provide a minimum of 4 accessible benches. Accessible benches shall have a back support or be affixed to a wall along its long dimension. Bench back support shall be 48 inches long minimum with a seat 20"-24" deep and 17"-19" high.

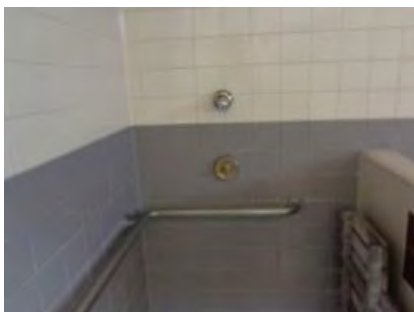
**Item Description:** Shower sprayer;

**Findings:** A hand held spray unit with hose is not provided.

**Recommendations:**  
Install a hand-held sprayer with a hose 59" long minimum and a non-positive shut off valve on the sprayer.

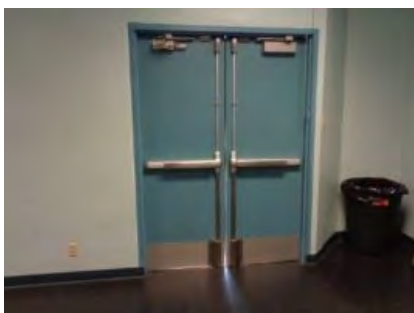
**Item Description:** Emergency exit doors;

**Findings:** Double exit doors are not accessible as each door leaf is only 27" wide.

**Recommendations:**  
Modify doors. One door leaf shall be 36" wide to provide a minimum clear width of 32".

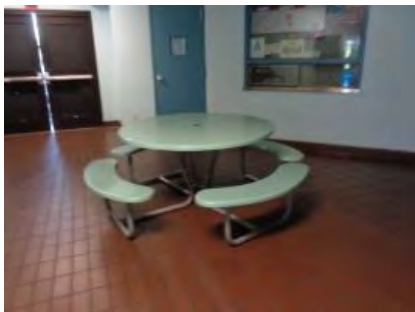
**Findings:** Table does not provide accessible seating.

**Recommendations:**  
Remove one seat and supports to provide clear space for a wheelchair.

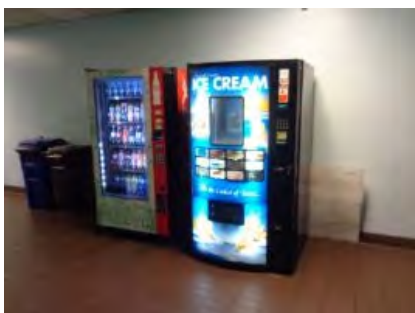
**Findings:** The ice cream vendor is not accessible due to height of operable parts.

**Recommendations:**  
Notify vending contractor to replace the ice cream machine. Any vending machines shall have all operable parts within 48" of the floor

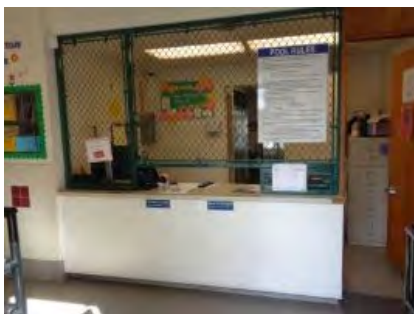
**Findings:**      Counter height is not accessible at 36" AFF.

**Recommendations:**  
Lower counter to a height not greater than 34" AFF.

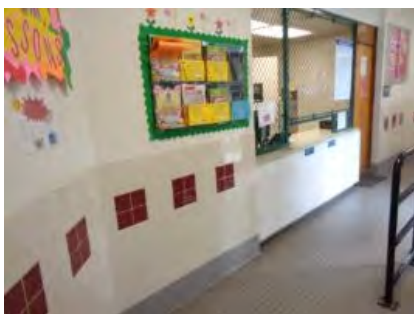
**Findings:**      Pamphlets are not accessible due to height.

**Recommendations:**  
Provide the same printed material at an accessible height at a nearby location, not greater than 48" AFF, or lower rack to same height.

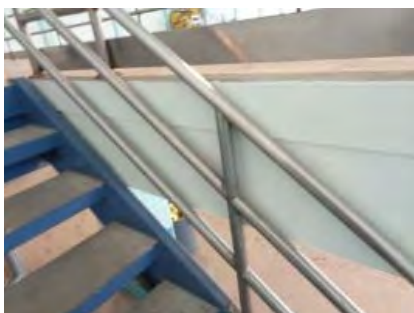
**Findings:**      The required minimum hand space of 1-1/2" is not provided where the handrails pass the balcony deck.

**Recommendations:**  
Modify handrails and/or deck at both sides to allow hand clearance.

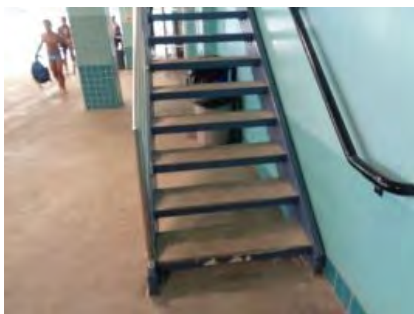
**Item Description:** Stair handrails; Stairs; Stairs

**Findings:** The bottom stair handrail extensions are not provided. Warning stripes are not provided at stairs. Vertical clearance under stairs is less than 80".

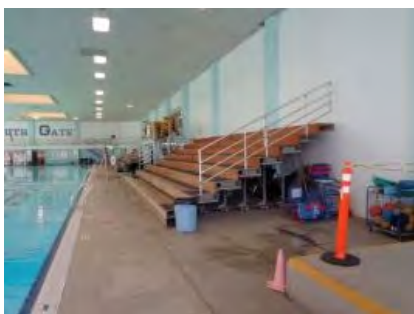
**Findings:** Bleacher seating is not accessible.

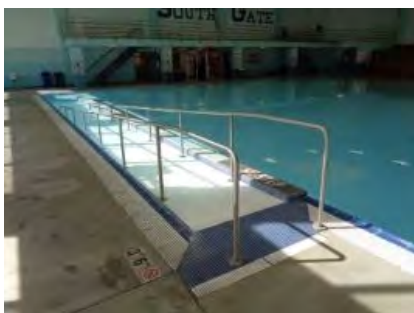
**Findings:** Aquatic wheelchairs are not available for use by disabled persons.

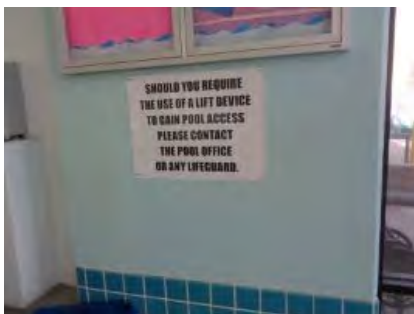
**Findings:** A pool lift is not in place and ready for use.

A pool lift is required to be ready for unassisted use during public hours of operation. Set pool lift in place and remove sign stating "CONTACT OFFICE".

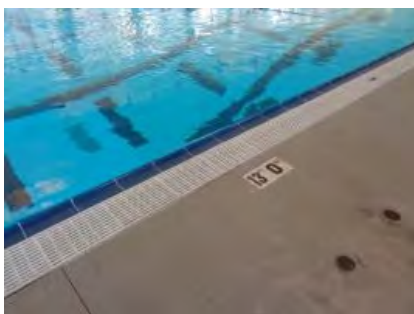
**Findings:** The current deck mounts for pool lift are located where the water depth of 13 feet.

Relocate pool lift. When a single pool lift is used, it shall be set where the water depth is 36 inches minimum and 48 inches maximum.

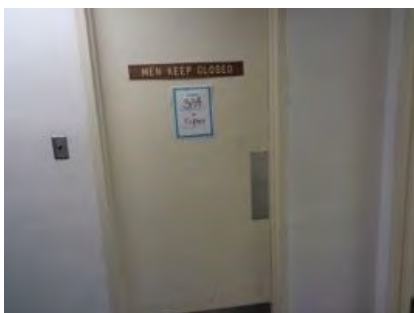
**Findings:** A Unisex locker room is not available. Some pool users require assistance to change, and a spouse of hired care-giver of the opposite sex can not enter to assist in the locker rooms.

Consider alterations of one staff restroom to provide accessible Unisex amenities such as shower, restroom, locker and dressing area.

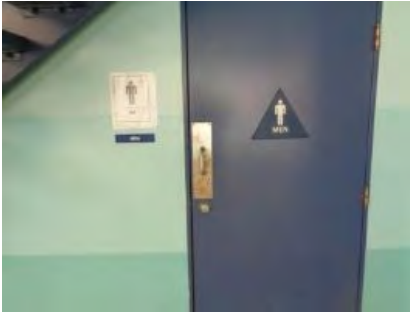
**Comment**      **SS-016**                      **Priority: 2**      **Estimated Direct Cost:**      \$75                      Maintenance

**Findings:**      The geometric door sign color fails to provide contrast with the door color.

Remove and replace door sign. New sign shall be white to provide visual contrast. Center sign on door at 58"-60" AFF.

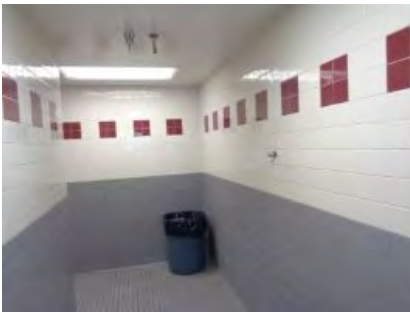
**Comment**      **SS-017**                      **Priority: 2**      **Estimated Direct Cost:**      \$3,200                      Contractor

**Findings:**      Wall control valve for overhead sprayer is not accessible for height at 58-1/2" AFF.

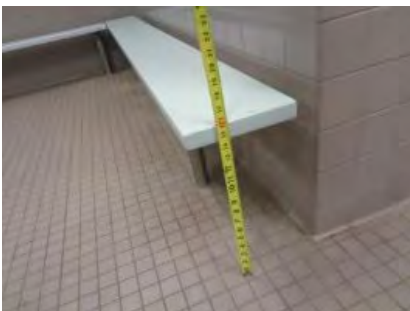
**Comment**      **SS-018**                      **Priority: 3**      **Estimated Direct Cost:**      \$575                      Contractor

**Findings:**      Accessible benches are not provided.

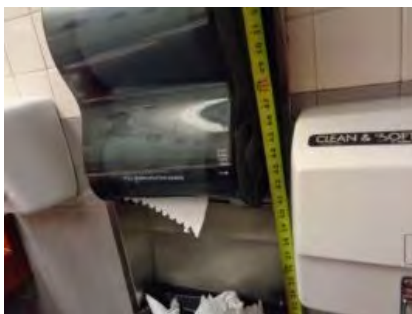
**Comment**      **SS-019**                      **Priority: 2**      **Estimated Direct Cost:**      \$1,200                      Contractor

**Findings:**      Dispensers are not accessible as they both require use of two hands, and require tight grasping and pinching. The side wheel for advancing paper requires twisting of the wrist.

**Recommendations:**  
Remove and replace one paper towel dispenser. New dispenser shall not require use of both hands, or tight grasping, pinching or twisting of the wrist. Mount new dispenser not higher than 40" AFF to the highest operable part.

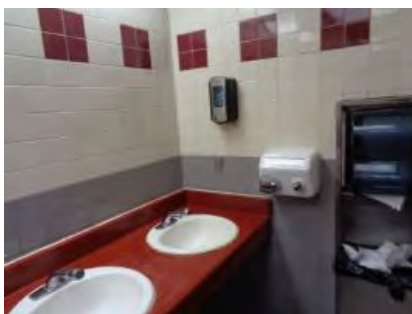
**Comment**      **SS-020**                      **Priority: 2**      **Estimated Direct Cost:**      \$1,300                      Contractor

**Findings:**      Soap dispensers at lavatories are not accessible due to height. Front apron of lavatory does not provide a minimum clear height of 29".

**Recommendations:**  
Lower one soap dispenser to a height not greater than 40" AFF to the highest operable part. Cut front apron as needed to obtain 29" minimum clear height above the floor.

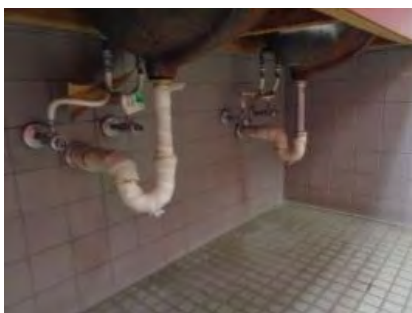
**Comment**      **SS-022**                      **Priority: 2**      **Estimated Direct Cost:**      \$75                      Maintenance

**Findings:**      Insulation beneath the lavatories is not complete.

**Recommendations:**  
Cover, wrap, or otherwise insulate all water lines, drains, valves and fittings. There shall also be no exposed sharp or abrasive elements under lavatories.

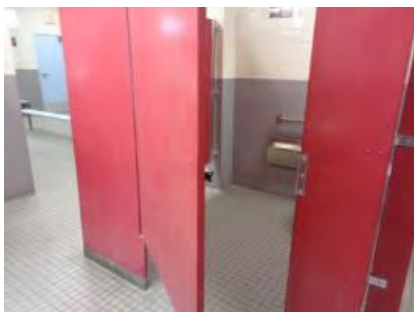
**Comment**      **SS-023**                      **Priority: 2**      **Estimated Direct Cost:**      \$190                      Maintenance

**Findings:** The accessible stall door is not self-closing. Accessible stall door is missing the required U-pull handle at both sides of door.

**Recommendations:**  
Replace the self-closing hinges. Install a U-shaped pull handle at both sides.

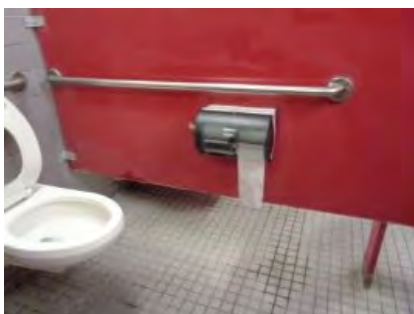
**Comment**      **SS-025**                      **Priority: 2**      **Estimated Direct Cost:**      \$3,750                      Contractor

**Findings:** Side grab bar is not compliant for location. Toilet paper dispenser is not compliant for location. Stall door is not located farthest from WC.

**Recommendations:**  
Relocate side grab bar to project a minimum 54" from the back wall. Relocate dispenser. Toilet paper dispenser shall be centered 7"-9" in front of WC. Modify partitions as needed to place door diagonally across from WC with a side stile a maximum 4" wide.

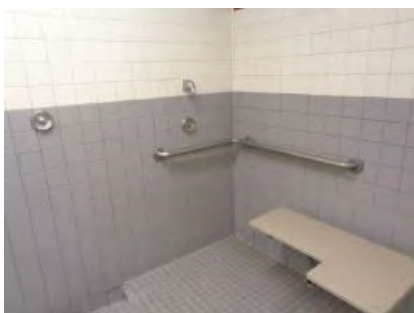
**Comment**      **SS-028**                      **Priority: 2**      **Estimated Direct Cost:**      \$95                      Maintenance

**Findings:** A hand held spray unit with hose is not provided.

**Recommendations:**  
Install a hand-held sprayer with a hose 59" long minimum and a non-positive shut off valve on the sprayer.

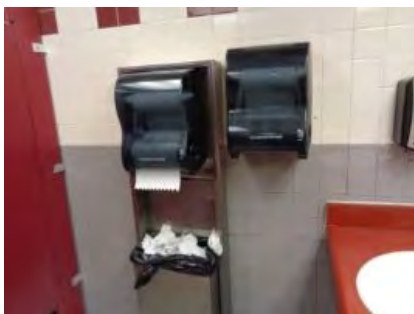
**Findings:** Dispensers are not accessible as they both require use of two hands, and require tight grasping and pinching. The side wheel for advancing paper requires twisting of the wrist.

**Recommendations:**  
Remove and replace one paper towel dispenser. New dispenser shall not require use of both hands, or tight grasping, pinching or twisting of the wrist. Mount new dispenser not higher than 40" AFF to the highest operable part.

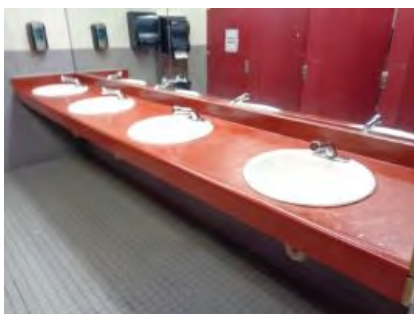
**Findings:** Soap dispensers at lavatories are not accessible due to height. Front apron of lavatory does not provide a minimum clear height of 29".

**Recommendations:**  
Lower one soap dispenser to a height not greater than 40" AFF to the highest operable part. Cut front apron as needed to obtain 29" minimum clear height above the floor.

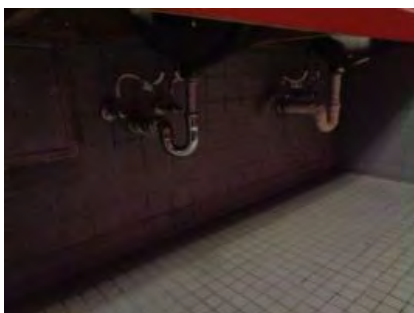
**Findings:** Insulation beneath the lavatories is not complete. Automatic faucets do not remain open for a minimum of 10 seconds.

**Recommendations:**  
Cover, wrap, or otherwise insulate all water lines, drains, valves and fittings. There shall also be no exposed sharp or abrasive elements under lavatories. Adjust the metering of each faucet to remain open for a minimum of 10 seconds.

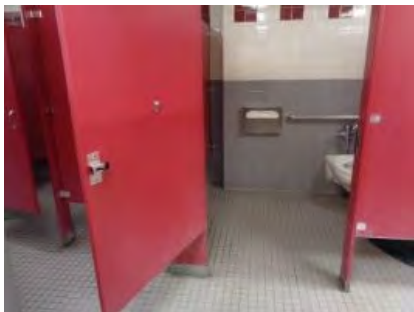
**Comment**      **SS-038**                      **Priority: 2**      **Estimated Direct Cost:**      \$190                      Maintenance

**Findings:** The accessible stall door is not self-closing. Accessible stall door is missing the required U-pull handle at both sides of door.

**Recommendations:**  
Replace the self-closing hinges. Install a U-shaped pull handle at both sides.

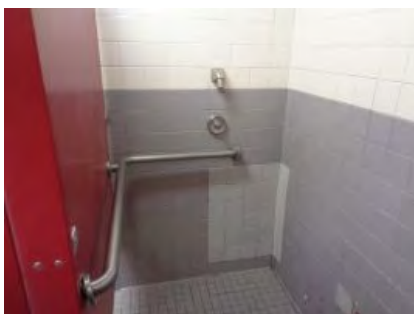
**Comment**      **SS-040**                      **Priority: 2**      **Estimated Direct Cost:**      \$995                      Maintenance

**Findings:** A hand held spray unit with hose is not provided. The required fold-up seat is not provided for the roll-in shower.

**Recommendations:**  
Install a hand-held sprayer with a hose 59" long minimum and a non-positive shut off valve on the sprayer. Install a fold-up seat at wall.

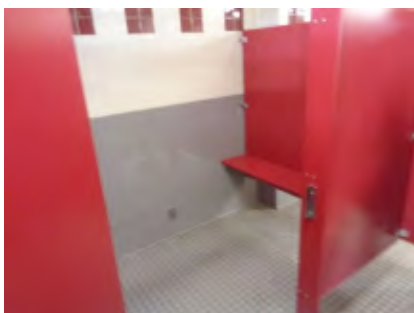
**Comment**      **SS-042**                      **Priority: 2**      **Estimated Direct Cost:**      \$5,000                      Contractor

**Findings:** The required 60" turning radius is not provided within dressing room.

**Recommendations:**  
Modify placement of partition panels as needed to increase space for a60" minimum turning radius.

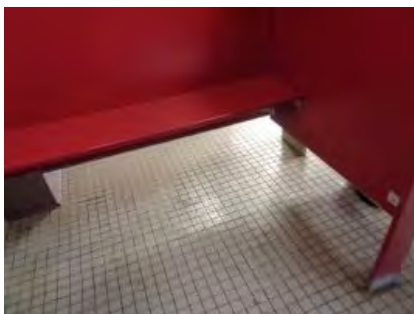
**Findings:** Bench is not accessible due to height and seat width.

**Recommendations:**  
Modify bench. Accessible bench shall have a seat height of 17"-19" with a seat width of 20"-24".

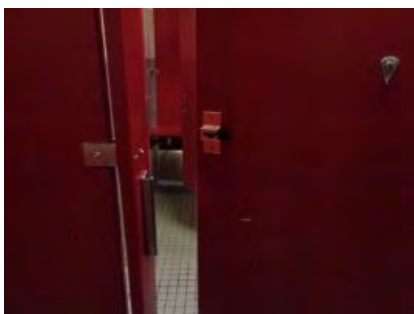
**Findings:** Accessible stall door is missing the required U-pull handle at both sides of door. The accessible stall door is not self-closing.

**Recommendations:**  
Install a U-shaped pull handle at both sides. Replace the self-closing hinges.

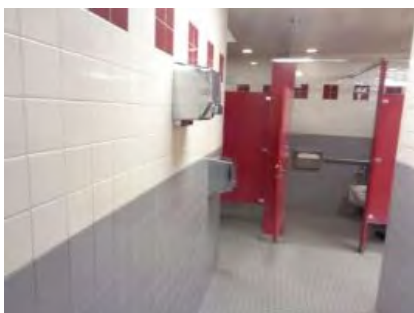
**Findings:** Hand dryers project 10" into the circulation route.

**Recommendations:**  
Recess hand dryers into wall. Projection of hand dryer into circulation route shall not be greater than 4".

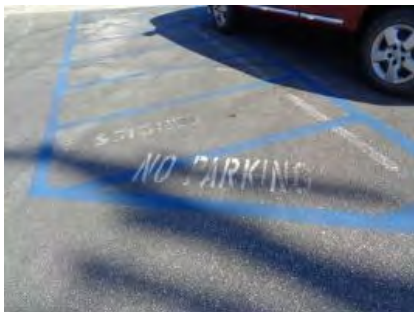
**Comment**      **WRC-003**      **Priority: 1**      **Estimated Direct Cost:**    \$1,400      Contractor

**Findings:** Diagonal stripes within access aisle does not provide the required visual contrast with the parking surface.

**Recommendations:**  
Re-stripe access aisle diagonal stripes in white when over asphalt. Border shall remain blue.

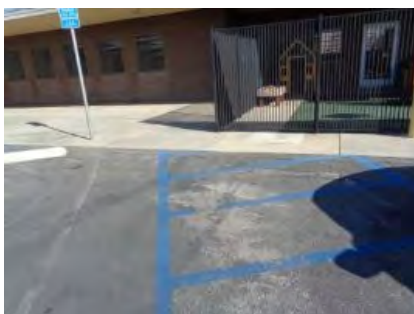
**Comment**      **WRC-004**      **Priority: 1**      **Estimated Direct Cost:**    \$14,400      Contractor

**Findings:** Truncated domes are not provided at the head of the accessible parking stall where the parking and walking surface meet as a flush transition.

**Recommendations:**  
Install truncated dome mats over the concrete walkway, across the head of the accessible parking stall and access aisle. Domes shall be 3 feet deep in the direction of travel.

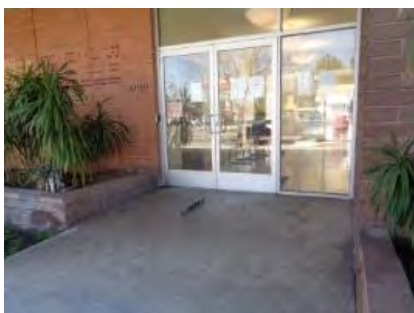
**Comment**      **WRC-005**      **Priority: 1**      **Estimated Direct Cost:**    \$2,700      Contractor

**Findings:** The exterior landing is not level, with a slope of 2.9%.

**Recommendations:**  
Remove and replace concrete at door. New concrete shall be level for a distance of 60" minimum, measured perpendicular to the face of the door when in the closed position. Slope a new concrete walkway from new landing to the city sidewalk connection. Slopes of walkway shall not exceed 5.0%. Cost at estimated \$15/sq. ft. for approximately 180 sq. ft.

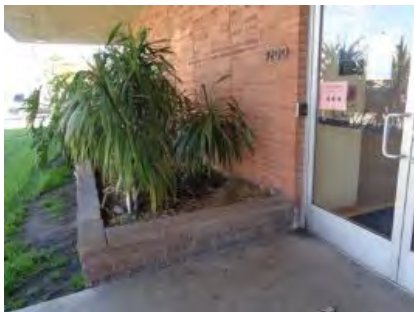
**Comment**      **WRC-006**      **Priority: 1**      **Estimated Direct Cost:**      \$560      Contractor

**Findings:** Door buzzer mounted at the brick wall is located within the swing of the door.

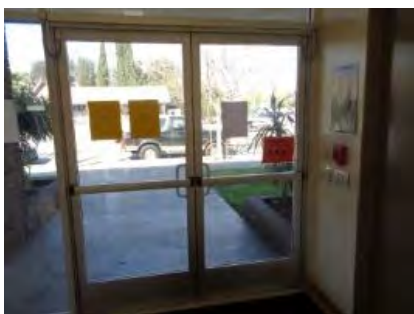
**Comment**      **WRC-007**      **Priority: 1**      **Estimated Direct Cost:**      \$1,740      Maintenance

**Item Description:**      Tactile exit signs; Door closers

**Findings:** Tactile exit signs are not provided at all grade level exit doors. All doors with automatic closers require adjustment for opening force and closing speed.

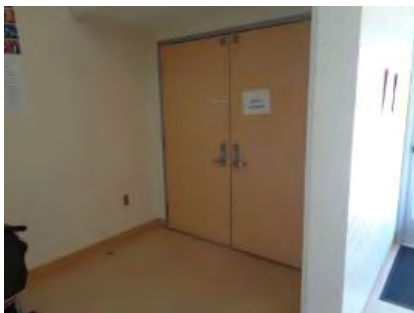
**Comment**      **WRC-008**      **Priority: 2**      **Estimated Direct Cost:**      \$190      Maintenance

**Item Description:**      Room Identification signs;

**Findings:** The required tactile room I.D. signs are not provided at various rooms. I.D. signs for interior rooms or spaces are required.

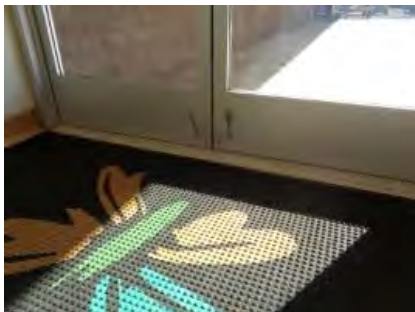
**Comment**      **WRC-010**      **Priority: 1**      **Estimated Direct Cost:**      \$95      Maintenance

**Item Description:**      Door stops;

**Findings:** Door stops at the push side of doors interfere with the requirement for a smooth surface.

**Recommendations:**  
Remove all door stops.

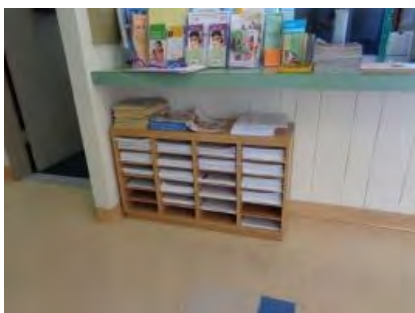
**Comment**      **WRC-012**      **Priority: 3**      **Estimated Direct Cost:**      \$60      Maintenance

**Item Description:**      Pamphlet rack;

**Findings:** The pamphlet rack is not accessible, having shelves outside of the accessible reach range.

**Recommendations:**  
Raise rack. The lowest reach shall not be lower than 15" AFF and the highest reach not greater than 48" AFF.

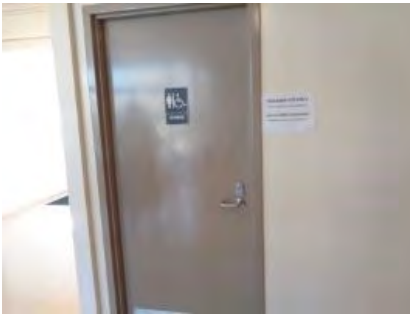
**Comment**      **WRC-013**      **Priority: 2**      **Estimated Direct Cost:**      \$150      Maintenance

**Item Description:**      Door Signage; Tactile wall signage

**Findings:** Doorway leading to the Women's restroom is not identified with the required geometric sign. The required tactile wall sign is not provided at doorway.

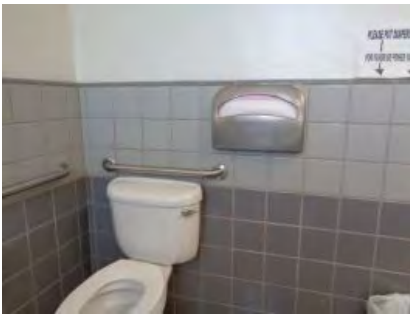
**Comment**      **WRC-015**      **Priority: 2**      **Estimated Direct Cost:**      \$1,600      Contractor

**Item Description:**      Rear grab bar; Seat cover dispenser

**Findings:** Rear grab bar is not compliant for height and provides less than 1-1/2" clear space above WC tank. Rear grab bar is not compliant for length. Seat cover dispenser at wall will interfere with placement of new rear grab bar.

Remove and replace rear grab bar. Provide a minimum 1-1/2" clearance over WC tank. Relocate seat cover dispenser to area below rear grab bar.

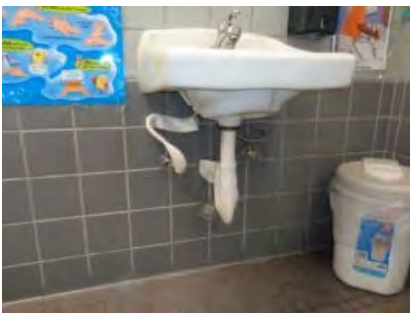
**Comment**      **WRC-017**      **Priority: 2**      **Estimated Direct Cost:**      \$75      Maintenance

**Item Description:**      Lavatory Insulation;

**Findings:** Insulation beneath the lavatory is not complete.

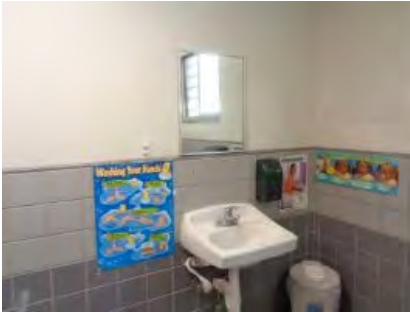
**Findings:** Mirror height is not compliant at 51-1/4" AFF to the lowest edge.

**Recommendations:**  
Lower mirror. The lowest reflective edge shall not be higher than 40" AFF.

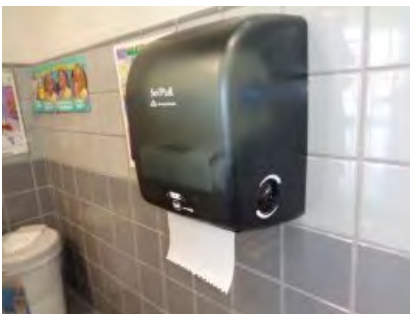
**Findings:** Dispenser is not accessible due to height. Dispenser is not compliant as it requires use of two hands and requires tight grasping and pinching. The side wheel for advancing paper requires twisting of the wrist.

**Recommendations:**  
Remove and replace paper towel dispenser. New dispenser shall not require tight grasping, pinching or twisting of the wrist. Mount new dispenser not higher than 30" AFF to the highest operable part.

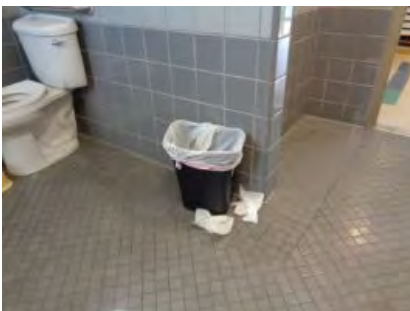
**Item Description:**      Loose waste basket;

**Findings:** The loose waste can could move and block access to fixtures and dispensers.

**Recommendations:**  
Remove loose waste can and install a semi-recessed wall waste receptacle.

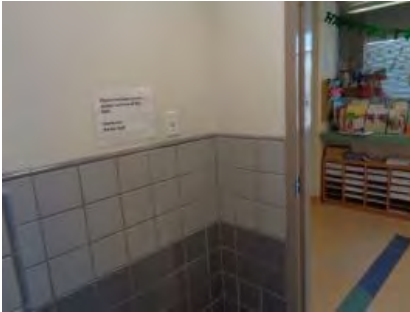
**Comment**      **WRC-021**      **Priority: 2**      **Estimated Direct Cost:**      \$800      Contractor

**Item Description:**      Light Switch;

**Findings:** Light switch is not compliant for height at 55-1/2" to the top of the box.

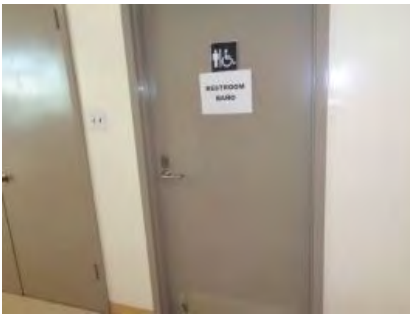
**Comment**      **WRC-022**      **Priority: 2**      **Estimated Direct Cost:**      \$150      Maintenance

**Item Description:**      Door Signage; Tactile wall signage

**Findings:** Doorway leading to the Men's restroom is not identified with the required geometric sign. The required tactile wall sign is not provided at doorway.

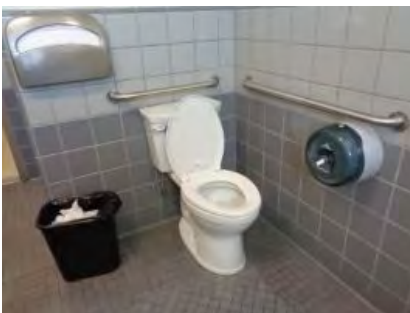
**Comment**      **WRC-024**      **Priority: 2**      **Estimated Direct Cost:**      \$1,200      Contractor

**Item Description:**      Rear grab bar; Seat cover dispenser

**Findings:** Rear grab bar is not compliant for length. Seat cover dispenser at wall will interfere with placement of new rear grab bar.

Remove and replace rear grab bar. Relocate seat cover dispenser to area below rear grab bar. Price includes moving the items and tile patching.

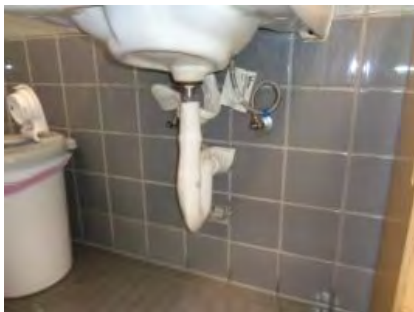
**Comment**      **WRC-026**      **Priority: 2**      **Estimated Direct Cost:**      \$75      Maintenance

**Item Description:**      Lavatory Insulation;

**Findings:** Insulation beneath the lavatory is not complete.

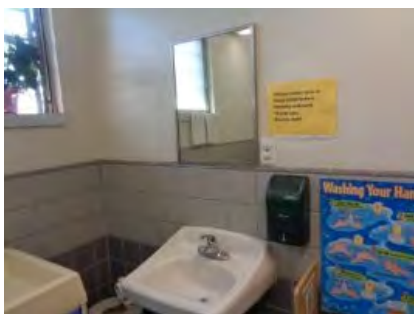
**Comment**      **WRC-027**      **Priority: 2**      **Estimated Direct Cost:**      \$1,200      Maintenance

**Item Description:**      Mirror;

**Findings:** Mirror height is not compliant at 51-1/4" AFF to the lowest edge.

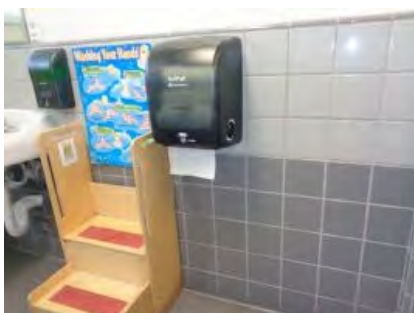
**Comment**      **WRC-028**      **Priority: 2**      **Estimated Direct Cost:**      \$600      Contractor

**Item Description:**      Paper towel dispenser;

**Findings:** Dispenser is not accessible due to height. Dispenser is not compliant as it requires use of two hands and requires tight grasping and pinching. The side wheel for advancing paper requires twisting of the wrist.

Remove and replace paper towel dispenser. New dispenser shall not require tight grasping, pinching or twisting of the wrist. Mount new dispenser not higher than 30" AFF to the highest operable part.

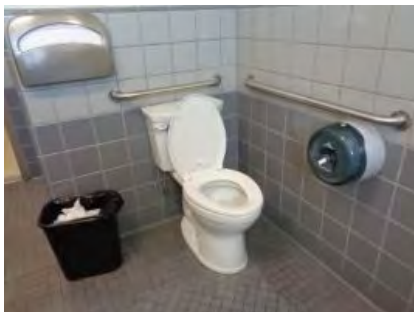
**Item Description:**      Loose waste basket;

**Findings:**      The loose waste can could move and block access to fixtures and dispensers.

**Recommendations:**  
Remove loose waste can and install a semi-recessed wall waste receptacle.
