# City of South Gate

# Volume 2

## Appendix B Facilities Barrier Assessment Report

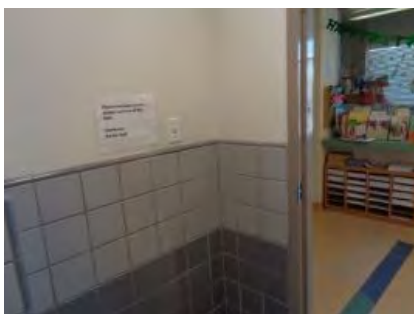
**Findings:**      Light switch is not compliant for height at 55-1/2" to the top of the box.

**Recommendations:**  
Lower switch. New height shall not be higher than 48" AFF to the top of the box.

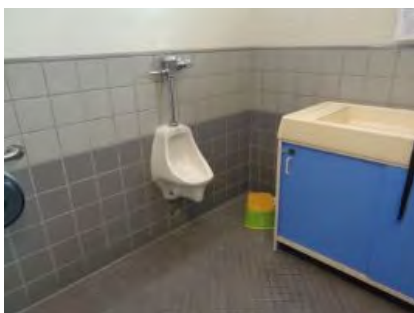
**Findings:**      Urinal is not compliant, having a rim height of 21" AFF and a flush handle height of 47" AFF. The required clear floor space at the urinal and lavatory is blocked by the baby changing table.

**Recommendations:**  
Lower fixture to a rim height of 17" MAX and lower the flush handle to a height not greater than 44" AFF. Replace changing table with a wall-mounted table.

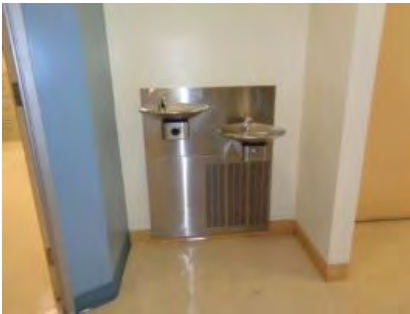
**Item Description:**      Drinking Fountain;

**Findings:**      Water flow is not a minimum 4" high.

**Recommendations:**  
Adjust bubbler to provide water flow at 4" high minimum.

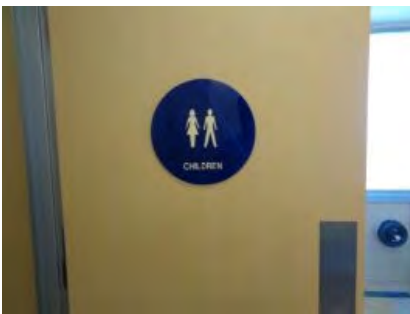
**Item Description:**      Door Signage;

**Findings:**      The existing Unisex geometric door sign is not compliant as the two geometric shapes do not have contrasting colors .

**Recommendations:**  
Provide a Unisex geometric door sign having a light color triangle over a dark circle, centered on the door at 58"-60" AFF.

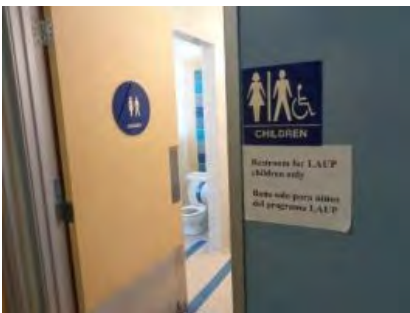
**Item Description:**      Tactile wall sign;

**Findings:**      The existing tactile wall sign is not compliant due to Braille spacing which does not conform to California Braille spacing requirements.

**Recommendations:**  
Remove and discard tactile wall sign. Provide one new tactile wall sign having Grade 2 Braille beneath raised text and a raised pictogram. Mount sign on the wall, at the latch side of door, centered at 56" AFF.

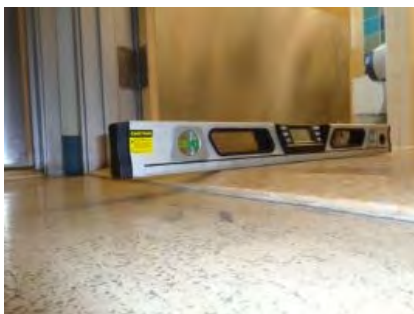
**Findings:** Door threshold is greater than 1/2" in height.

**Recommendations:**  
Modify threshold as needed to better transition the floor height differential between the restroom floor and the hall floor. Bevel shall occur over the full width of the threshold.

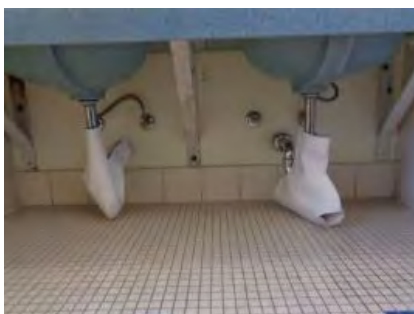
**Findings:** Insulation beneath the lavatory is not complete.

**Recommendations:**  
Reset drain insulation and secure. Cover, wrap, or otherwise insulate all water lines, valves and fittings. There shall also be no exposed sharp or abrasive elements under lavatory.

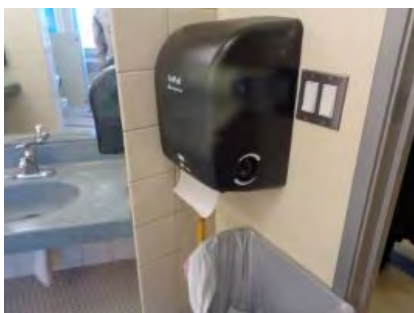
**Findings:** Dispensers are not accessible as they both requires use of two hands, requiring tight grasping and pinching. The side wheel for advancing paper requires twisting of the wrist.

**Recommendations:**  
Remove and replace one paper towel dispenser. New dispenser shall not require tight grasping, pinching or twisting of the wrist. Mount new dispenser not higher than 30" AFF to the highest operable part.

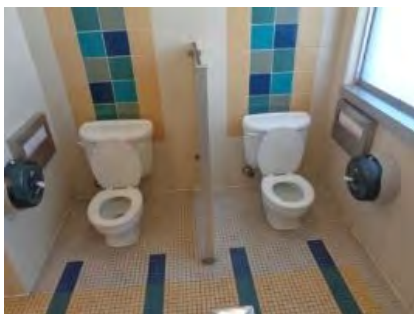
**Item Description:**      Accessible WC;

**Findings:**      Four WC's are provided. An accessible WC is not provided.

**Recommendations:**  
Modify restroom as needed to provide one accessible WC with grab bars and wheelchair clearance conforming to CBC 11B-604.3

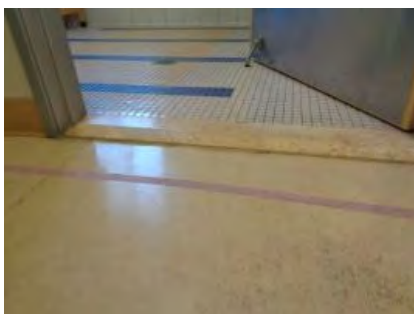
**Item Description:**      Door threshold height;

**Findings:**      Door threshold is greater than 1/2" in height.

**Recommendations:**  
Modify threshold as needed to better transition the floor height differential between the restroom floor and the hall floor. Bevel shall occur over the full width of the threshold.

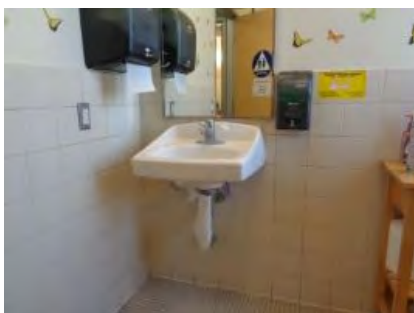
**Item Description:**      Lavatory height;

**Findings:**      Lavatory rim height is 34-1/2" AFF.

**Recommendations:**  
Lower lavatory approximately 1/2". Rim height shall not be higher than 34" AFF and an apron height of 29" minimum.

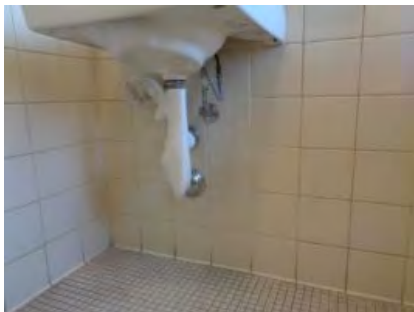
**Comment**      **WRC-042**      **Priority: 2**      **Estimated Direct Cost:**      \$75      Maintenance

**Item Description:**      Lavatory Insulation;

**Findings:** Insulation beneath the lavatory is not complete.

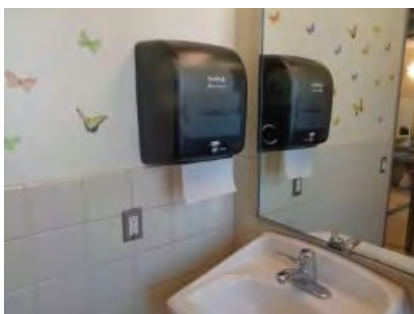
**Comment**      **WRC-043**      **Priority: 2**      **Estimated Direct Cost:**      \$600      Contractor

**Item Description:**      Paper towel dispenser;

**Findings:** Dispenser is not accessible at 49" to the highest operable part. Dispenser is not accessible as it requires use of two hands and requires tight grasping and pinching. The side wheel for advancing paper requires twisting of the wrist.

Remove and replace one paper towel dispenser. New dispenser shall not require tight grasping, pinching or twisting of the wrist. Mount new dispenser not higher than 40" AFF to the highest operable part.

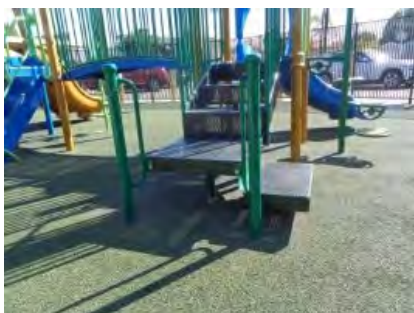
**Comment**      **WRC-044**      **Priority: 3**      **Estimated Direct Cost:**      \$10,190      Contractor

**Item Description:**      Transfer platform; Contrasting stripes

**Findings:** The required transfer space next to the transfer platform is obstructed by support posts. The required contrasting stripes are not provided at transfer steps.

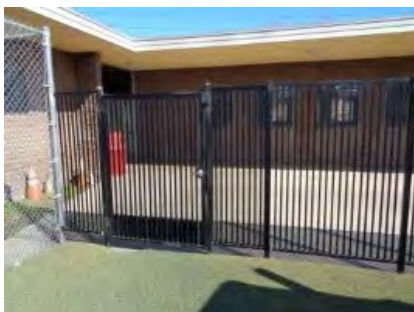
**Item Description:**      Tactile exit signs;

**Findings:**      Tactile exit signs are not provided at all playground gates.

**Recommendations:**  
Provide tactile exit signs at each exit gate. Mount signs at the latch side of gates. Signs shall have Grade 2 Braille beneath raised text stating "EXIT".

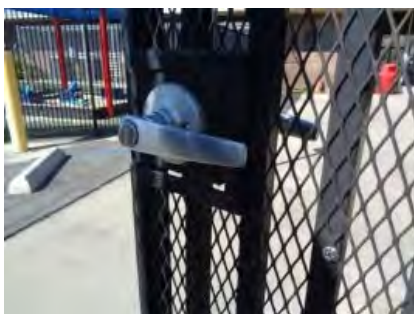
**Item Description:**      Lever gate handles;

**Findings:**      Lever handles have straight ends.

**Recommendations:**  
Replace lever handles at gates having levers.

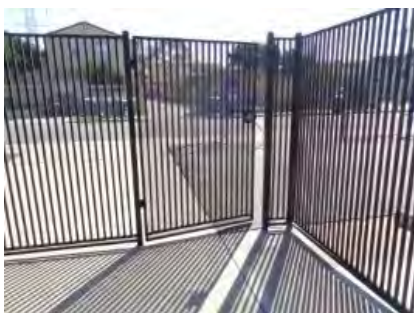
**Item Description:**      Smooth panels; Strike-side clearance

**Findings:**      A smooth panel is not provided at the bottom 10" of gates. The required minimum side-strike clearance of 12" is not provided at both gates, measuring 9".

**Recommendations:**  
Provide a smooth kick plate across the full width of gates at the push side. The smooth surface shall be a minimum 10" high. Reverse the swing of both gates, placing hinges at opposite side, to provide compliant clearance.

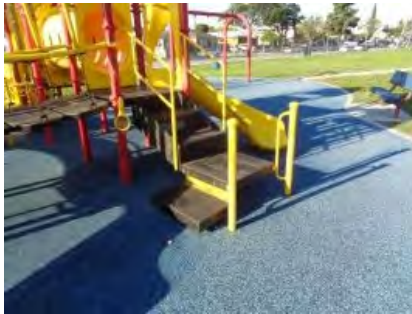
**Comment** CCP-001 **Priority:** 3 **Estimated Direct Cost:** \$1,190 **Contractor**

**Item Description:** Transfer platform; Contrasting Stripes

**Findings:** The required transfer space next to the transfer platform is obstructed by both support posts. The required contrasting stripes are not provided at transfer steps.

**Recommendations:** Modify location of platform supports to provide a transfer space immediately next to platform without interference. Provide contrasting stripes in white. The stripes shall be a minimum of 2 inches wide to a maximum of 4 inches wide placed parallel to, and not more than 1 inch from, the nose of the step or upper approach. The stripes shall extend the full width of the steps.

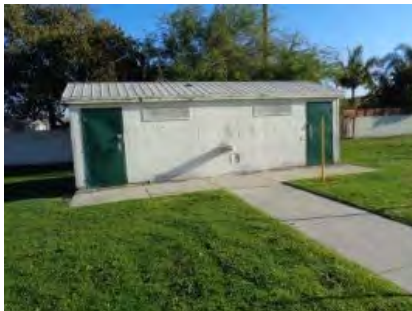
**Comment** CCP-003 **Priority:** 2 **Estimated Direct Cost:** \$60 **Maintenance**

**Item Description:** Accessibility of restrooms;

**Findings:** Restroom building has been vandalized and closed until repairs can be been made.

**Recommendations:** Assess accessibility at the time of restoration.

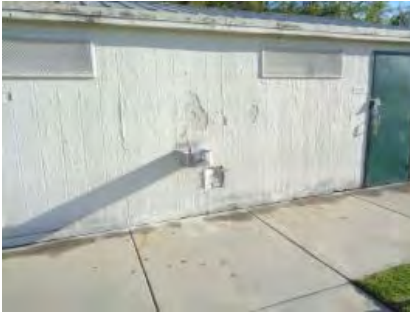
**Item Description:** Drinking fountain;

**Findings:** A single drinking fountain is not compliant. Pedestrian protection is not provided.

**Recommendations:**  
Remove and replace DF with a combination Hi/Lo model. Provide protection rails or wing walls, or provide new DF at a location outside of circulation routes.

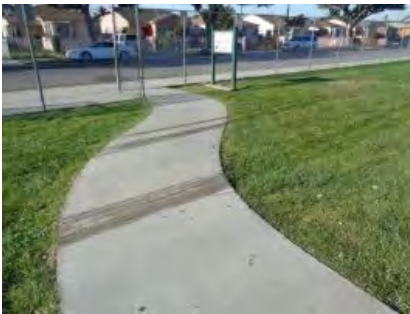
**Item Description:** Walkway;

**Findings:** Concrete is broken and will continue to further degenerate as Park Maintenance vehicles drive across walkway.

**Recommendations:**  
Replace damaged concrete.

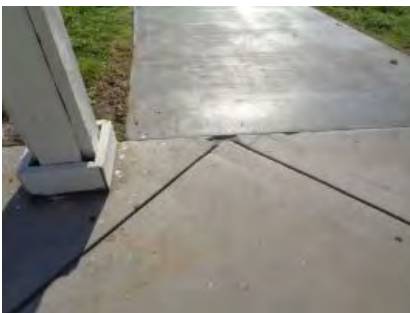
**Item Description:** Walkway;

**Findings:** Concrete near post at walkway is broken with a change in level greater than 1/4".

**Recommendations:**  
Patch damaged concrete.

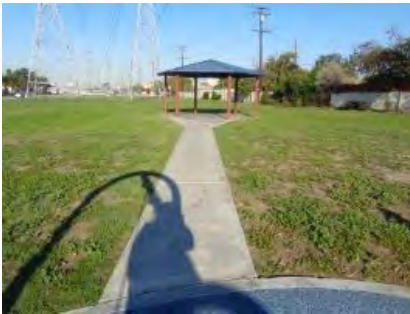
Walkway to pergola

**Findings:** 38 feet of walkway is undersized for width at 46"-47" wide.

**Recommendations:**  
Widen walkway to a minimum 48" wide.

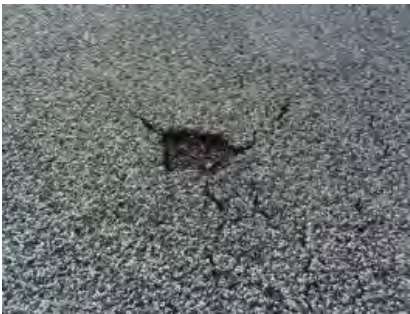
Play structure ages 5-12 yrs. old

**Findings:** Ground surface has out-lived its useful life span and is damaged throughout.

**Recommendations:**  
Have soft ground surface evaluated for replacement. Cost is associated with an evaluation.

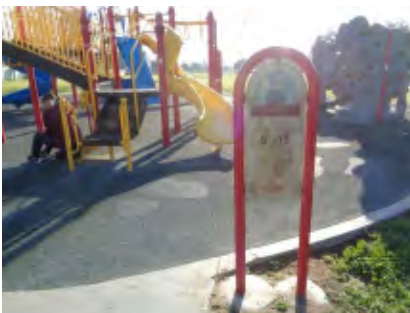
Play structure ages 5-12 yrs. old

**Findings:** The required contrasting stripes are not provided at transfer steps.

**Recommendations:**  
Provide contrasting stripes in white. The stripes shall be a minimum of 2 inches wide to a maximum of 4 inches wide placed parallel to, and not more than 1 inch from, the nose of the step or upper approach. The stripes shall extend the full width of the steps.

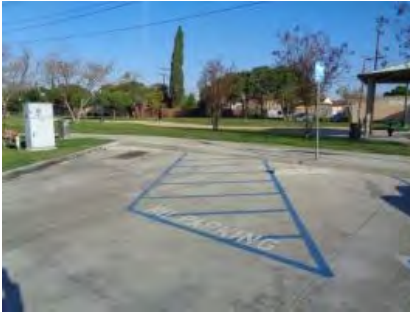
**Item Description:** Van stall; Tow-away Sign

**Findings:** Stall is located at the wrong side of the access aisle. The required tow-away warning sign is not provided.

**Recommendations:**  
Relocate stall markings and sign post to the left side of access aisle. Provide one a CALTRANS R-100B tow sign within direct view of the stall. The blank spaces for vehicle reclaiming information shall be filled-in and made a permanent part of the sign in lettering a minimum 1 inch high.

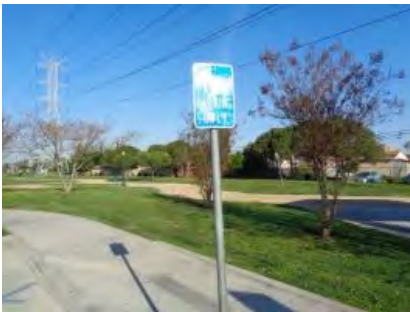
**Item Description:** Stall sign;

**Findings:** Sign is damaged. The additional sign stating "MINIMUM FINE \$250" and "VAN ACCESSIBLE" are not provided.

**Recommendations:**  
Replace the existing sign and provide the additional signs. The lowest edge of the lowest sign shall be 80" minimum.

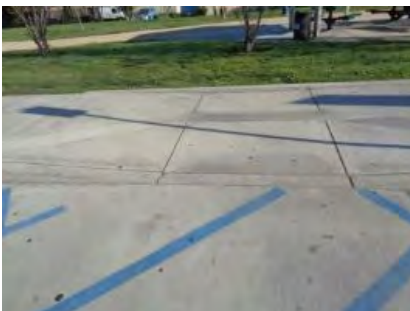
**Item Description:** Curb ramp;

**Findings:** Truncated domes are not provided at curb ramp.

**Recommendations:**  
Install a 36"X48" truncated dome mat a 36"X48" over ramp surface, 6"-8" from the curb face line.

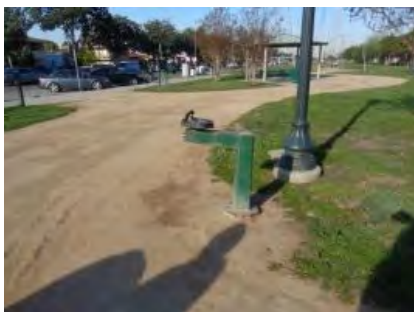
**Findings:**    Pedestrian protection is not provided at DF.

Path      **Code Reference:**    CBC 11B-602.9 ,

**Recommendations:**  
Install wing walls or rails at both sides, or relocate DF outside of the pathway.

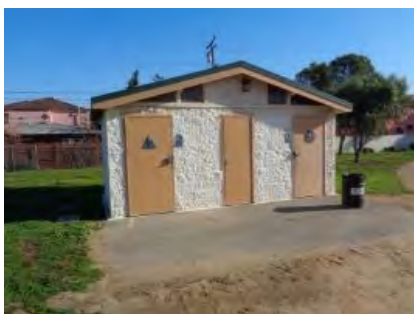
**Findings:**    At each restroom, the door and wall signs are mounted too high.

Both Restrooms      **Code Reference:**    CBC 11B-703.7.2.6    CBC 11B-216.2,

**Recommendations:**  
Lower door signs to a position centered 58"-60" AFF. The wall signs shall be centered at 56" AFF.

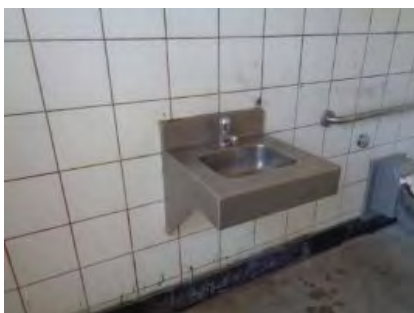
**Findings:**    Automatic faucet does not remain open for a minimum of 10 seconds.

Women's Restroom      **Code Reference:**    CBC 11B-606.4,

**Recommendations:**  
Adjust the metering of faucet to remain open for a minimum of 10 seconds.

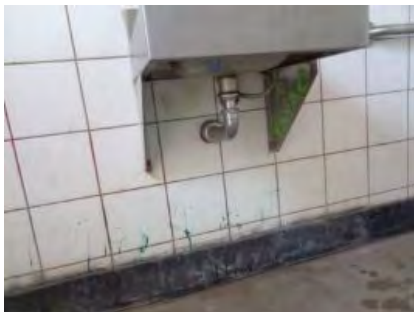
**Comment**    **CCP-017**                    **Priority: 2**            **Estimated Direct Cost:**    \$75                    Maintenance

**Item Description:**    Lavatory Insulation;

**Findings:** Insulation beneath the lavatory is not provided.

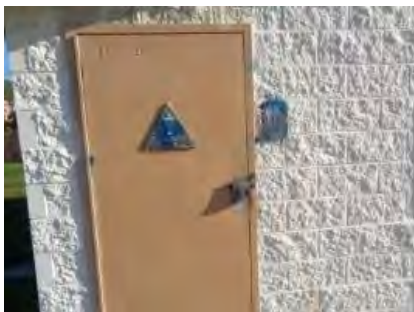
**Comment**    **CCP-018**                    **Priority: 2**            **Estimated Direct Cost:**    \$95                    Maintenance

**Item Description:**    Exterior Door latch;

**Findings:** Latch is not accessible.

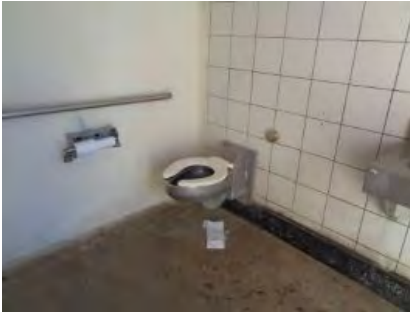
Men's Restroom

**Findings:** A rear grab bar is not provided at WC.

**Recommendations:**  
Provide a 36" minimum grab bar at the back wall. See detail D033 for location details.

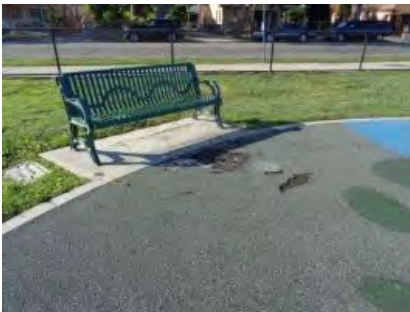
Play structure ages 5-12 yrs. old

**Findings:** Ground surface is damaged at various locations.

**Recommendations:**  
Patch soft ground surface as needed.

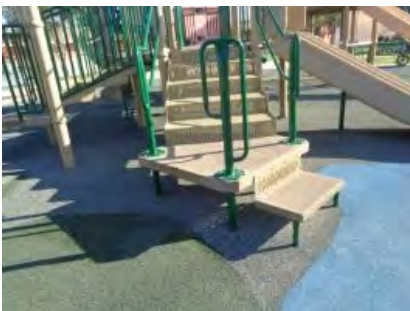
Play structure ages 5-12 yrs. old

**Findings:** The required contrasting stripes are not provided at transfer steps.

**Recommendations:**  
Provide contrasting stripes in white. The stripes shall be a minimum of 2 inches wide to a maximum of 4 inches wide placed parallel to, and not more than 1 inch from, the nose of the step or upper approach. The stripes shall extend the full width of the steps.

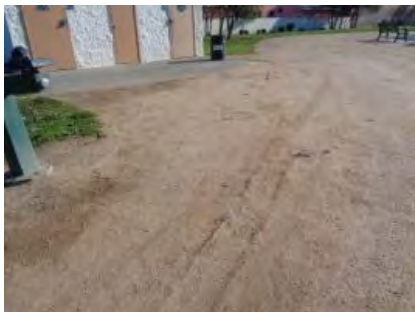
**Item Description:** Stable surface;

**Findings:** Pathway surface consists of decomposed granite (DG) and is not stable and firm, with areas of abrupt changes in level where distorted by vehicle travel and erosion.

**Recommendations:**  
Groom all DG pathways as needed. Consider adding stabilizing admixtures or binders to increase firmness and stability. Periodic maintenance of DG paths is required to ensure path remains stable and firm, and free of distortions.

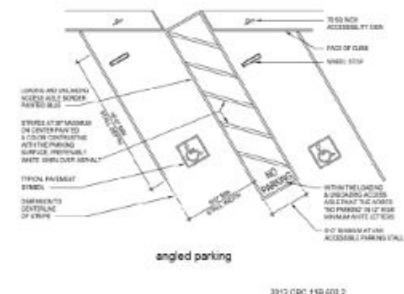
**Item Description:** Van stall;

**Findings:** Van stall is located at the wrong side of the access aisle.

**Recommendations:**  
Relocate stall markings and sign post to the left side of access aisle.

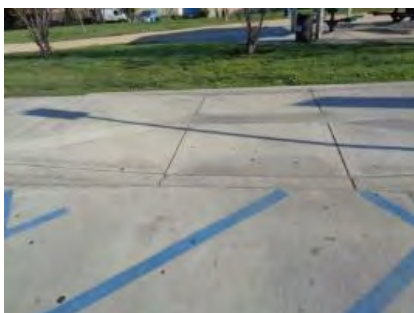
**Item Description:** Curb ramp;

**Findings:** Truncated domes are not provided at curb ramp.

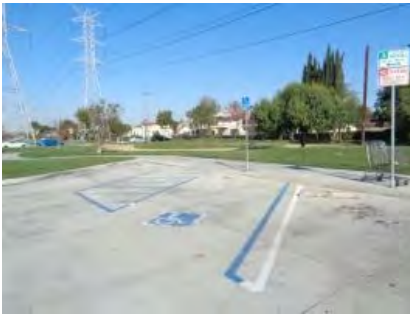
**Item Description:** Van stall; Pavement ISA; Tow-away Sign

**Findings:** Stall is located at the wrong side of the access aisle. The ISA pavement sign is not compliant for proportion or size. The required tow-away warning sign is not provided.

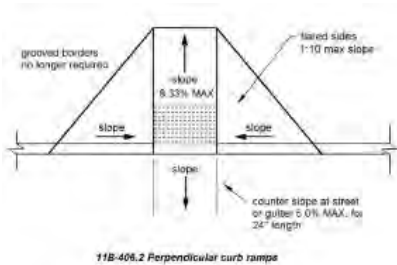
**Item Description:** Curb ramp;

**Findings:** Truncated domes are not provided at curb ramp.

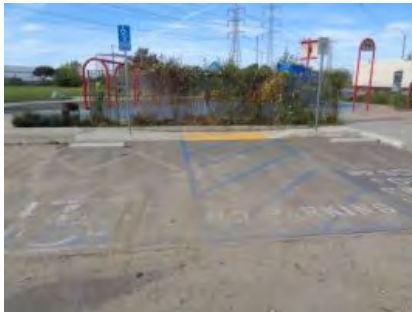
**Comment CP-001**      **Priority: 1**      **Estimated Direct Cost:** \$1,460      Contractor

**Item Description:** Stall surface; Stall striping

**Findings:** Stall surface is not stable, having a large amount of dirt across the entire hard surface. Stall stripes are greatly deteriorated due to abrasion of dirt.

**Recommendations:**  
Sweep parking surface and maintain. Reseal parking surface and restripe.

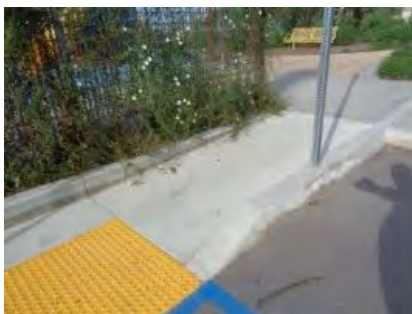
**Comment CP-003**      **Priority: 1**      **Estimated Direct Cost:** \$60      Maintenance

**Item Description:** Curb ramp;

**Findings:** Clear width of ramp is obstructed by vegetation.

**Recommendations:**  
Trim vegetation.

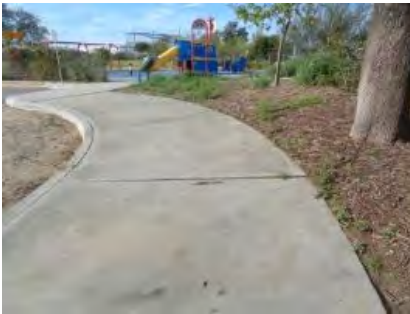
**Item Description:** Abrupt edges;

**Findings:** Concrete edges are raised at two slabs at curved walkway.

**Recommendations:**  
Grind concrete edges as needed.

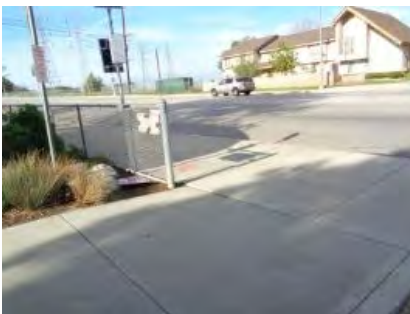
**Item Description:** Abrupt edge;

**Findings:** Concrete edge is raised 3/4" at walkway connection to city sidewalk.

**Recommendations:**  
Grind concrete edge as needed.

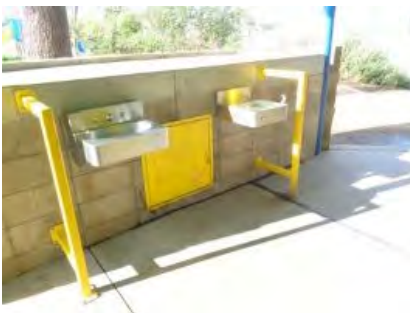
**Item Description:** Lavatory;

**Findings:** Lavatory is centered 14-1/2" from pedestrian guard.

**Recommendations:**  
Relocate guard to provide a minimum 15" clear space to the center of lavatory.

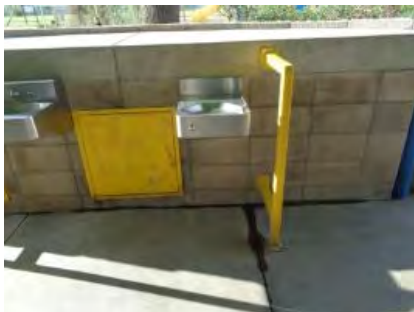
Restroom Exterior

**Findings:** Drinking fountain is centered 13" from pedestrian rail.

**Recommendations:**  
Relocate guard to provide a minimum 16" clear space to the center of drinking fountain.

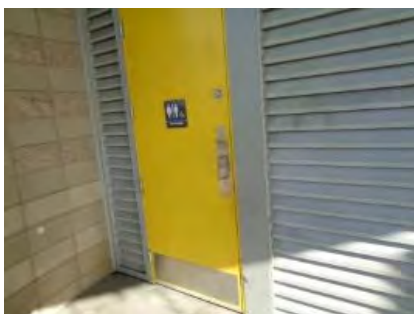
Restroom Exterior

**Findings:** The required geometric door signs are not provided at each restroom door.  
The required tactile wall sign is not provided at each restroom doorway.

**Recommendations:**  
Provide a Unisex restroom geometric door sign centered at 58"-60" AFF. Sign shall have a light color triangle over a dark circle. Provide a tactile wall sign at each restroom doorway, having Grade 2 Braille beneath raised text and a raised pictogram. Mount sign on wall, at the latch side of door.

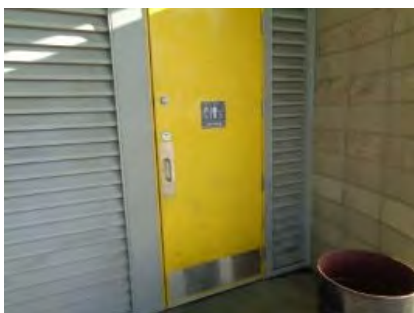
Restrooms

**Findings:** Automatic door closers at both restrooms require adjustment for opening force and closing speed.

**Recommendations:**  
Adjust both door closers to provide an operational effort of 5 lbf maximum and so that from an open position of 90 degrees, the time required to move the door to a position of 12 degrees from the latch is 5 seconds minimum.

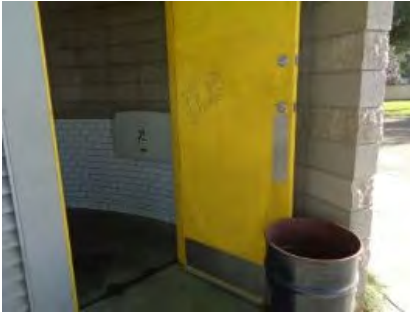
**Comment CP-011** **Priority: 2** **Estimated Direct Cost:** \$370 **Maintenance**

**Item Description:** Door locks;

**Findings:** Locks are both restroom doors are not compliant for height, centered at 54" AFF.

**Recommendations:**  
Lower locks to within the accessible range of 34"-44" AFF.

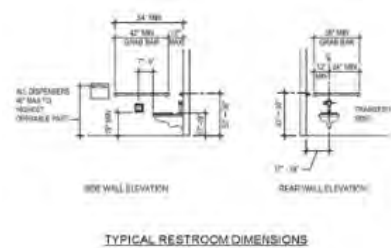
**Comment CP-012** **Priority: 2** **Estimated Direct Cost:** \$3,200 **Contractor**

**Item Description:** WC location;

**Findings:** The accessible WC is not compliant for location, centered 19" from the side wall.

**Recommendations:**  
Reset waste line within wall to center WC 17"-18" from the side wall.

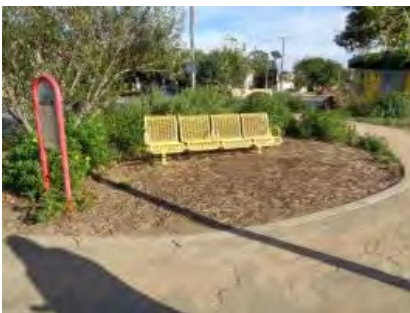
**Comment CP-013** **Priority: 3** **Estimated Direct Cost:** \$750 **Contractor**

**Item Description:** WC seating;

**Findings:** Wheel chair seating is not provided next to fixed seating.

**Recommendations:**  
Provide an accessible route to the existing seats, allowing a 60" minimum turning radius and a seating area a minimum 30"X48" next seats.

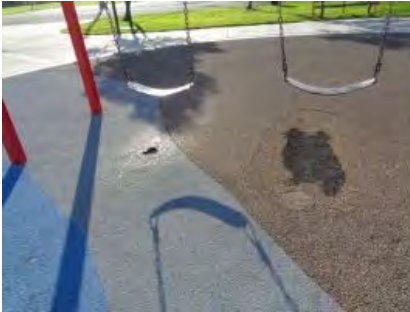
**Comment CP-014**      **Priority: 3**      **Estimated Direct Cost:** \$190      Maintenance

**Item Description:** Soft ground surface;

**Findings:** Ground surface at swings is damaged and worn.

**Recommendations:**  
Repair soft ground surface.

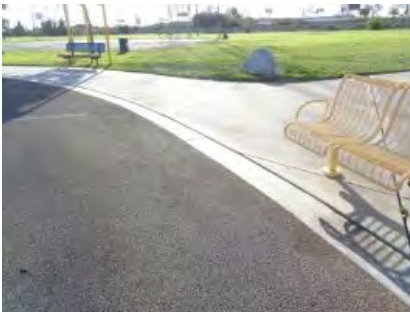
**Comment CP-015**      **Priority: 3**      **Estimated Direct Cost:** \$2,400      Contractor

**Item Description:** Abrupt edge;

**Findings:** Concrete edge is raised, greater than 1/4" at edge of play area.

**Recommendations:**  
Grind 40 feet of concrete edge.

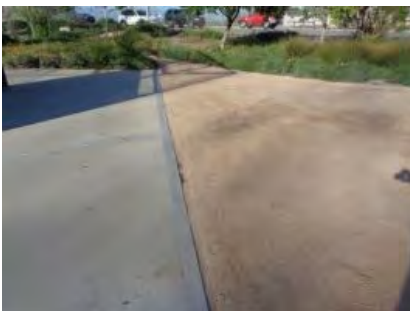
**Comment CP-016**      **Priority: 1**      **Estimated Direct Cost:** \$60      Maintenance

**Item Description:** Stable surface;

**Findings:** Pathway surface consists of decomposed granite (DG) and is not stable and firm, with areas of abrupt changes in level where distorted by wear and erosion. Path connection to concrete walkway is not smooth and level.

**Recommendations:**  
Groom all DG pathways as needed. Consider adding stabilizing admixtures or binders to increase firmness and stability. Periodic maintenance of DG paths is required to ensure path remains stable and firm, and free of distortions.

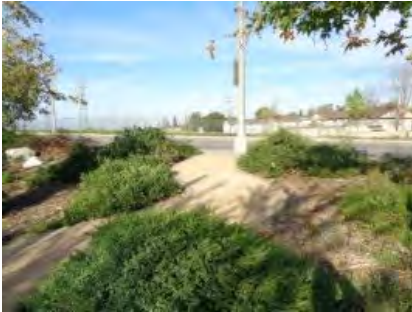
**Item Description:** Signage;

**Findings:** The decomposed granite pathway connecting to the city sidewalk on Garfield is not accessible and signage is not provided to indicate the location of the accessible route to the park.

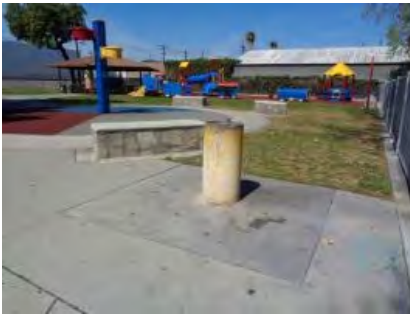
**Item Description:** Drinking Fountain;

**Findings:** DF is not accessible

**Recommendations:**  
Replace DF with a Hi/Lo combination unit

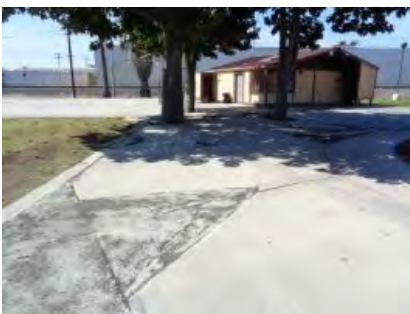
**Item Description:** Concrete area;

**Findings:** Concrete plaza area has been severely uplifted by tree roots

**Recommendations:**  
Remove and replace concrete.

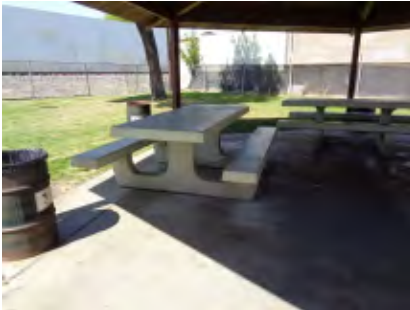
**Item Description:** Wheelchair seating;

**Findings:** Wheelchair seating is not provided next to fixed seating

**Recommendations:**  
Add a concrete pad 36"X 60" next to the fixed seating, at two locations.

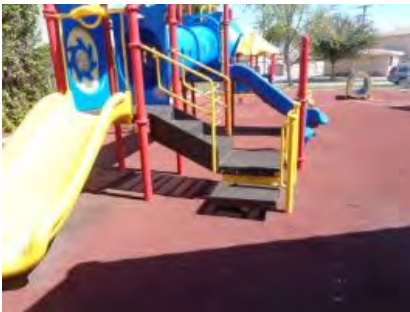
**Item Description:** Contrasting stripes; Transfer Platform

**Findings:** The required contrasting stripes are not provided at transfer steps and train steps. Transfer space is not directly adjacent to the transfer platform due to placement of the vertical uprights which project 5 inches into the required clear space.

**Recommendations:**  
Provide contrasting stripes in white. The stripes shall be a minimum of 2 inches wide to a maximum of 4 inches wide placed parallel to, and not more than 1 inch from, the nose of the step or upper approach. The stripes shall extend the full width of the steps. Modify vertical uprights to mount at the sides of the platform to allow a wheelchair approach without obstructions.

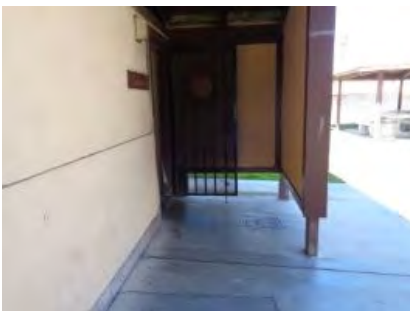
**Item Description:** Sign; Accessible Route

**Findings:** The geometric sign (circle) is not visible when approaching the restroom building. Walkway entering restroom has a cross slope of 5.6%.

**Recommendations:**  
Provide new geometric sign, a dark 12" circle, at the wall, centered 58-60" above the ground. Replace concrete.

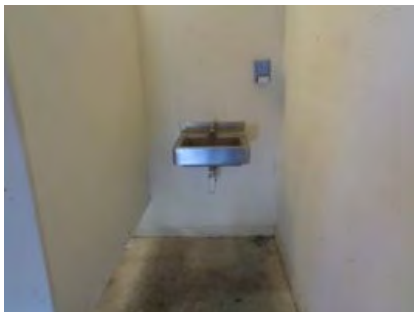
**Item Description:** Lavatory alcove; Lavatory Position

**Findings:** Alcove is not 36" wide. Lavatory knee space is insufficient due to fixture height.

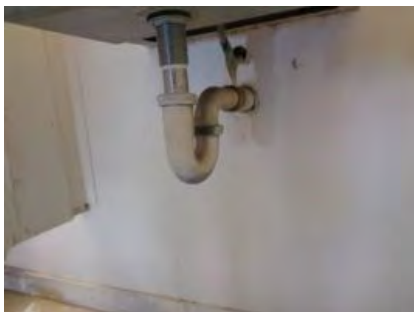
**Item Description:** Lavatory Insulation; Soap Dispenser; Hand Dryer

**Findings:** Lavatory piping is not covered to prevent skin contact. Dispenser is not accessible at 47" AFF. Handdryer projects more than 4" from the wall.

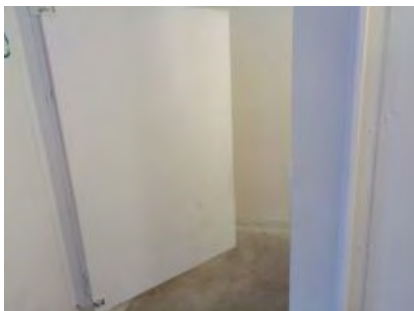
**Item Description:** Stall Door; Stall Door

**Findings:** Door is not self-closing. The required U-pull handles are not provided at the interior or exterior sides of door.

Replace self-closing hinges. Install a U-pull handle below the latch.

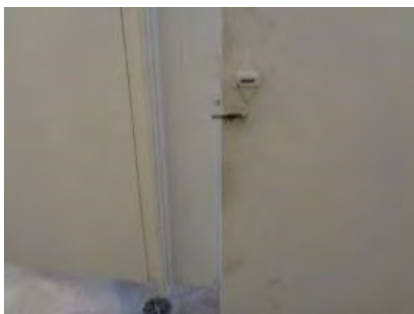
**Findings:** Door latch is not accessible.

**Recommendations:**  
Replace barrel latch with a slide or flip-over latch.

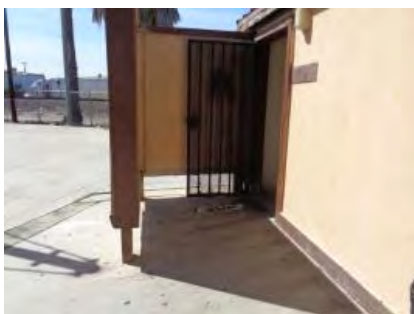
**Findings:** The geometric sign (circle) is not visible when approaching the restroom building. Walkway entering restroom has a cross slope of 5.6%.

**Recommendations:**  
Provide new geometric sign, a dark 12" circle, at the wall, centered 58-60" above the ground.  
Replace concrete.

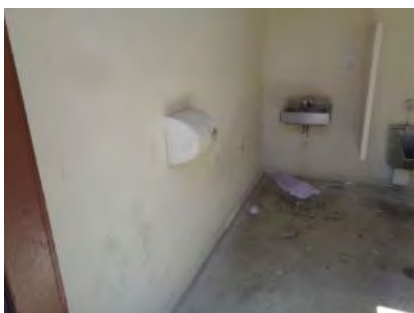
**Findings:** Handdryer projects more than 4" from the wall.

**Recommendations:**  
Provide a recessed hand dryer, projecting no more than 4" from the wall.

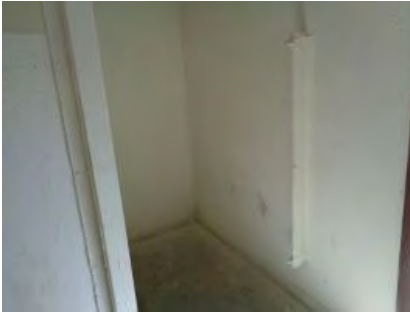
**Findings:** Stall door is missing.

**Recommendations:**  
Provide new stall door.

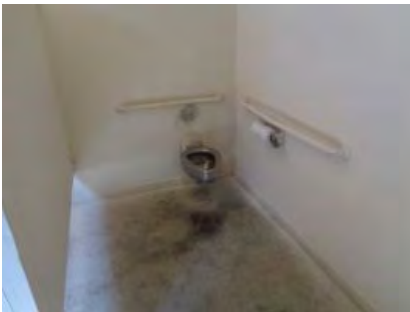
**Findings:** Grab bars are not compliant for depth from wall. The space between the wall and grab bar is 3".

**Recommendations:**  
Replace grab bars. The space between the wall and grab bars shall be 1-1/2".

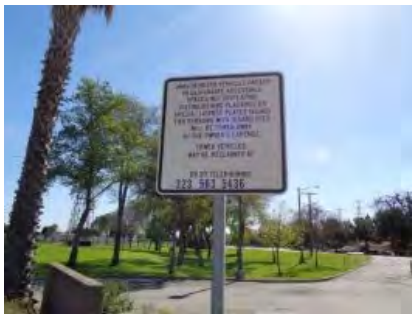
**Comment**    **HRP-001**                      **Priority: 1**            **Estimated Direct Cost:**    \$500                      Contractor

**Item Description:**    Tow-away Signs;

**Findings:** The required tow-away warning signs are not provided at the park entrances at Monroe Avenue and Century Blvd. The existing sign at the South parking area is not properly posted and not visible upon entering the parking area.

**Recommendations:**  
Provide one post-mounted CALTRANS R-100B tow sign at each park entrance, within direct upon entering the parking areas. The blank spaces for vehicle reclaiming information shall be filled-in and made a permanent part of the sign, in lettering a minimum 1 inch high.

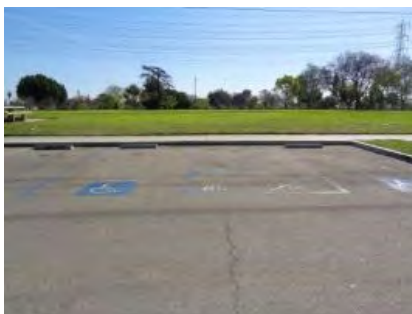
**Comment**    **HRP-002**                      **Priority: 1**            **Estimated Direct Cost:**    \$4,060                      Contractor

**Item Description:**    Curb Ramp; Stall signs

**Findings:** The existing stall layouts (two places) are not compliant as they uses a curb ramp to the far right of the right accessible stall. This requires a person from the left stall to wheel or walk behind a parked vehicle other than their own. Stall signs are not provided at four stalls.

**Recommendations:**  
At two parking areas at the North lot, provide each with a new parallel curb ramp at the head of the access aisles, between the two stalls. Provide post-mounted signs at each stall. See detail for proper signs.

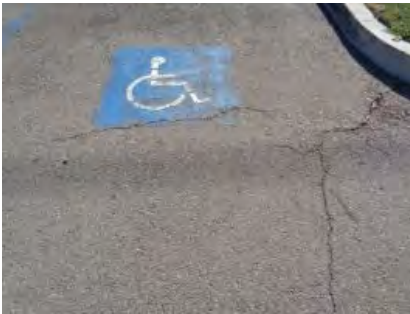
**Comment**     **HRP-004**     **Priority: 1**     **Estimated Direct Cost:**     \$1,400     Contractor

**Item Description:**     Stall surface;

**Findings:** Paint is faded at ALL accessible stalls. Asphalt surface has not been maintained and is cracking.

**Recommendations:**  
Reseal parking stalls as needed and restripe accessible stalls.

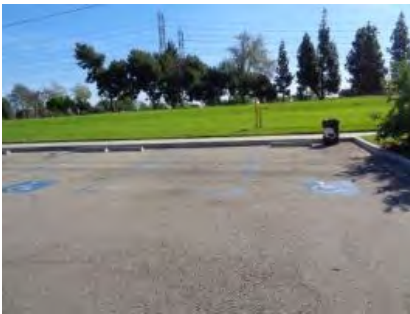
**Comment**     **HRP-005**     **Priority: 1**     **Estimated Direct Cost:**     \$750     Contractor

**Item Description:**     Access aisle stripes;

**Findings:** Diagonal stripes in access aisles fail to provide the required visual contrast with the parking surface.

**Recommendations:**  
Re-stripe access aisles with white diagonal stripes, 36" O.C. maximum. Interrupt white stripes at area of white lettering stating "NO PARKING". Access aisle border shall remain blue.

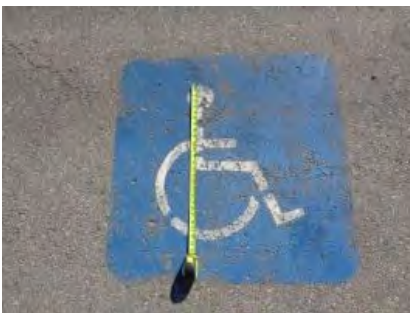
**Comment**     **HRP-006**     **Priority: 1**     **Estimated Direct Cost:**     \$400     Contractor

**Item Description:**     Stall ISA markings;

**Findings:** Stall ISA markings are not compliant for size and do not have the required white border.

**Recommendations:**  
Provide larger ISA's at each stall. Symbol shall be a minimum 36" high with a white border.

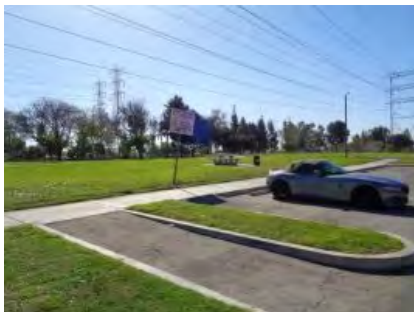
**Comment**      **HRP-007**      **Priority: 1**      **Estimated Direct Cost:**    \$576      Contractor

**Item Description:**    Detectable warning surface;

**Findings:** At two curb ramps adjoining the two accessible stall areas, the curb ramps are missing the required truncated domes.

**Recommendations:**  
Install truncated dome mats at each ramp, placed over the concrete for maximum life. Domes shall be placed across the full width of ramp.

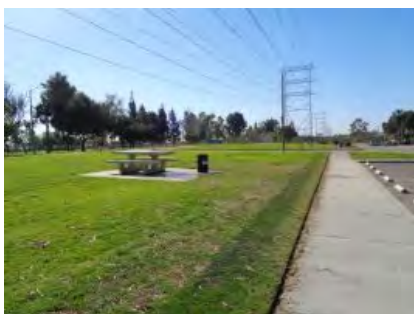
**Comment**      **HRP-008**      **Priority: 3**      **Estimated Direct Cost:**    \$600      Contractor

**Item Description:**    Tables;

**Findings:** Picnic tables are provided and are not wheelchair accessible.

**Recommendations:**  
Provide an accessible route to connect the existing walkway with the table area. Two locations.

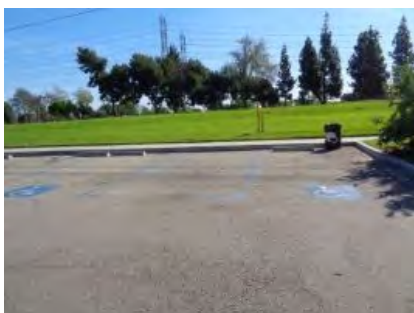
**Comment**      **HRP-009**      **Priority: 1**      **Estimated Direct Cost:**    \$60      Maintenance

**Item Description:**    Obstruction;

**Findings:** Trash barrels, when located within accessible stalls, can block the use of parking and become the source for an ADA-related lawsuit.

**Recommendations:**  
Create a policy where all accessible parking stalls are maintained free and clear of obstructions.

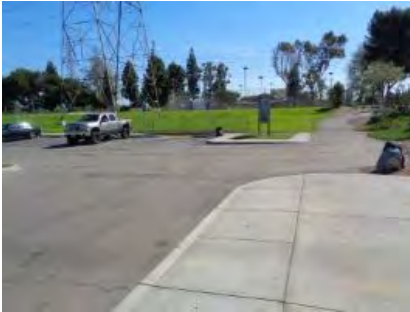
**Item Description:** Accessible Route;

**Findings:** An accessible route is not provided between accessible parking and the bike path trailhead.

**Recommendations:**  
Install a curb ramp to complete the accessible route. The existing curb ramp nearby cannot serve the accessible route as it requires one to traverse the drive aisles.

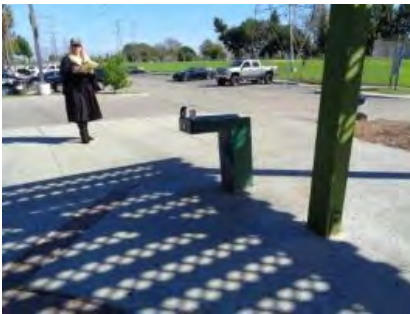
**Item Description:** Drinking Fountain;

**Findings:** DF is not dual height and pedestrian protection is not provided.

**Recommendations:**  
Replace DF with a Hi/Lo combination DF and either relocate DF outside of circulation routes or add wing walls or wing rails.

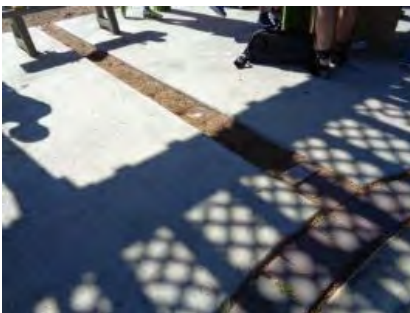
**Item Description:** Ground Surface;

**Findings:** Bricks are missing from a portion of the walkway. Concrete joints are greater than 1/2".

**Recommendations:**  
Replace bricks and seal large joints with epoxy caulking.

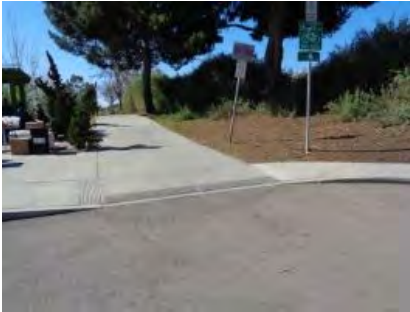
**Item Description:** Curb Ramp;

**Findings:** Ramp to bike path is missing truncated domes.

Install truncated dome mats across ramp surface, placed 6" to 8" from the curb line. Domes shall be placed across the full width of ramp.

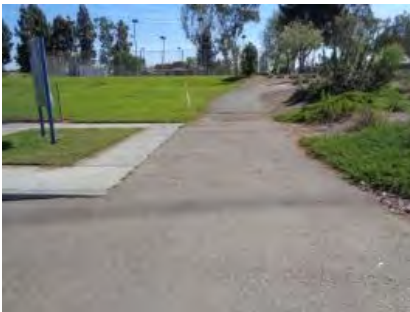
**Item Description:** Service Road;

**Findings:** Service road also serves as an accessible route. The asphalt surface is aged and damaged. Truncated domes are not provided between the walk portion and the vehicular way.

Resurface asphalt as needed. Install truncated domes across the full width of the flush transition, 36" deep in the direction of travel, in line with the curb line.

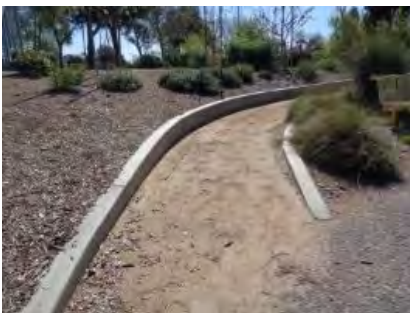
**Item Description:** Stable surface;

**Findings:** Pathway surface consists of decomposed granite (DG) and is not stable and firm, with areas of abrupt changes in level where distorted by vehicle travel and erosion.

Groom the DG pathway as needed. Consider adding stabilizing admixtures or binders to increase firmness and stability. Periodic maintenance of DG paths is required to ensure path remains stable and firm, and free of distortions.

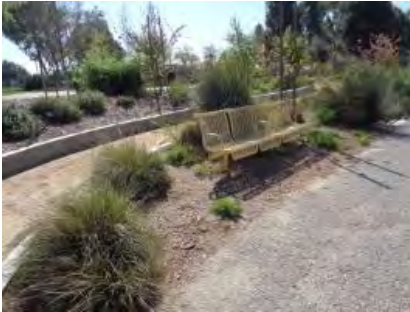
**Item Description:** Wheelchair seating area;

**Findings:** Wheelchair seating is not provided next to fixed seating.

Provide a level concrete or asphalt wheelchair seating area, 30"X48" minimum, next to fixed seating and connecting to the existing walkway.

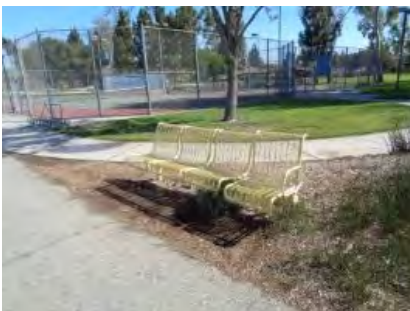
**Item Description:** Wheelchair seating area;

**Findings:** Wheelchair seating is not provided next to fixed seating.

Provide a level concrete or asphalt wheelchair seating area, 30"X48" minimum, next to fixed seating and connecting to the existing walkway.

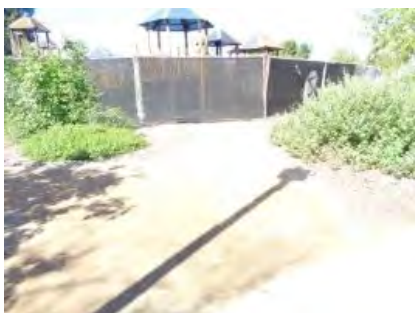
**Item Description:**     Play area;

**Findings:**     Play area was not available for survey as it was fenced-off after an arson event.

**Recommendations:**  
Play area will need to be reviewed for access compliance after reconstruction.

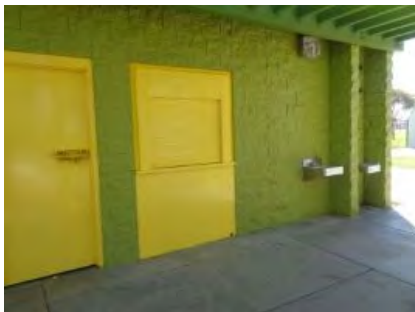
**Item Description:** Service Window;

**Findings:** Window height is not accessible at 42" AFF.

**Recommendations:**  
Lower service window to a height not greater than 34" AFF.

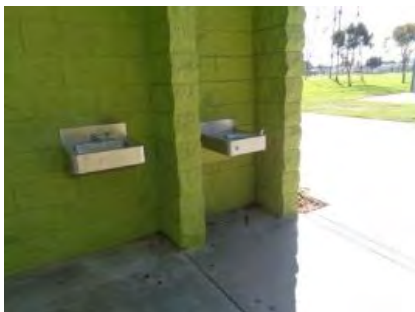
**Item Description:** Level ground area;

**Findings:** The clear ground space at the sink and drinking fountain are not level, with a slope of 3.3%.

**Recommendations:**  
Replace concrete at sink and DF, approximately 65 sq. feet.

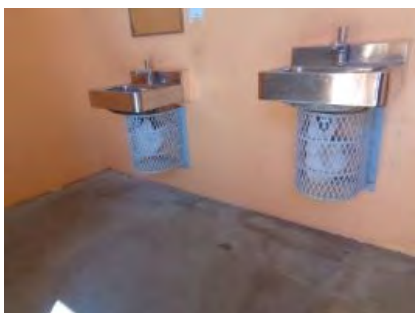
**Item Description:** Lavatory knee space;

**Findings:** The required knee space at the accessible lavatory is obstructed by the metal cage over piping.

**Recommendations:**  
Remove cage. If security of plumbing is a concern, install a metal cover which slopes back from the front. Cover shall conform to knee space requirements at lavatories. See CBC Figure 11B-306.3.

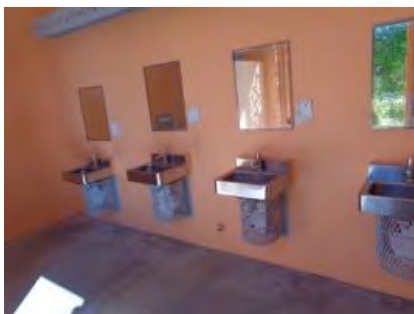
**Comment**    **HRP-025**                    **Priority: 2**            **Estimated Direct Cost:**    \$1,350                    Maintenance

**Item Description:**    Accessible Mirror; Soap Dispenser

**Findings:** The mirror over the accessible lavatory is not compliant for height. Soap dispenser is missing, however, the base on the wall indicates the dispenser was not compliant for height.

**Recommendations:**  
Lower mirror to a height not greater than 40" AFF to the lowest reflective edge. Accessible dispensers shall be no higher than 40" AFF to the highest operable part.

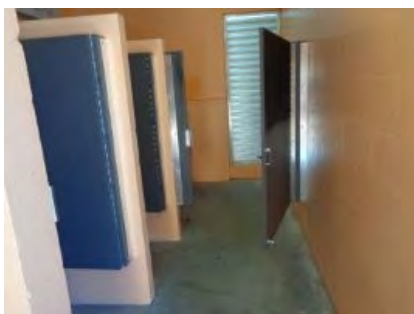
**Comment**    **HRP-027**                    **Priority: 2**            **Estimated Direct Cost:**    \$95                    Maintenance

**Item Description:**    Stall Door;

**Findings:** The accessible stall door is not self-closing.

**Recommendations:**  
Replace the self-closing hinges.

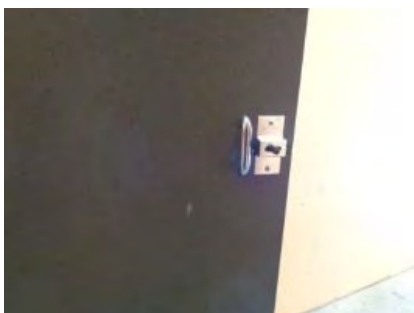
**Comment**    **HRP-028**                    **Priority: 2**            **Estimated Direct Cost:**    \$95                    Maintenance

**Item Description:**    Stall Door;

**Findings:** Accessible stall door is missing the required U-pull handle at the pull side.

**Recommendations:**  
Install a U-shaped pull handle below the latch.

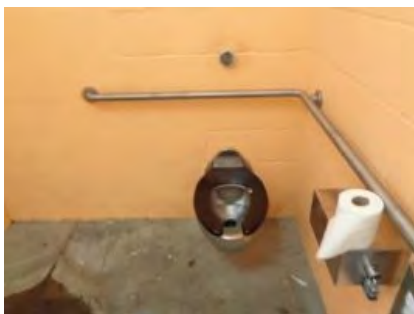
**Findings:** WC is not compliant for location, centered less than 17" from the side wall.

**Recommendations:**  
Relocate WC to provide a location of the fixture centered 17"- 18" from the side wall.

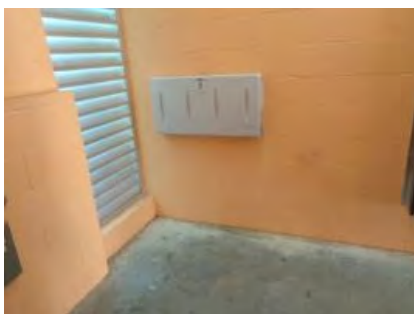
**Findings:** baby changing tables are not allowed in toilet compartments within a multiple accommodation toilet facility.

**Recommendations:**  
Remove baby changing table.

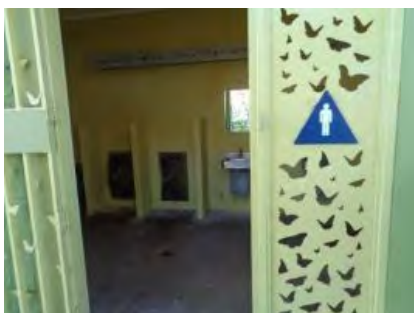
**Findings:** The geometric sign at each restroom is non-compliant for height.

**Recommendations:**  
Raise each sign to a height centered 58"- 60" AFF.

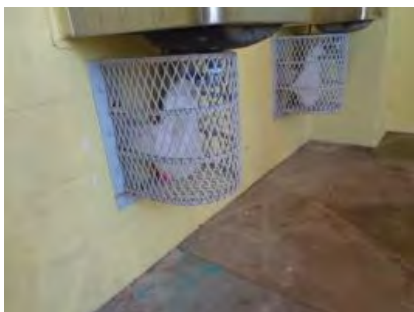
**Comment**      **HRP-032**                      **Priority: 2**              **Estimated Direct Cost:**      \$190                      Maintenance

**Item Description:**      Lavatory knee space;

**Findings:**      The required knee space at the accessible lavatory will be obstructed by the metal cage over piping.

**Recommendations:**  
Remove cage at the center lavatory. If security of plumbing is a concern, install a metal cover which slopes back from the front. Cover shall conform to knee space requirements at lavatories. See CBC Figure 11B-306.3.

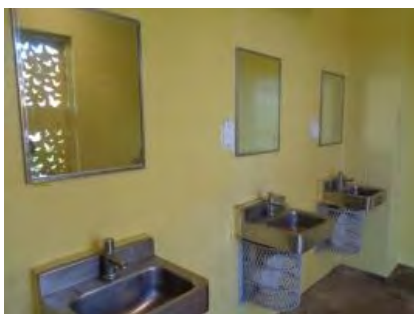
**Comment**      **HRP-033**                      **Priority: 2**              **Estimated Direct Cost:**      \$1,350                      Maintenance

**Item Description:**      Accessible Mirror; Soap Dispenser

**Findings:**      Mirrors are not compliant for height. Soap dispensers are missing, however, the baseplate on the wall indicates the dispensers were not compliant for height.

**Recommendations:**  
Lower the center mirror to a height not greater than 40" AFF to the lowest reflective edge. Provide one accessible dispenser at the center lavatory. Dispenser shall be no higher than 40" AFF to the highest operable part.

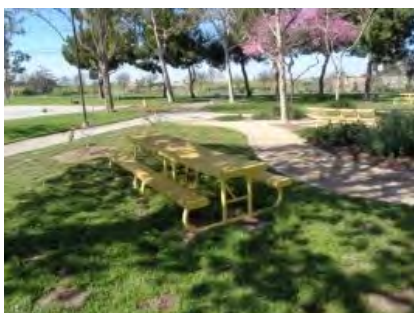
**Comment**      **HRP-035**                      **Priority: 3**              **Estimated Direct Cost:**      \$3,220                      Contractor

**Item Description:**      Table;

**Findings:**      Picnic tables are provided near play area. Tables are not wheelchair accessible.

**Recommendations:**  
Provide an accessible route to connect the existing walkway with two of the three tables near the play area. Modify tables for compliant knee space.

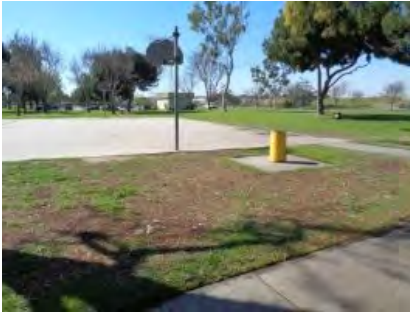
**Item Description:** Drinking Fountain;

**Findings:** DF is not dual height. DF is not located on an accessible route.

**Recommendations:**  
Connect DF pad with the walkway. Provide a combination Hi/Lo DF.

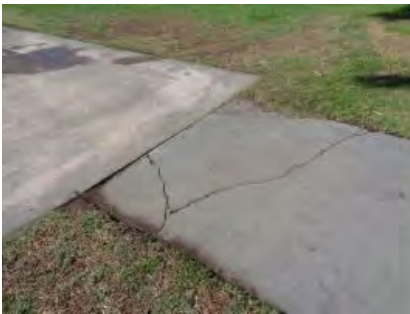
**Item Description:** Concrete path;

**Findings:** Concrete is broken, with cracks and uneven surface.

**Recommendations:**  
Replace 9 sq. ft. of concrete.

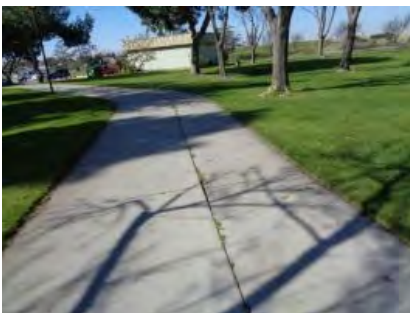
**Item Description:** Concrete path;

**Findings:** Concrete is broken, with cracks and uneven surfaces at various locations of pathway.

**Recommendations:**  
Replace concrete walkway.

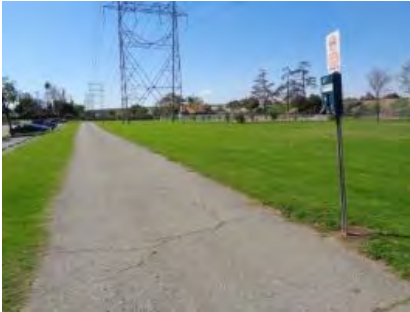
**Item Description:** Dog cleanup bag dispensers;

**Findings:** At the walk path, two post-mounted dog cleanup dispensers are not accessible due to excessive height.

**Recommendations:**  
Lower both dispensers to a height not greater than 48" to the highest operable part.

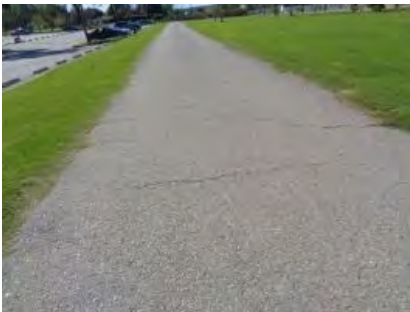
**Item Description:** Asphalt walkway;

**Findings:** Asphalt surface has not been maintained and has cracks with vegetation, heaving and uneven surfaces at various locations of pathway.

**Recommendations:**  
Repair surfaces as needed and reseal asphalt walkways.

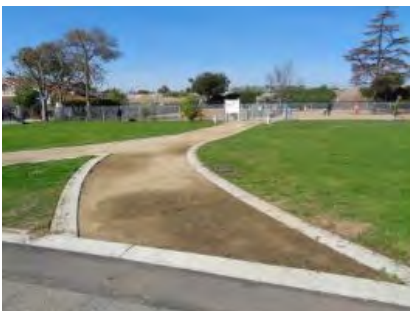
**Item Description:** Approach to Dog Park;

**Findings:** Pathway surface consists of decomposed granite (DG) and is not stable and firm, with areas of abrupt changes in level where distorted by vehicle travel and erosion.

**Recommendations:**  
Groom the DG pathway as needed. Consider adding stabilizing admixtures or binders to increase firmness and stability. Periodic maintenance of DG paths is required to ensure path remains stable and firm, and free of distortions.
