# City of South Gate

# Volume 2

## Appendix B Facilities Barrier Assessment Report

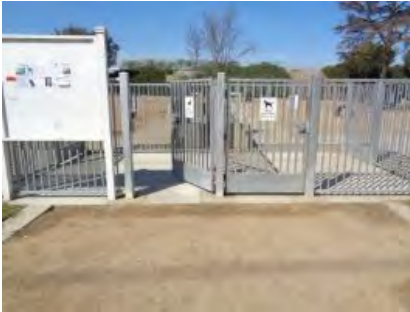
**Comment**      **HRP-042**      **Priority: 3**      **Estimated Direct Cost:**      \$500      Contractor

**Item Description:** Gate landing;

**Findings:** DG surface at edge of gate is not even with the surface of the concrete, creating an abrupt edge greater than 1/4".

**Recommendations:**  
Raise the surface of the DG walkway to meet the concrete landing.

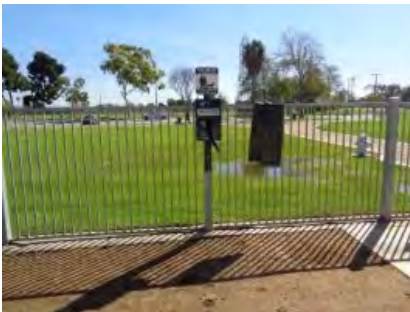
**Comment**      **HRP-043**      **Priority: 3**      **Estimated Direct Cost:**      \$190      Maintenance

**Item Description:** Dog clean-up bag dispensers;

**Findings:** At each separate dog area, the post-mounted dog clean-up dispensers are not accessible due to excessive height.

**Recommendations:**  
Lower each dispenser to a height not greater then 48" to the highest operable part.

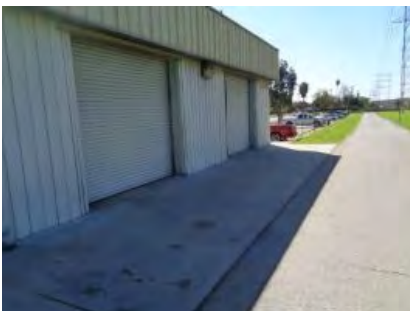
**Comment**      **HRP-044**      **Priority: 3**      **Estimated Direct Cost:**      \$2,700      Contractor

**Item Description:** Asphalt walkway;

**Findings:** Asphalt surface connection to the concrete apron of the garage is not smooth and continuous, having depressions which create abrupt edges within the walkway.

**Recommendations:**  
Walkway surface repairs shall include grinding and an overlay, as needed, to correct the low edge next to the concrete apron.

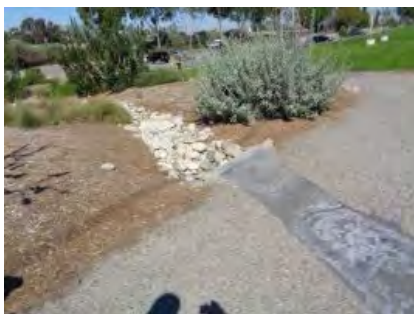
**Comment**      **HRP-045**      **Priority: 1**      **Estimated Direct Cost:**      \$120      Maintenance

**Item Description:** Drop-off;

**Findings:** Over the creek bed, at the edge of the walkway, an abrupt change in level greater than 4" occurs.

**Recommendations:**  
Provide a 6" high warning curb along the full length of the drop-off where the vertical drop is greater than 4".

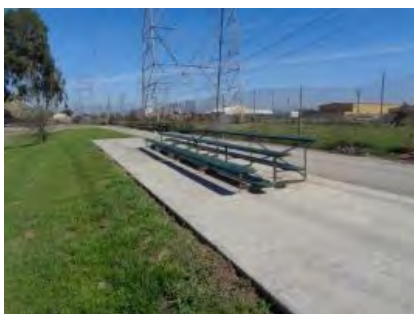
**Comment**      **HRP-046**      **Priority: 3**      **Estimated Direct Cost:**      \$1,400      Contractor

**Item Description:** Bleachers;

**Findings:** Wheelchair seating is not provided at bleachers.

**Recommendations:**  
Shorten bleacher seating at two places (one each side) to provide space for one wheelchair each, a minimum 30" wide.

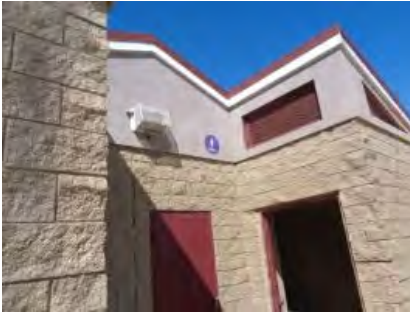
**Comment**     **HRP-048**                     **Priority: 2**             **Estimated Direct Cost:**     \$75                     Maintenance

**Item Description:**     Signs;

**Findings:** The geometric doorway signs are not compliant for height.

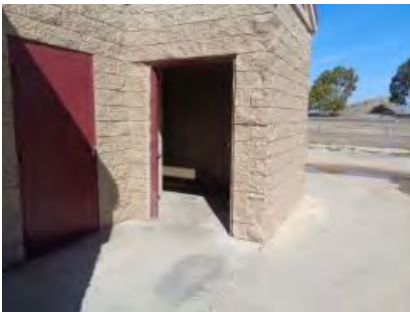
**Comment**     **HRP-049**                     **Priority: 2**             **Estimated Direct Cost:**     \$75                     Maintenance

**Item Description:**     Signs;

**Findings:** Tactile room designation signs have not been provided at the entrance doors to restrooms.

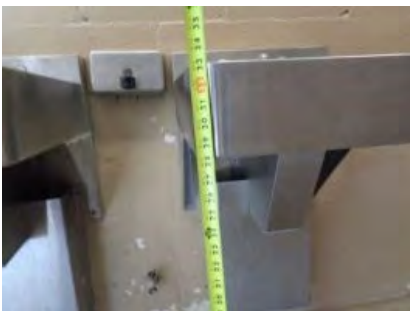
**Comment**     **HRP-050**                     **Priority: 2**             **Estimated Direct Cost:**     \$9,600                     Contractor

**Item Description:**     Lavatories;

**Findings:** Lavatories are not compliant for knee space or front apron height.

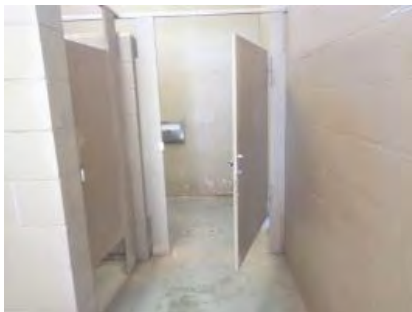
**Comment**     **HRP-051**     **Priority: 2**     **Estimated Direct Cost:**     \$60     Maintenance

**Item Description:**     Clearance at stall door;

**Findings:** The required 18" strike-side clearance at the accessible stall door is not provided.

**Recommendations:**  
Reverse the swing of the accessible stall door until alterations can be made to increase the interior clearances within the restroom, including the required 60" turning radius in front of the accessible stall door.

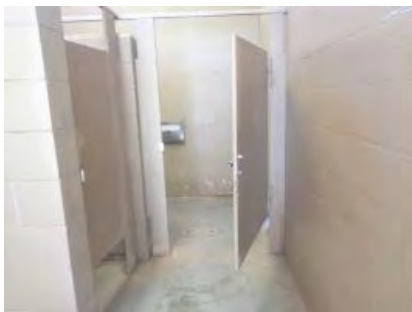
**Comment**     **HRP-052**     **Priority: 2**     **Estimated Direct Cost:**     \$95     Maintenance

**Item Description:**     Stall Door;

**Findings:** The accessible stall door is not self-closing.

**Recommendations:**  
Replace the self-closing hinges.

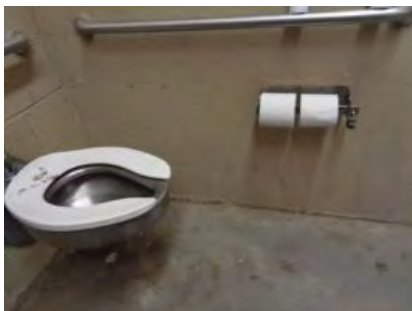
**Comment**     **HRP-053**     **Priority: 2**     **Estimated Direct Cost:**     \$1,250     Contractor

**Item Description:**     Toilet paper dispenser (TPD); Side grab bar

**Findings:** TPD is not compliant for location. Side grab bar does not project 54" from the corner.

**Recommendations:**  
Reposition dispenser. Center dispenser to 7"- 9" in front of the WC. Reposition side grab bar. See detail for dimensions.

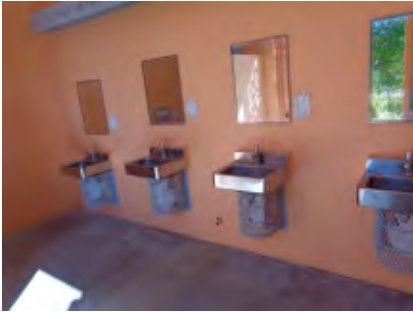
**Item Description:**     Lavatories;

**Findings:** Lavatories are not compliant for knee space or front apron height.

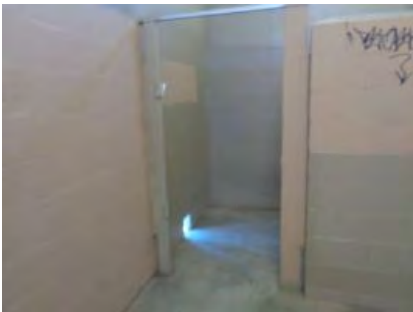
**Item Description:**     Stall Door;

**Findings:** Stall door has been removed.

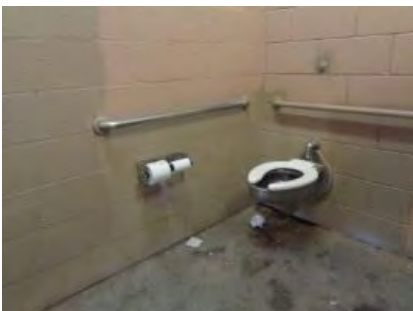
**Item Description:**     Toilet paper dispenser (TPD); Side grab bar

**Findings:** TPD is not compliant for location. Side grab bar does not project 54" from the corner.

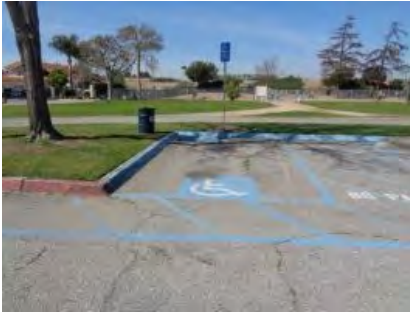
**Item Description:** Site Access; Stall surface; Access aisle stripes; Stall ISA markings

**Findings:** The Accessible parking stall requires traversing the vehicular area with no crossing. Paint is faded and the asphalt surface has not been maintained. Stall slopes at wheel stop are greater than 2.1% Diagonal stripes within the access aisle is blue and not contrasting with the parking surface. Stall ISA markings are not compliant for size and do not have a white border.

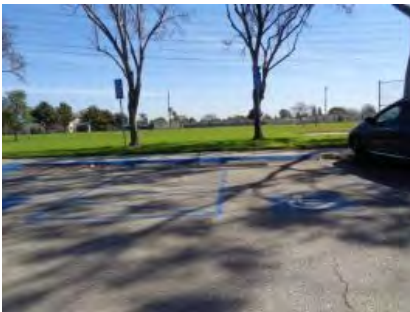
**Item Description:** Curb Ramp;

**Findings:** The existing stall layout is not compliant as it uses a curb ramp to the left of the left accessible stall. This requires a person from the right stall to wheel or walk behind a parked vehicle other than their own.

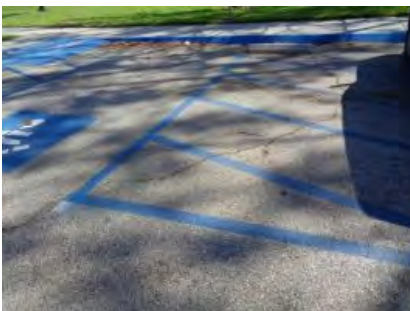
**Item Description:** Stall surface; Access aisle stripes; Stall ISA markings; Access aisle

**Findings:** Asphalt surface has not been maintained and is cracking. Diagonal stripes within the access aisle fails to provide the required visual contrast with the parking surface. Stall ISA markings are not compliant for size or proportion and do not have the required white border. The existing wheel stop inside the access aisle is an obstruction to the required clear space.

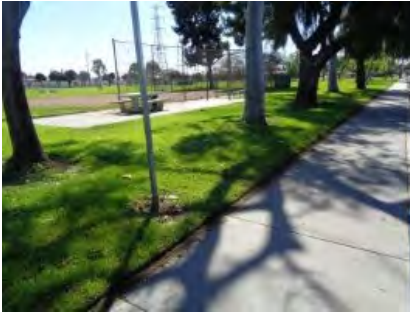
**Item Description:**      Site access;

**Findings:** An accessible route is not provided to the boundary of the ball field.

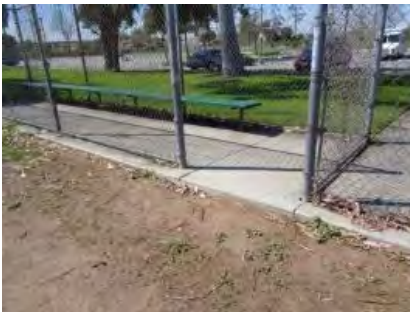
**Item Description:**      Dug Outs;

**Findings:** The field level is lower than the concrete in the dug outs, creating an abrupt edge.

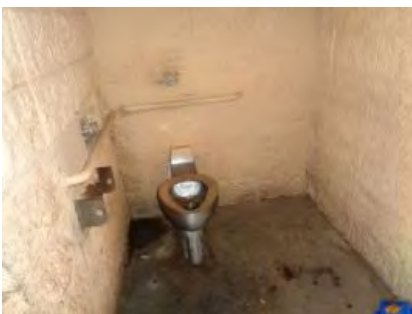
**Item Description:** Accessible Restrooms;

**Findings:** A wheelchair accessible restroom is not provided.

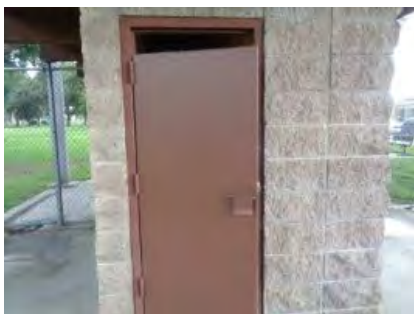
**Item Description:**     Restroom signs;

**Findings:** Restroom is not identified with the required geometric door sign.

**Recommendations:**  
At the restroom door provide a Unisex geometric restroom sign.

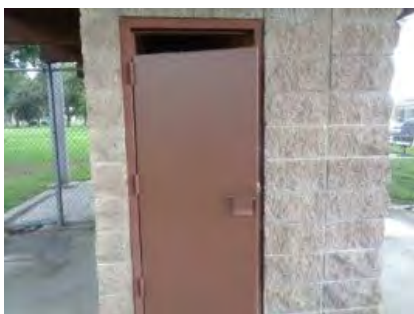
**Item Description:**     Outdoor restroom;

**Findings:** Restroom is not accessible.

**Recommendations:**  
Provide a compliant directional sign indicating the location of the nearest accessible restroom at Walnut St.

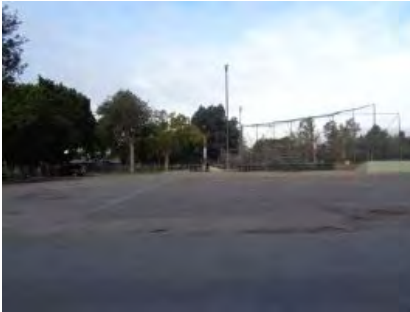
**Item Description:** Accessible Parking;

**Findings:** The parking area serving the ball fields has not been maintained. The parking surface is greatly damaged with cracks, heaving and pot holes. The number of stalls available cannot be determined due to faded paint. There is no indication that accessible parking was ever provided in this lot.

**Recommendations:**  
Resurface parking area and provide new accessible stalls. The number of accessible stalls shall be determined from the overall number of parking stalls and ADA Table 208.2. New accessible stalls shall be located on an accessible route, closest to the ball fields.

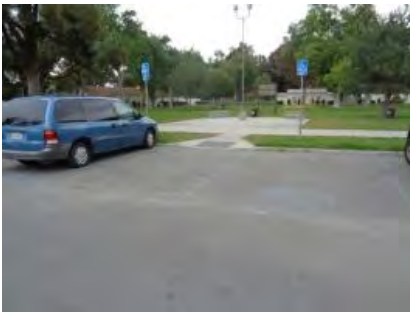
**Item Description:** Number of Stalls; Stall surface

**Findings:** Parking space for 76 vehicles is provided. Only two accessible stalls have been installed and 3 are required. Stall striping is greatly faded.

**Recommendations:**  
Create one additional accessible parking stall, located at the street parking area, to serve Farmers Market activities. Reseal parking area and restripe accessible stalls.

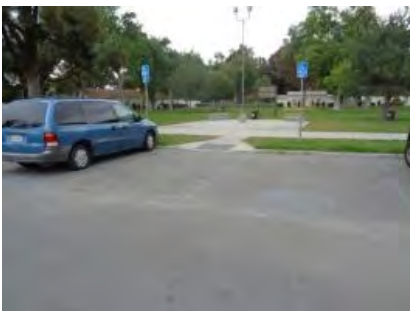
**Item Description:** Access aisle stripes;

**Findings:** Diagonal stripes within the access aisle fails to provide the required visual contrast with the parking surface.

**Recommendations:**  
Re-stripe access aisles with white diagonal stripes, 36" O.C. maximum when over asphalt. Interrupt white diagonal stripes at area of white lettering stating "NO PARKING". Access aisle borders shall remain blue.

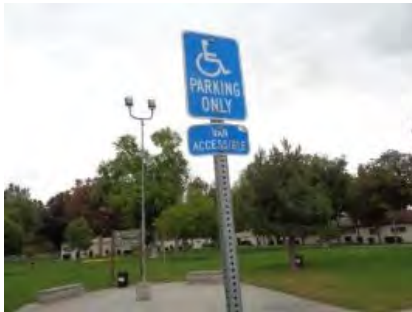
**Item Description:** Stall signs;

**Findings:** The additional stall signs stating "MINIMUM FINE \$250" are not provided.

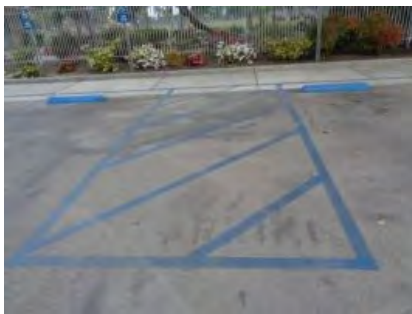
**Item Description:** Access aisle stripes; Stall markings

**Findings:** Diagonal stripes within the access aisle fails to provide the required visual contrast with the parking surface. The words "NO PARKING" are not painted on the ground within the access aisles.

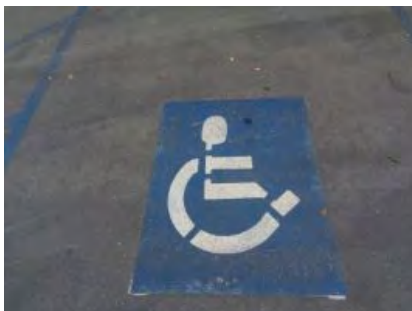
**Item Description:** Stall ISA markings;

**Findings:** Stall ISA pavement signs are not compliant. The proportions are wrong and the ISA's do not have the required white border.

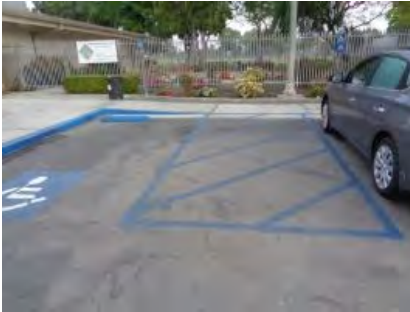
**Item Description:** Detectable warning surface;

**Findings:** The parallel curb ramp serving the accessible stalls is missing the required truncated domes.

**Recommendations:**  
Install a truncated dome mat across the full width of the ramp surface, 36" deep in the direction of travel at both ends of ramp.

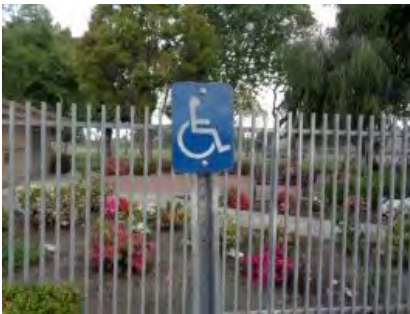
**Item Description:** Stall signs;

**Findings:** The required additional signs stating "MINIMUM FINE \$250" is missing at each stall.

**Recommendations:**  
At each stall sign add the required "MINIMUM FINE \$250" sign immediately beneath the existing sign. The lowest edge of the lowest sign shall be no less than 60" above the ground.

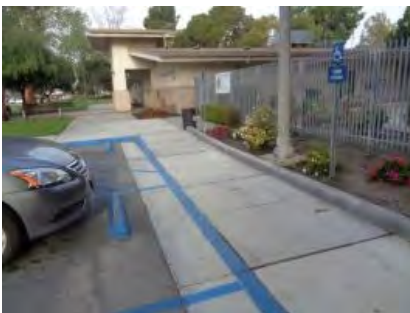
**Item Description:** Stall signs;

**Findings:** The stall closest to the building is not designated as a Van stall.

**Recommendations:**  
Remove the sign stating "VAN ACCESSIBLE" from the second stall closest to the building and post it at the first stall.

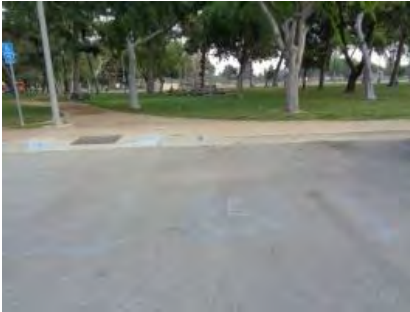
**Item Description:** Number of Stalls; Access aisle stripes

**Findings:** Parking space for 68 vehicles is provided. Only two accessible stalls have been installed and 3 are required. Diagonal stripes within the access aisle fails to provide the required visual contrast with the parking surface.

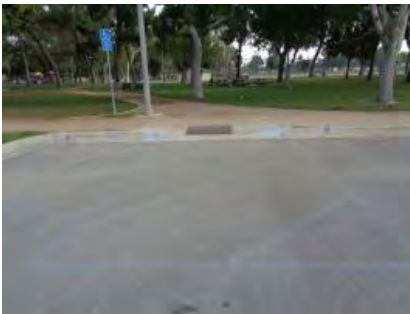
**Item Description:** Stall markings; Stall ISA markings

**Findings:** The words "NO PARKING" are not painted on the ground within the access aisles. Stall ISA pavement signs do not have the required white border.

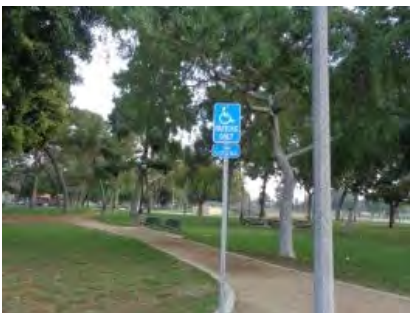
**Item Description:** Stall signs;

**Findings:** The additional stall signs stating "MINIMUM FINE \$250" are not provided.

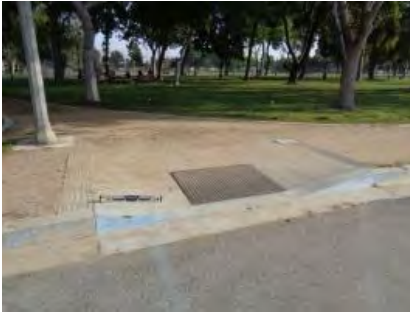
**Item Description:** Curb ramp;

**Findings:** The side curb ramp flare slopes are greater than 10% and were found to be 14%.

**Recommendations:**  
Demolish both sides of curb ramp and construct new side flares using the least slope possible, not to exceed 10% (1:10).

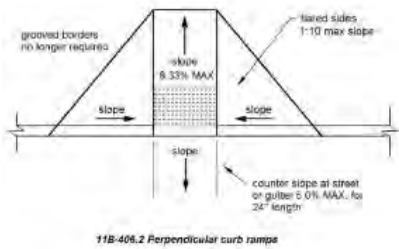
**Item Description:** Curb ramp; Detectable Warning Surface

**Findings:** The existing built-up curb ramp can remain to serve the single accessible stall. Truncated domes are not provided at curb ramp.

**Recommendations:** Resurface ramp as needed. When striping the new Van stall, no portion of the ramp slope shall project into the area of the stall. After resurfacing, provide a truncated dome mat at the ramp surface, 48" wide and 36" in the direction of travel.

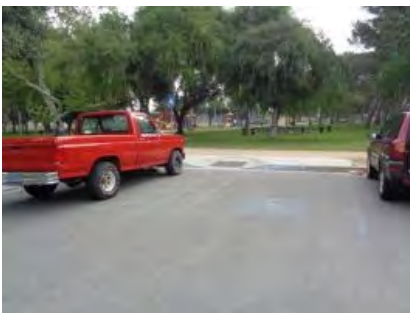
**Item Description:** Stall striping; Stall markings; Stall ISA markings

**Findings:** Striping is faded. The words "NO PARKING" are not painted on the ground within the access aisles. Stall ISA pavement signs do not have the required white border.

**Recommendations:** Reseal parking surface. Restripe accessible parking stalls. Provide lettering in white, a minimum 12" high, stating "NO PARKING", located at the foot of each access aisle. ISA pavement signs shall be a minimum 36" high with a white border.

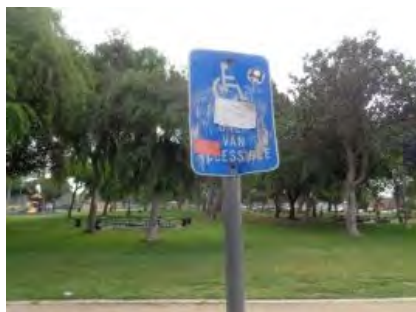
**Item Description:**      Stall signs;

**Findings:** The sign at the Van stall has been damaged and the required additional sign stating "MINIMUM FINE \$250" is missing. The right stall is missing the sign post and required signs.

**Recommendations:**  
Replace the Van sign and add the required "MINIMUM FINE \$250" sign. At the right stall provide a new post with ISA sign and Fine sign.

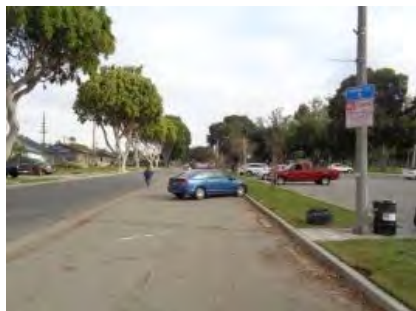
**Item Description:**      Number of Stalls;

**Findings:** Parking space for 109 vehicles is provided. Only one accessible stall has been installed and 5 are required.

**Recommendations:**  
Create new accessible parking stalls, dispersed at both ends of parking area.

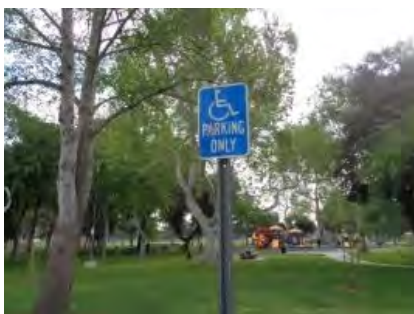
**Findings:** Stall sign post is missing the additional sign stating "MINIMUM FINE \$250"

Add the required "MINIMUM FINE \$250" sign.

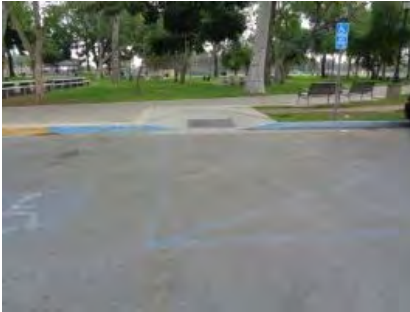
**Item Description:** Stall signs; Curb ramp; Access aisle stripes; Stall ISA markings

**Findings:** The sign post and signs at the left Van stall are missing. The curb ramp side flare slopes are greater than 13%. Diagonal stripes within the access aisle fails to provide the required visual contrast with the parking surface. Stall ISA pavement sign do not have the required white border.

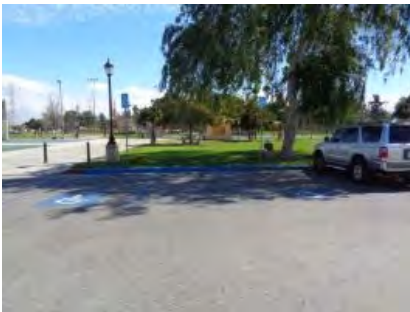
**Item Description:** Number of Stalls;

**Findings:** Parking space for 162 vehicles is provided. Only 5 accessible stalls have been installed and 6 are required.

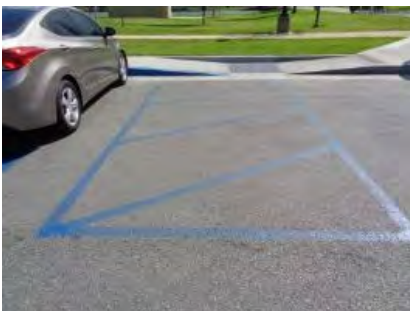
**Item Description:** Access aisle stripes; Curb ramp; Stall markings

**Findings:** Diagonal stripes within the access aisle fails to provide the required visual contrast with the parking surface. Curb ramp access is not fully within the boundary of the access aisles. The words "NO PARKING" are not painted on the ground within the access aisles.

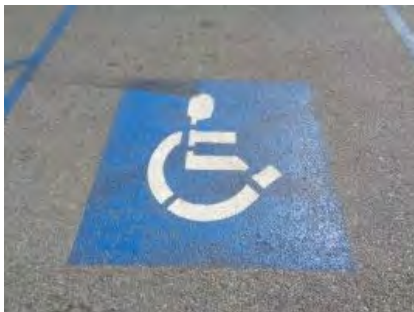
**Item Description:** Stall ISA markings;

**Findings:** Stall ISA markings are not compliant for size or proportion and do not have the required white border.

**Recommendations:**  
Provide a larger ISA at the stall. Symbol shall be a minimum 36" high with a white border.

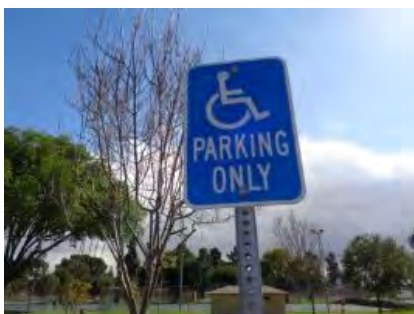
**Item Description:** Stall signs;

**Findings:** Each of the five accessible stalls are missing the additional sign stating "MINIMUM FINE \$250"

**Recommendations:**  
Add the required "MINIMUM FINE \$250" sign at each stall. The lowest edge of the lowest sign shall be 80" minimum above the ground.

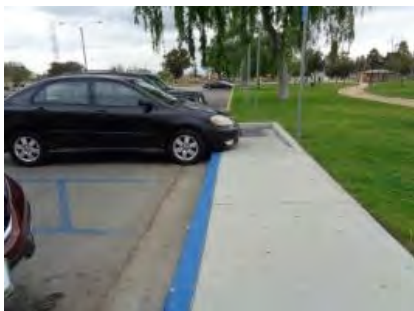
**Item Description:** Wheel Stops;

**Findings:** Wheel stops are not provided to prevent the overhang of parked vehicles from reducing the width of the walkway.

**Recommendations:**  
Add a wheel stops at both accessible parking stalls which overhang the accessible route.

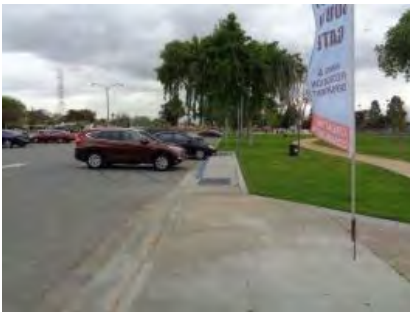
**Findings:** The service road driveway apron is missing the required truncated domes.

Provide truncated domes across the full width of apron, over the slope of the apron.

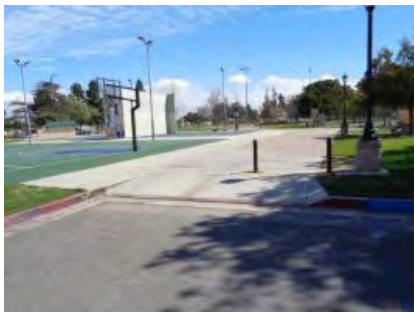
**Comment**      **SGP-054**      **Priority: 1**      **Estimated Direct Cost:**      \$2,016      Contractor

**Item Description:**      Service Road Driveway;

**Findings:** The service road driveway apron is missing the required truncated domes.

**Recommendations:**  
Provide truncated domes across the full width of apron, over the slope of the apron.

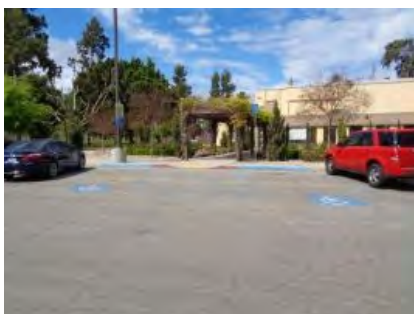
**Comment**      **SGP-055**      **Priority: 1**      **Estimated Direct Cost:**      \$5,600      Contractor

**Item Description:**      Number of Stalls; Stall surface

**Findings:** Approximately 130 vehicle parking spaces are provided. Only 2 accessible stalls have been installed and 5 are required. Reseal the cracked asphalt surface as needed.

**Recommendations:**  
Reseal the cracked asphalt surface as needed and re-paint: Create three (3) additional accessible stalls with compliant access aisle. Provide blue stalls with the ISA symbol in a white border. Insure that the stalls and access aisle do not have slope in any direction that exceeds 2.0 % grade. Provide an access aisle with a blue border, white hatched lines and the letters "No Parking" in white. Reseal the cracked asphalt surface as needed and re-stripe the existing accessible stalls and access aisles.

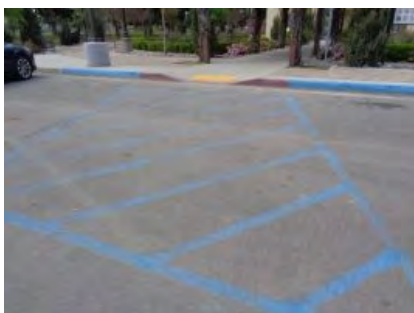
**Comment**      **SGP-057**      **Priority: 1**      **Estimated Direct Cost:**      \$1,100      Contractor

**Item Description:**      Access aisle stripes; Stall markings

**Findings:** Diagonal stripes within the access aisle fails to provide the required visual contrast with the parking surface. Stalls shall be located as close as possible to the Auditorium entrance doors. The words "NO PARKING" are not painted on the ground within the access aisle.

**Recommendations:**  
Re-stripe access aisles with white diagonal stripes, 36" O.C. maximum when over asphalt. Interrupt white diagonal stripes at area of white lettering stating "NO PARKING". Access aisle borders shall remain blue. Provide lettering in white, a minimum 12" high, stating "NO PARKING", located at the foot of the access aisle.

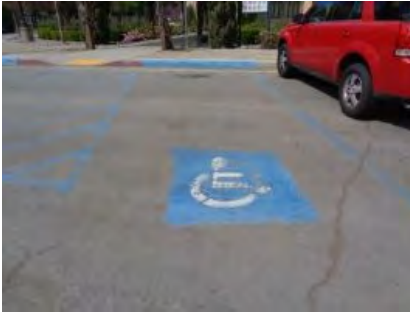
**Item Description:** Stall ISA markings;

**Findings:** Stall ISA pavement signs do not have the required white border.

**Recommendations:**  
ISA pavement signs shall be a minimum 36" high with a white border.

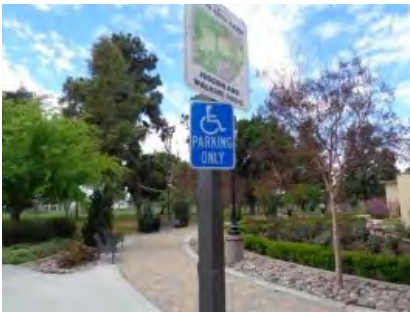
**Item Description:** Stall signs;

**Findings:** Each of the accessible stalls is missing the additional required sign stating "MINIMUM FINE \$250".

**Recommendations:**  
Add the required "MINIMUM FINE \$250" sign at each stall. The lowest edge of the lowest sign shall be 80" minimum above the ground.

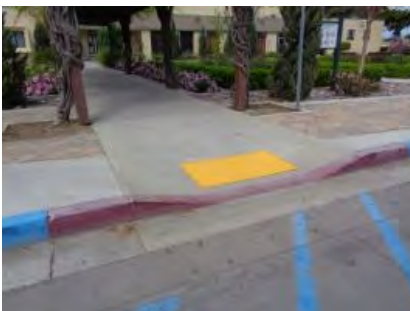
**Item Description:** Curb Ramp; Curb Ramp

**Findings:** The side flares of the curb ramp are not compliant due to excessive slopes, 19% at the left side and 21% at the right side. The truncated dome mat at curb ramp is undersized at 24" deep and placement on ramp is incorrect.

**Recommendations:**  
Demolish both sides of curb ramp and construct new side flares using the least slope possible, not to exceed 10% (1:10). Remove and replace the truncated dome mat. New mat shall measure 36" deep and 48" wide. The mat shall be positioned where the edge nearest the curb is 6 inches to 8 inches from the line at the face of the curb.

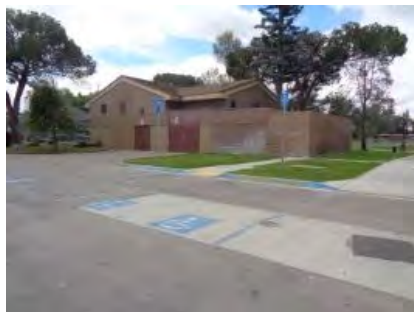
**Item Description:** Accessible stall layout; Stall surfaces

**Findings:** Three accessible stalls improperly share one access aisle. A second access aisle can not be added due to service road. Asphalt surfaces have not been maintained and the surface is cracking and heaving.

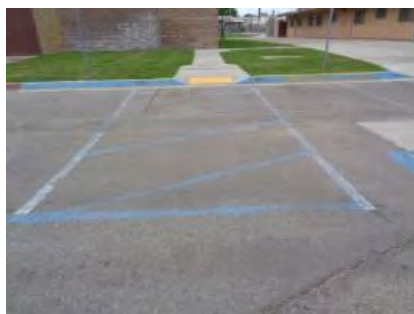
**Item Description:** Access aisle stripes; Stall markings

**Findings:** Diagonal stripes within the access aisle fails to provide the required visual contrast with the parking surface. The words "NO PARKING" are not painted on the ground within the access aisle.

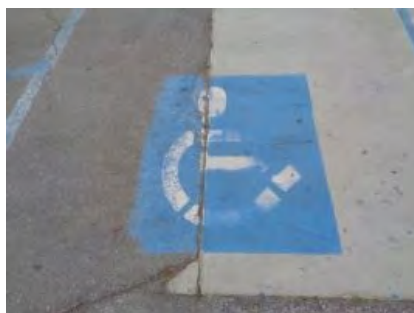
**Item Description:** Stall ISA markings;

**Findings:** Stall ISA pavement signs do not have the required white border.

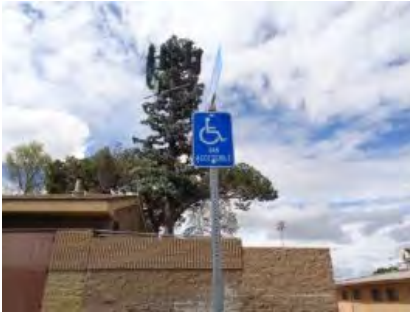
**Findings:** Each of the accessible stalls is missing the additional required sign stating "MINIMUM FINE \$250".

Add the required "MINIMUM FINE \$250" sign at each stall. The lowest edge of the lowest sign shall be 80" minimum above the ground.

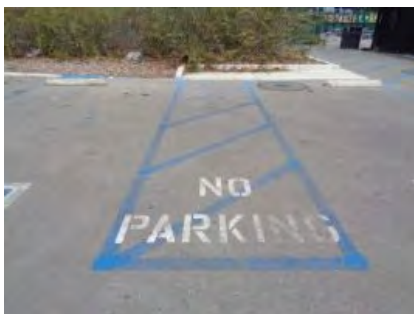
**Item Description:** Access aisle stripes - all stalls;

**Findings:** Diagonal stripes within the access aisle fails to provide the required visual contrast with the parking surface.

**Recommendations:**  
Re-stripe access aisle with white diagonal stripes, 36" O.C. maximum when over asphalt. Interrupt white diagonal stripes at area of white lettering stating "NO PARKING". Access aisle borders shall remain blue.

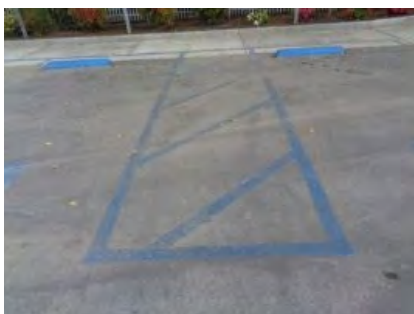
**Item Description:** Stall ISA markings;

**Findings:** Stall ISA pavement signs are not compliant for height.

**Recommendations:**  
Repaint ISA pavement signs, The ISA symbol shall be a minimum 36" high and have a white border.

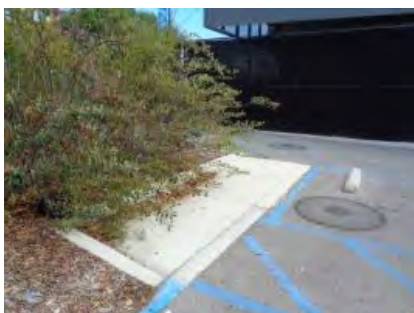
**Item Description:** Curb Cut obstruction;

**Findings:** The required clear width of the curb cut is obstructed by overhanging branches.

**Recommendations:**  
Trim back branches. Vertical clearance shall be to 80" minimum over the walkway.

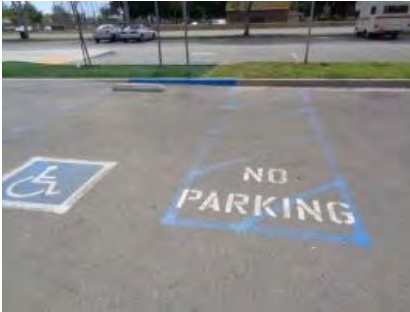
**Item Description:** Access aisle width;

**Findings:** Access aisle (single stall) is not compliant for width or length at 4'-8" wide and 17'-8" long.

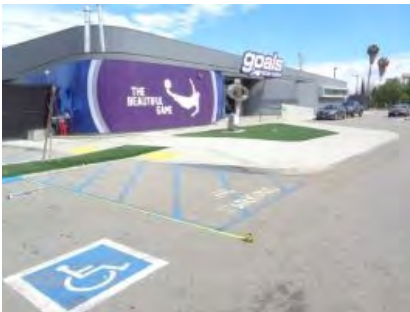
**Item Description:** Van stall length; Van stall slope

**Findings:** Van stall (South stall) is not compliant for length at 17'-8" long. Slope of stall and access aisle is not compliant at 2.8%. Stall slopes to curb ramp.

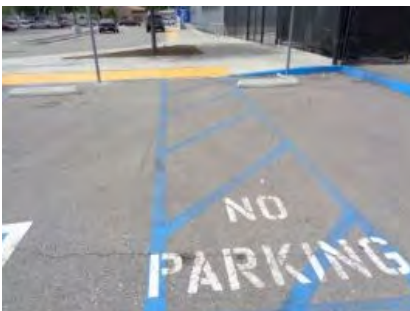
**Item Description:** Stall striping; Access aisle stripes

**Findings:** Striping is faded. Diagonal stripes within the access aisles fail to provide the required visual contrast with the parking surface.

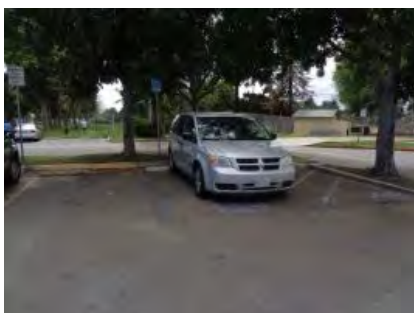
**Findings:** Asphalt surfaces have not been maintained. The surface is damaged, heaving and striping is greatly faded.

Resurface parking stall as needed, including leveling and restripe a new Van accessible stall.

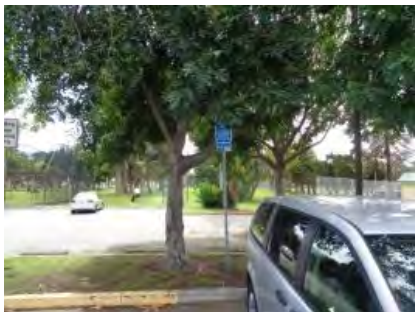
**Comment**      **SGP-083**      **Priority: 1**      **Estimated Direct Cost:**      \$60      Maintenance

**Item Description:**      Stall Signs;

**Findings:** Stall signs are obscured from view due to over-growth of tree branches.

**Recommendations:**  
Trim branches as needed to allow full view of posted stall signs.

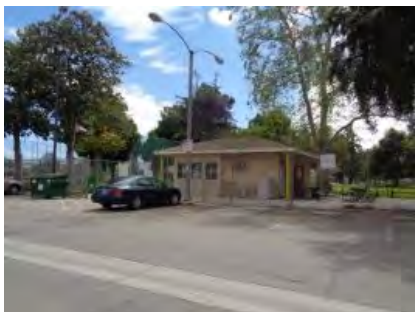
**Comment**      **SGP-084**      **Priority: 1**      **Estimated Direct Cost:**      \$2,250      Contractor

**Item Description:**      Accessible Parking;

**Findings:** Accessible parking is not provided for the golf facility.

**Recommendations:**  
Provide three accessible parking stalls with one being a Van accessible stall having an 8 foot wide access aisle. Provide an accessible route, a minimum 48" wide, across the front of the stalls. Provide wheel stops to prevent parked vehicle overhang from reducing the width of the accessible route.

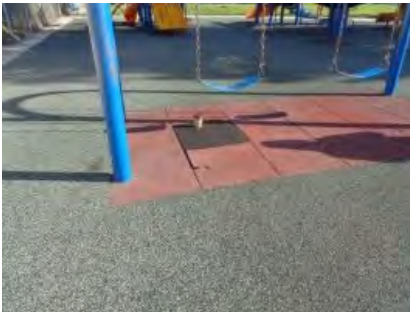
**Comment**    **SP-001**                      **Priority: 3**            **Estimated Direct Cost:**    \$190                      Maintenance

**Item Description:**    Soft ground surface;

**Findings:** Ground surface at swings is damaged and worn.

**Recommendations:**  
Repair soft ground surface.

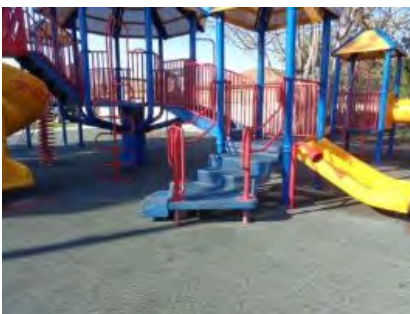
**Comment**    **SP-002**                      **Priority: 3**            **Estimated Direct Cost:**    \$10,190                      Contractor

**Item Description:**    Transfer platform; Contrasting stripes

**Findings:** The required transfer space next to the transfer platform is obstructed by support posts. The required contrasting stripes are not provided at transfer steps.

**Recommendations:**  
Modify location of platform supports to provide a transfer space immediately next to platform without interference. Provide contrasting stripes in white. The stripes shall be a minimum of 2 inches wide to a maximum of 4 inches wide placed parallel to, and not more than 1 inch from, the nose of the step or upper approach. The stripes shall extend the full width of the steps.

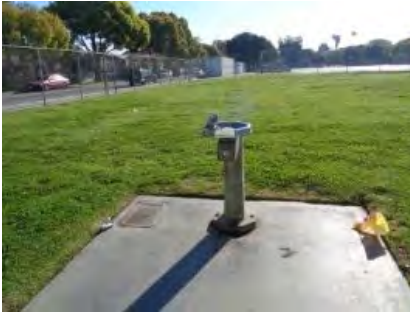
**Item Description:** Drinking fountain;

**Findings:** DF is not accessible. Spout angle is 45 degrees from the front edge. Push button is recessed.

**Recommendations:**  
Remove and replace with a compliant DF conforming to CBC 602.1

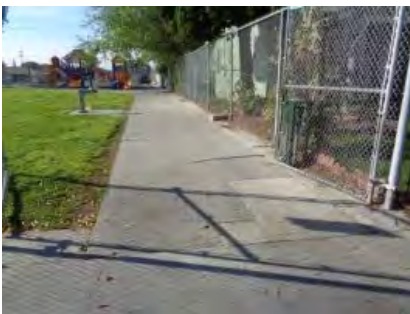
**Item Description:** Concrete walkway;

**Findings:** Walkway has broken and heaving slabs.

**Recommendations:**  
Remove and replace damaged concrete.

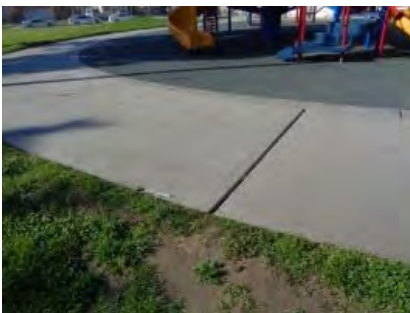
**Item Description:** Concrete joints;

**Findings:** Concrete walkway has excessive slab joints up to 2" wide.

**Recommendations:**  
Fill 18 slab joints with epoxy caulk. Each slab is 8 feet wide.

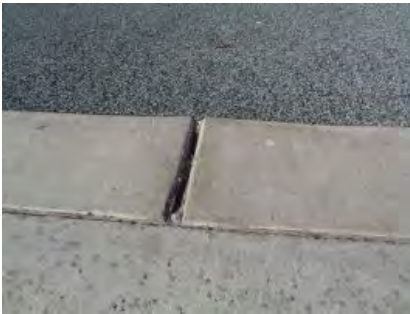
**Item Description:** Concrete joints;

**Findings:** Concrete ring surrounding play structure has excessive joints.

**Recommendations:**  
Fill all joints with epoxy caulk as needed.

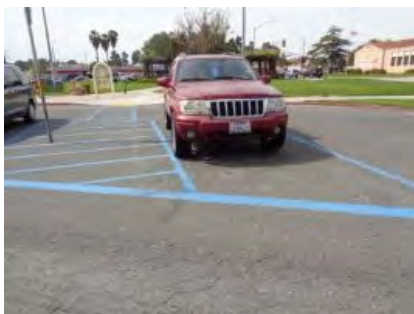
Item Description: Stall width;

Findings: Parking stall is 8 feet wide which does not meet the required minimum width of 9 feet.

Recommendations: Restripe stall to a minimum 9 feet wide.

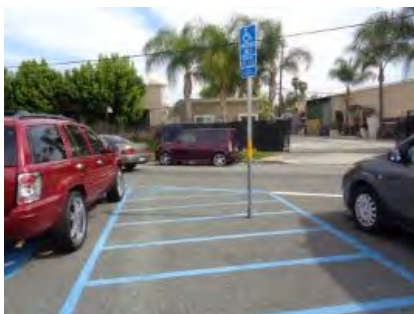
**Item Description:** Access Aisle;

**Findings:** Access aisle is not free of obstruction due to sign post.

Remove sign post from access aisle to the head of the accessible parking stall. Add one wheel stop to prevent parked vehicle overhang from striking sign post.

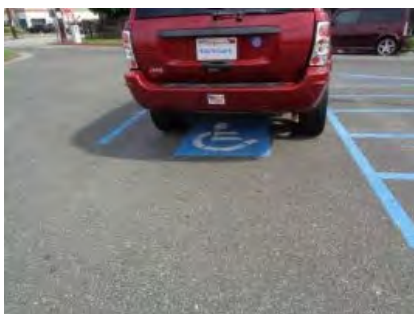
**Item Description:** Pavement ISA;

**Findings:** ISA sign is not compliant for display as the required border is not provided.

Provide a white border around the ISA symbol.

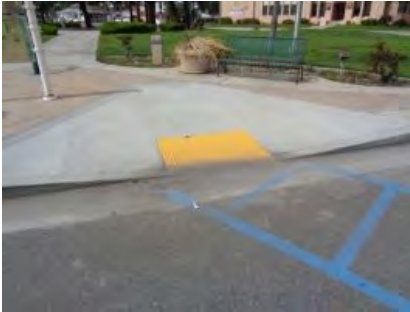
**Item Description:** Curb Ramp;

**Findings:** Ramp shows signs of water accumulation.

Demolish and rebuild gutter at curb ramp. Raise elevation of gutter to prevent the accumulation of water.

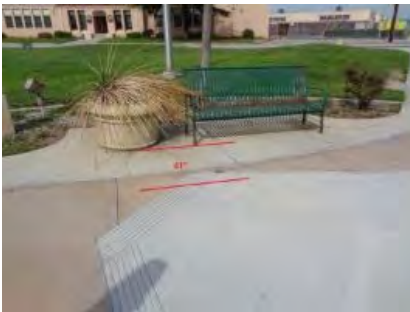
**Item Description:** Curb Ramp Landing;

**Findings:** The top landing of curb ramp is obstructed to a 41" depth due to location of bench and potted plant.

Move potted plant and bench back from curb ramp as needed to provide a minimum landing depth of 48".

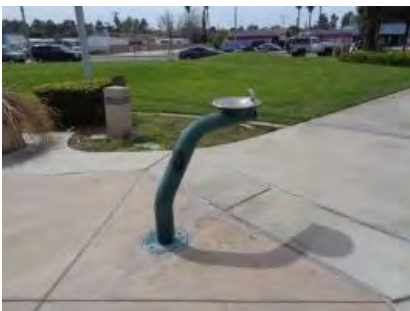
**Item Description:** Drinking Fountain;

**Findings:** DF is not located to prevent contact with pedestrians.

Relocate DF outside of the path of travel. Cost includes moving the drinking fountain and the drinking fountain's associated plumbing. Concrete will need to be removed for access and replaced.

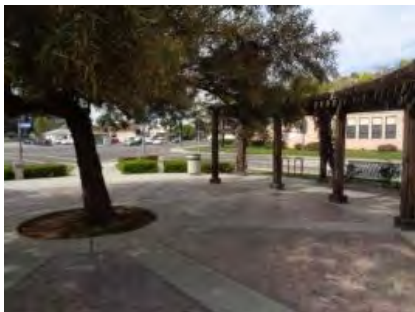
**Item Description:** Overhead Obstruction;

**Findings:** Tree branches reduce the overhead vertical clearance to less than 80 inches.

**Recommendations:**  
Trim branches and maintain a vertical clearance of 80" minimum over walkways.
